Fracture Analysis of Generator Fan Blades

Mahmood Sameezadeh and Hassan Farhangi

This chapter reports the failure investigation of a rotating axial flow fan of the Iran Montazer-Ghaem-VI 123 MW capacity generator unit. The unit was equipped with two rotating fans, one at each end namely at the turbine side and the exciter side of the generator. The failed fan consisting of 11 blades was mounted on the generator-rotor at the

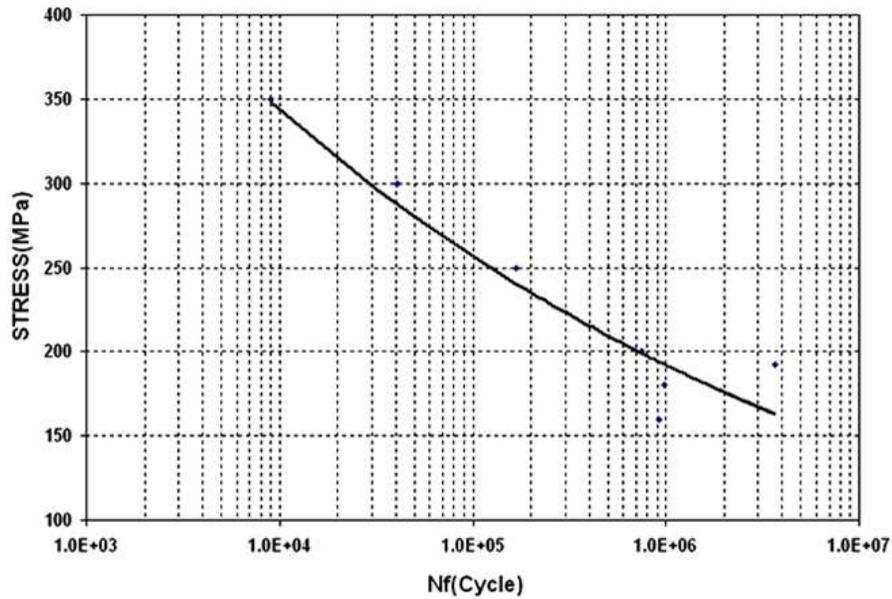
The measured lifetime versus applied stress from the rotary bending fatigue test is presented in Fig. 3. A SEM micrograph taken from the fracture surface of a tested specimen

Figure 3. Fatigue test S-N curve

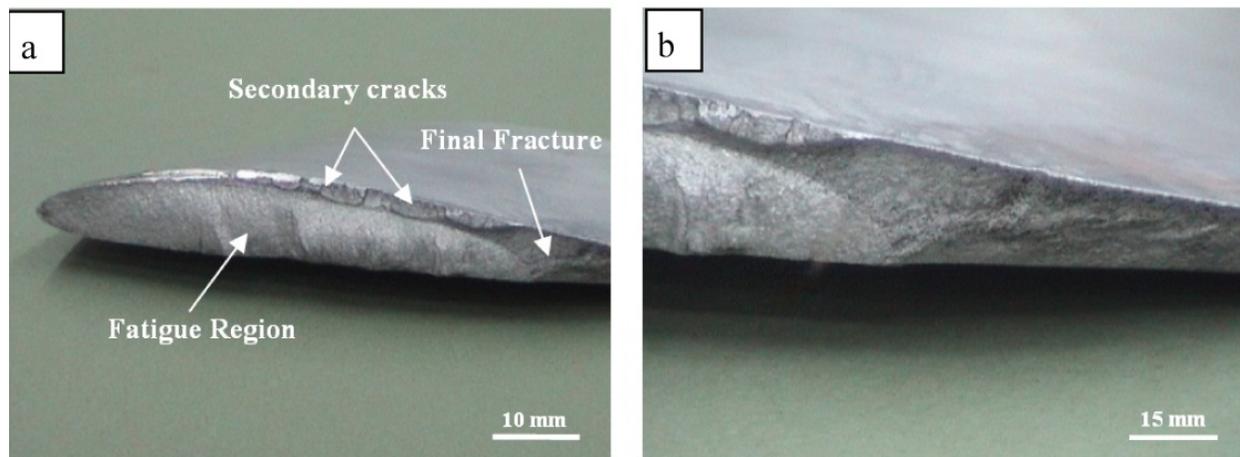
representative fractograph of the fracture surface of blade No. 8 is shown in Fig. 7a. It is observed to consist of two distinct regions at low magnification, a semi-elliptical and smooth region which is oriented normal to the blade axis and exhibits a macroscopically brittle appearance, and an outer region with a rougher and more ductile appearance. The transition from semi-elliptical region to the outer region can be clearly identified in Fig. 7b. In this region the remaining cross section of the blade failed by tensile overload.

Figure 7. (a) Fracture surface of blade No. 8, (b) transition from fatigue to tensile overload fracture

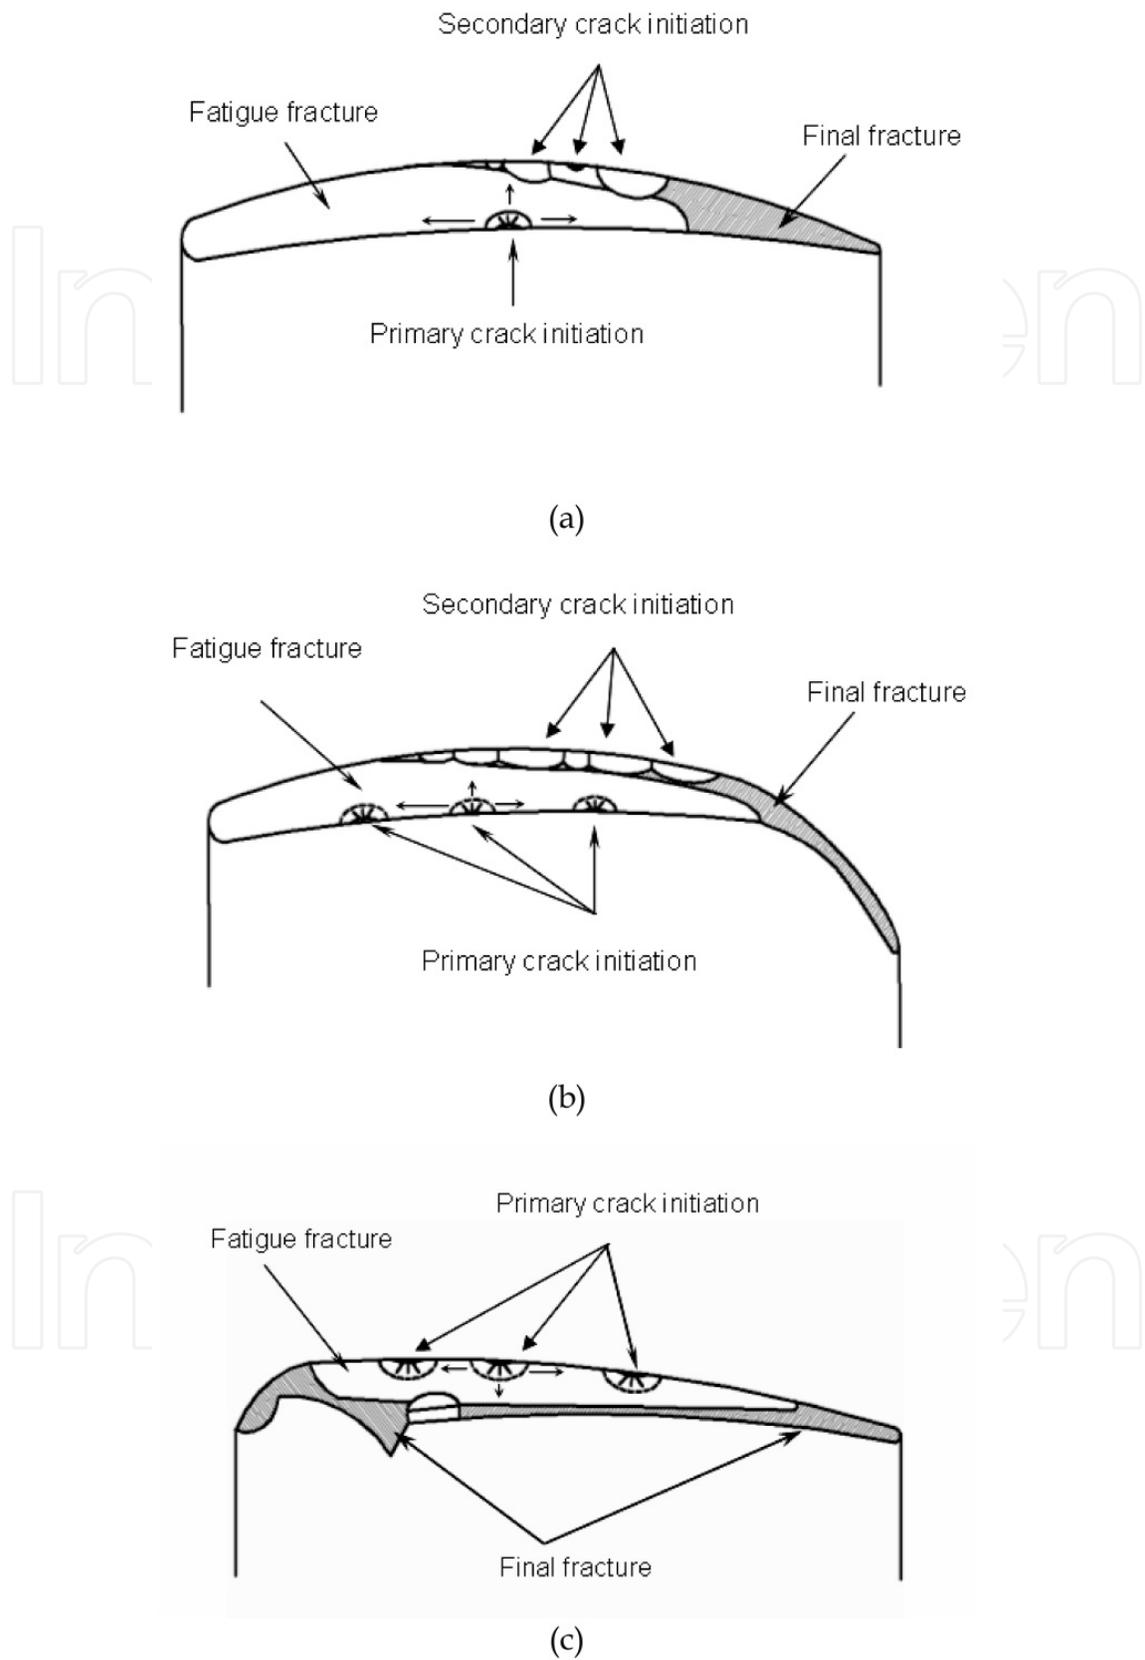
Table 3 shows the crack lengths which are measured on the surface of cracked blades. Schematic drawings of the fracture surfaces of three broken fan blades which show multiple crack initiation sites as well as the macroscopic crack growth paths are presented in Fig. 11. Also, For the first and the second fractured blades (blades No. 1 & No. 8), primary crack initiation sites are located on the concave side of the airfoils near the centre where the cross-sectional area is high. Primary cracks have coalesced during fatigue crack growth to form shallow semi-elliptical crack geometry and have propagated to reach the final cracks. In

addition, several small semi-elliptical cracks are also shown to have initiated from the opposite convex side of the airfoils.

According to Fig. 11 the presence of shallow semi-elliptical cracks on both concave and convex sides of the airfoils is indicative of the influences of considerable bending stresses during crack propagation.

Figure 11. Schematic drawings of the fracture surfaces: (a) blade No. 1, (b) blade No. 8 and (c) blade No. 11

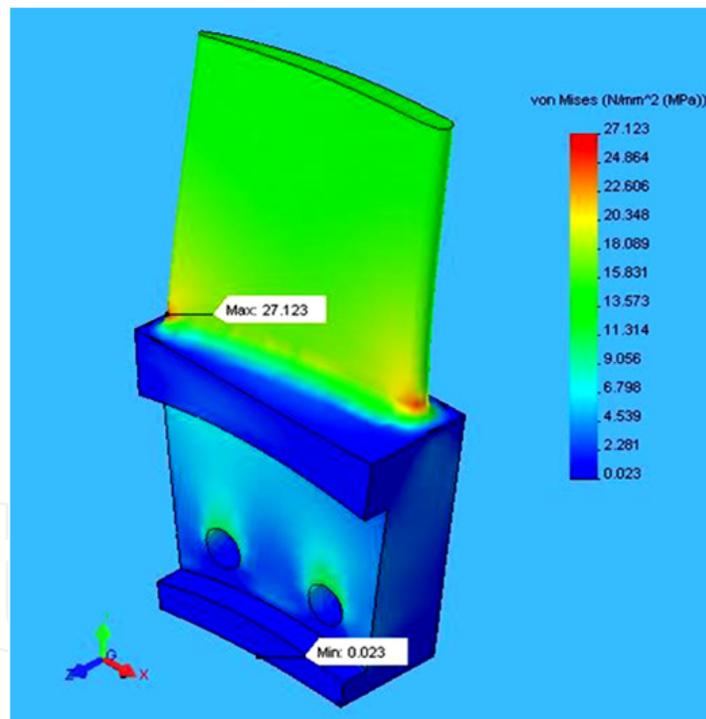
A 3D finite element model was used to simulate the normal operation of the fan blades. The results revealed that the maximum total stress acting on the blade under normal condition was about 27 MPa which occurred close to the transition radius between the airfoil and the root where the cracks initiated in fractured blades (Fig. 14) (Ataei, 2006). The bending stress introduced by the action of the air flow pressure are less important (Cohen, 1987) and was estimated as about 7 MPa. According to the results, the steady state stresses are very low in comparison with the strength of the blade material therefore, it can be concluded that the fracture accident was happened during an abnormal condition.

Figure 14. Finite element simulation of the fan blade, which shows the stress distribution under normal operating condition (Ataei, 2006)
