Abrasive Effects Observed in Concrete Hydraulic Surfaces of Dams and Application of Repair Materials

José Carlos Alves Galvão,
Kleber Franke Portella and Aline Christiane Morales Kormann
*Federal Technological University of Paraná, Institute of Technology for Development,
Federal University of Paraná
Brazil*

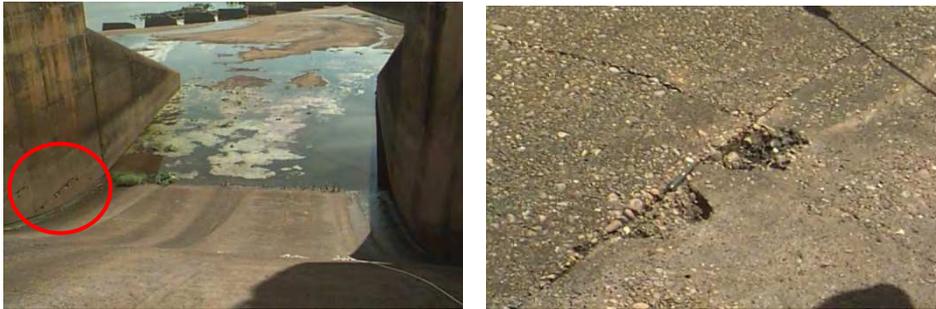
When performed visual inspection of the dam in southeastern Brazil were analyzed various structures such as the surface of the spillway surface of the slab, side walls, pillars of the gates and blocks of dissipation. These structures were found several points of deterioration and abrasive processes.

Is shown in Fig. 2a, overview of the spillway. It is observed that the wall of the gate shows signs of erosion (highlighted). Is shown in Fig 2b, defect in a slab of the spillway caused by abrasion.

Fig. 2. (a) Spillway dam presented deterioration by abrasion. (b) Defects in the concrete structure caused by abrasive process

As noted in the inspections, the state of degradation of the dam due to abrasion processes requires additional repairs to the concrete hydraulic structure. To repair the dam shown in Fig, were proposed four types of RM: mortar with silica fume, epoxy mortar, mortar and polymer concrete with steel fibers. These repair materials were evaluated for mechanical properties of strength and durability. The highlight is the test of abrasion resistance according to ASTM C 1138. The samples subjected to abrasion tests were evaluated according to the wear surface.

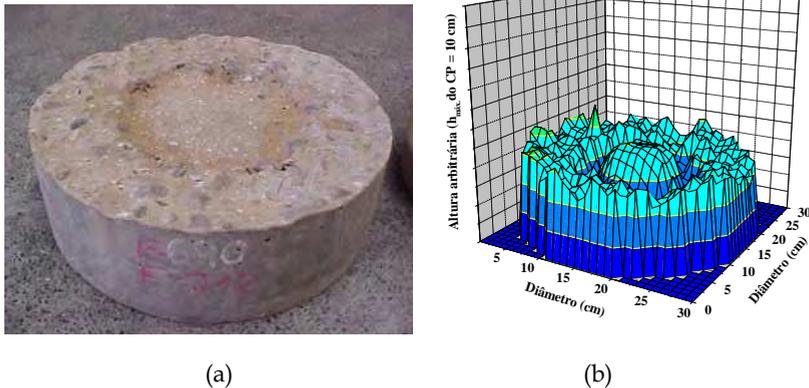
The average mass loss for the substrate system | mortar with silica fume was 5.53% and was virtually in the region of the substrate and the interface between both materials.

Fig. 4, shows the performance of the system substrate | mortar with silica fume, 72 hours after the test.

Fig. 4. Results of testing of abrasion resistance of the RM with silica fume. (a) Specimen after test. (b) 3D schematic graph of wear occurred in the abrasion resistance test (underwater method).

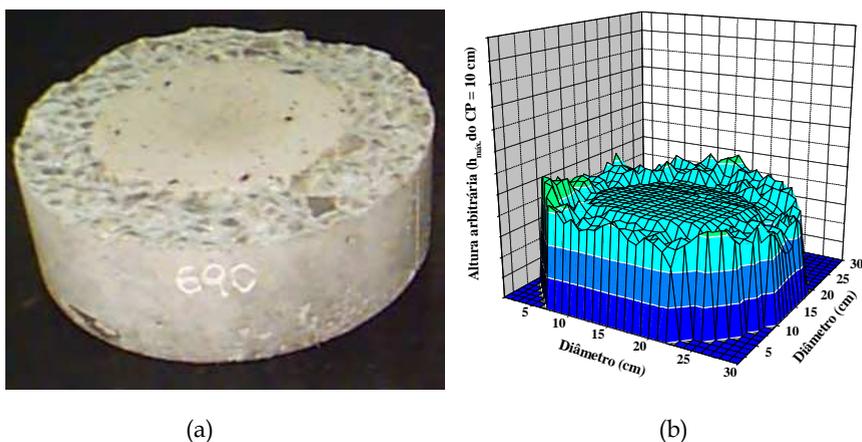
The mass loss for the substrate system | epoxy mortar was averaging 2%. It can be seen in Fig. 5 that much of the material was extracted from the substrate, with little influence in the region of interface. This effect can be attributed to high compressive strength of the material (over 90 MPa).

Fig. 5. Results of testing of abrasion resistance of the RM with epoxy mortar . (a) Specimen after test. (b) 3D schematic graph of wear occurred in the abrasion resistance test (underwater method).

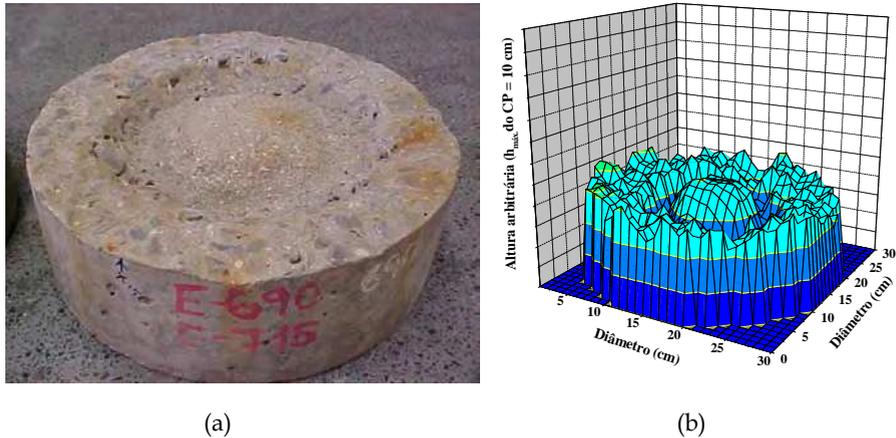
In Fig. 6, shows the performance of the system substrate | polymer mortar. The average weight loss was 6.4% and located in the substrate interface | polymer mortar.

Fig. 6. Results of testing of abrasion resistance of the RM with polymer mortar . (a) Specimen after test. (b) 3D schematic graph of wear occurred in the abrasion resistance test (underwater method).

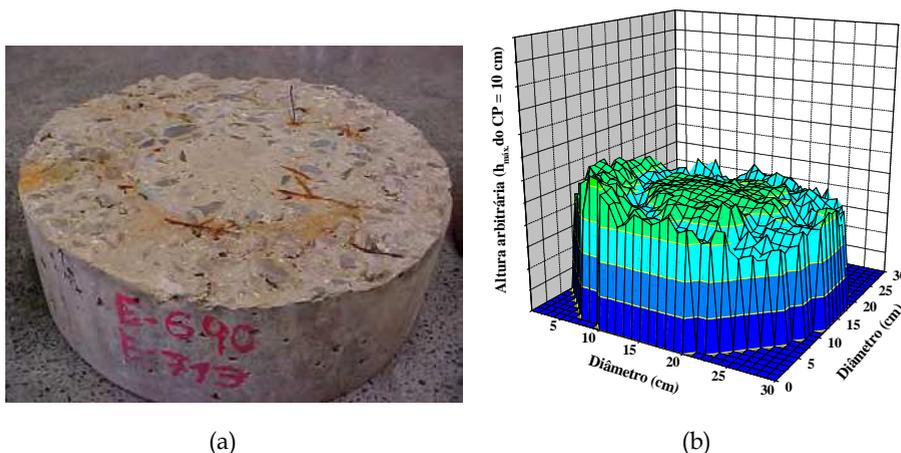
The effect of abrasion on the test substrate system | concrete with steel fibers was also not very pronounced. The mass loss was more intense in the region of RC, as shown in Fig. 7.

Fig. 7. Results of testing of abrasion resistance of the RM with concrete with steel fibers. (a) Specimen after test. (b) 3D schematic graph of wear occurred in the abrasion resistance test (underwater method).

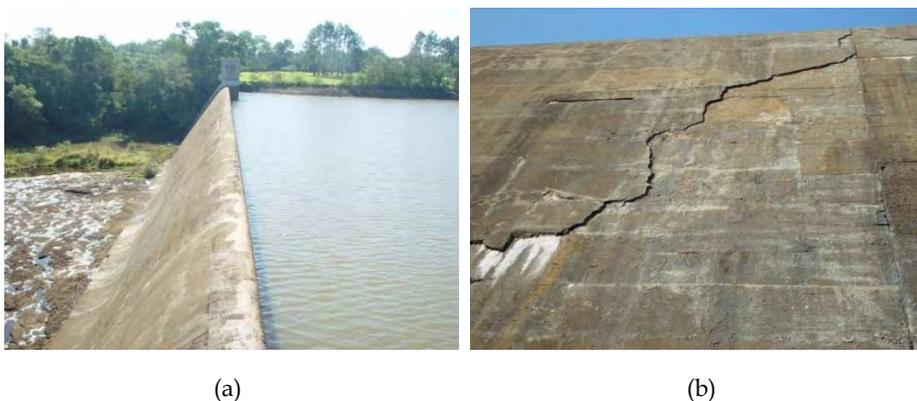
In Fig. 8a presents the overview of the spillway of the dam and in Fig. 8b, a detail of the displacement of the surface caused by hydraulic abrasive processes.

Fig. 8. (a) Overview of the spillway of the dam. (b) Detail of the displacement of the surface caused by hydraulic abrasive processes.

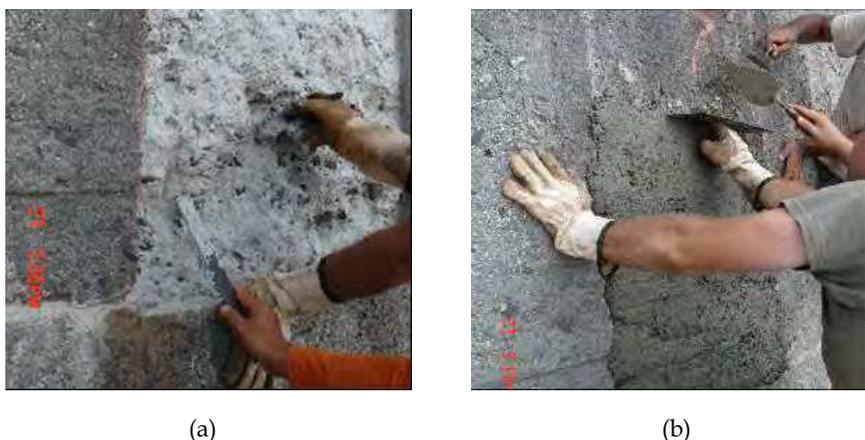
Fig. 10. (a) Application of bridge bonding. (b) Launch of the repair material.

As a bridge bonding was applied on the dry surface substrate, a structural adhesive epoxy resin of high viscosity (Fig. 10a). This care has been taken to ensure good bond strength between the substrate and RM.

The concrete was cast into the point of application of the substrate with a trowel and pestle, removing air bubbles from the material (Fig. 10b).

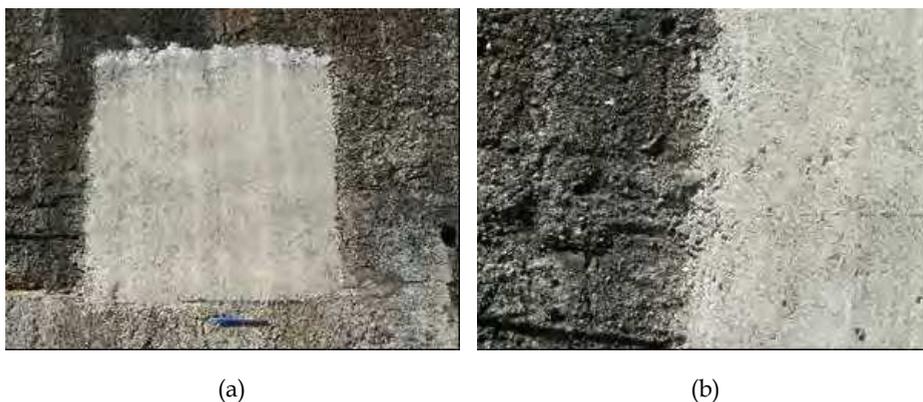
It can be seen in Fig. 11a the repair material applied to the surface of the hydraulic concrete structure is well adhered to the substrate. In the detail of Fig. 11b the interface between old concrete and the RM applied not showed flaws or defects, even after the period of water flow in the spillway of the dam and the middle attacks.

Fig. 11. Application point of repair material. (a) Reference concrete without additions. (b) Detail of the border between the RM and the substrate.

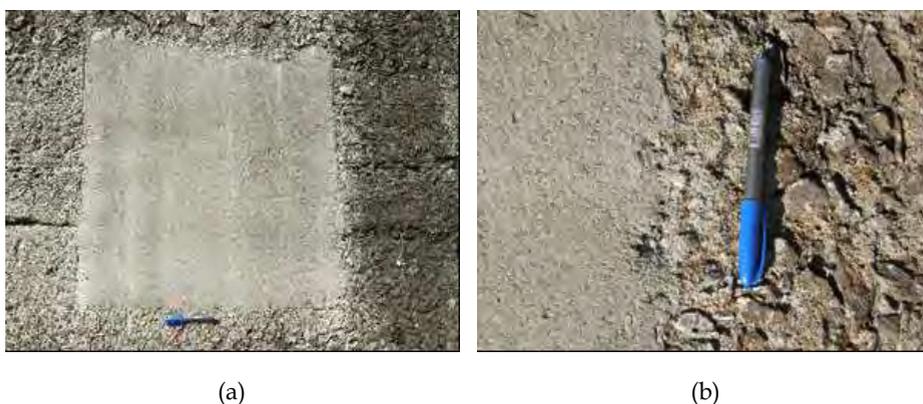
Fig. 12. Application point of repair material. (a) Concrete with addition of recycled LDPE in the content of 2.5%. (b) Detail of the border between the RM and the substrate.

It appears that the point of application above a superior performance compared with other repair materials. At this point the surface has good finish, smooth and free of imperfections, even after the occurrence of water flow in the spillway and aggression in the middle. At no point were visually observed cracks or fissures.

The defects in the substrate were completely contained at this point of application of RM made of concrete with added content in 2.5% recycled LDPE material.
