Fracture Analysis of Generator Fan Blades

Mahmood Sameezadeh and Hassan Farhangi

This chapter reports the failure investigation of a rotating axial flow fan of the Iran Montazer-Ghaem-VI 123 MW capacity generator unit. The unit was equipped with two rotating fans, one at each end namely at the turbine side and the exciter side of the generator. The failed fan consisting of 11 blades was mounted on the generator-rotor at the

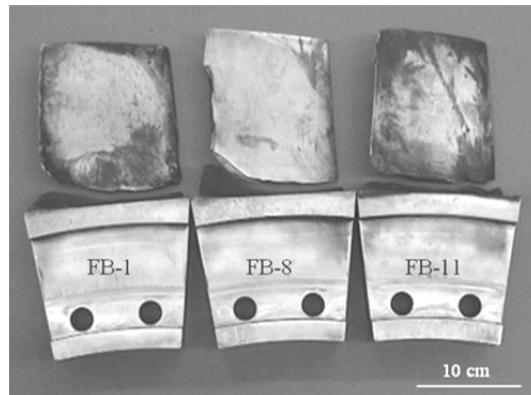
Visual inspections indicated that the accident has led to three different categories for the fan blades of the turbine side (Table 1). Dye penetrant testing revealed the cracked blades which did not completely fracture during the accident. A photograph of the fractured blades, labelled in according with their location on the fan is shown in Fig. 2.

Figure 2. Fractured fan blades

The fracture location of the broken blades can be identified from Fig. 2. It can be seen that the fracture had occurred close to the transition radius between the blade airfoil and the blade root. All the fracture surfaces exhibited very similar macroscopic features. A

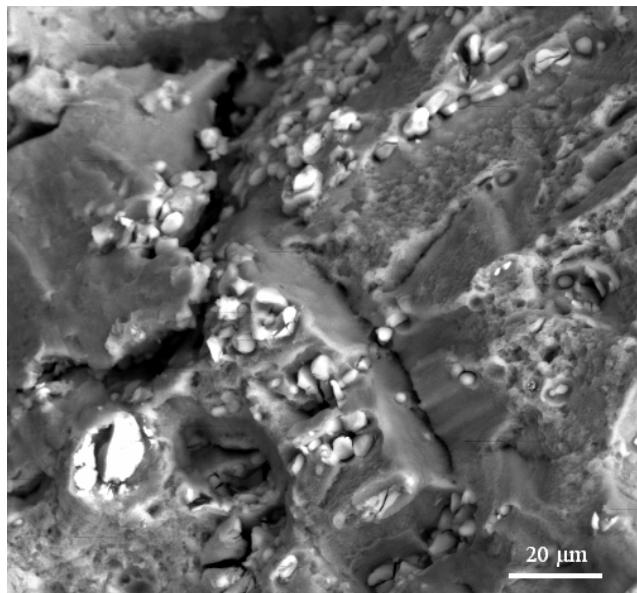
The measured lifetime versus applied stress from the rotaty bending fatigue test is presented in Fig. 3. A SEM micrograph taken from the fracture surface of a tested specimen

is shown in Fig. 4. Presence of several second phase particles on the surface is obvious. This kind of large particles can accelerate the fatigue crack initiation and affect the fatigue behaviour of the blade material.

Figure 4. Fracture surface of a fatigue test specimen

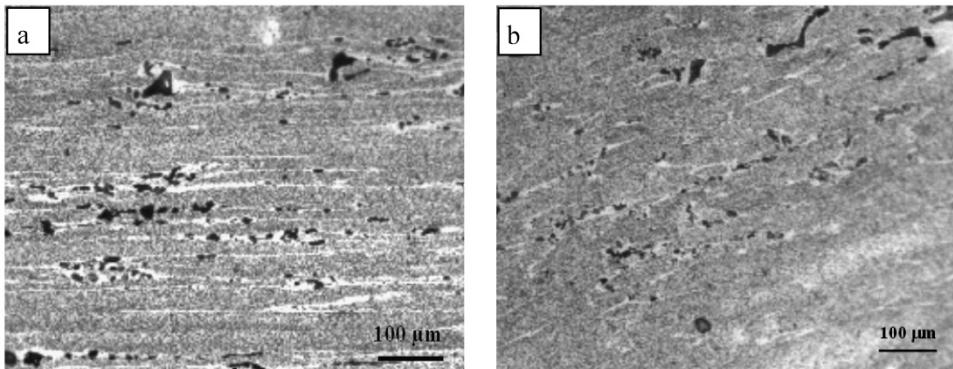
Typical microstructures of the blade material in the longitudinal and transverse sections of a cracked airfoil are shown in Fig. 5. The microstructure consists of elongated grains and second phase particles in the longitudinal direction. Various types of second phase particles can be identified in the SEM micrograph, shown in Fig. 6. The large and elongated particle on the micrograph was subjected to EDS analysis. The composition of the particle contained iron, copper and aluminum which is consistent with the β -phase ($\text{Al}_7\text{Cu}_2\text{Fe}$) particles common to aluminum alloys (Merati, 2005).

Figure 5. Microstructures of longitudinal (a) and transverse (b) sections of a cracked blade

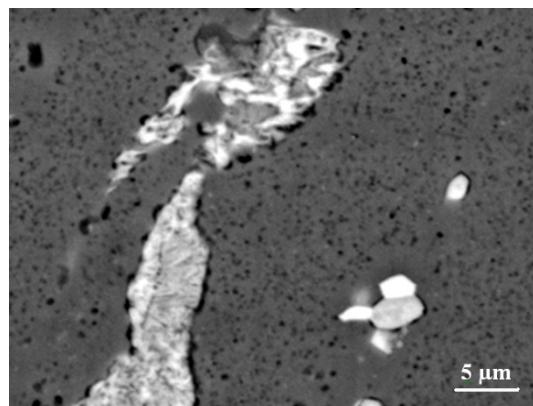
Figure 6. SEM micrograph showing large second phase particles

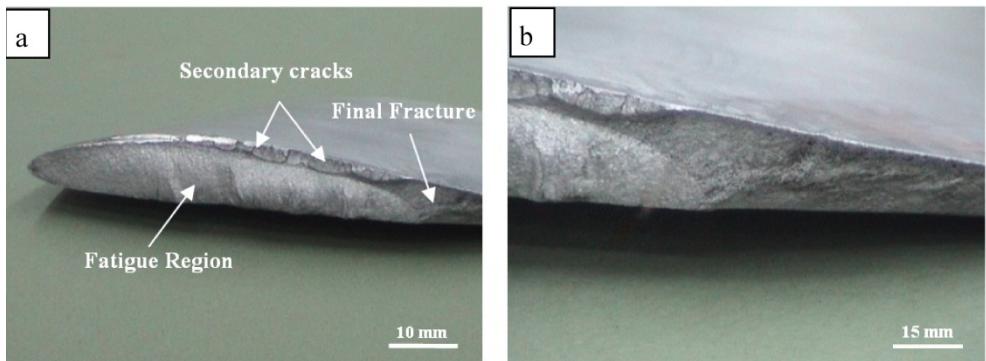
representative fractograph of the fracture surface of blade No. 8 is shown in Fig. 7a. It is observed to consist of two distinct regions at low magnification, a semi-elliptical and smooth region which is oriented normal to the blade axis and exhibits a macroscopically brittle appearance, and an outer region with a rougher and more ductile appearance. The transition from semi-elliptical region to the outer region can be clearly identified in Fig. 7b. In this region the remaining cross section of the blade failed by tensile overload.

Figure 7. (a) Fracture surface of blade No. 8, (b) transition from fatigue to tensile overload fracture

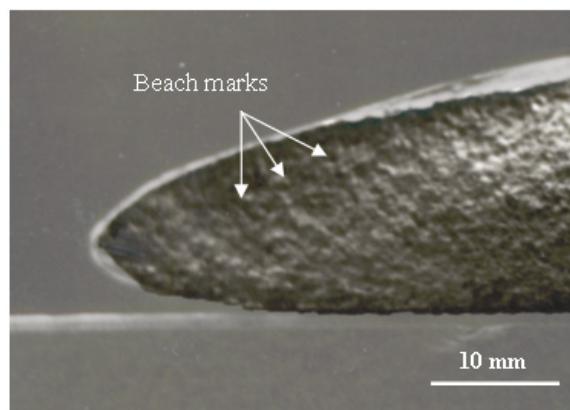
Faint beach marks indicative of the progressive nature of crack growth in the semi-elliptical region can be seen in Fig. 8. Parallel microscopic fracture surface markings can also be observed in this region at higher magnifications in SEM micrograph as shown in Fig. 9. A schematic drawing of the fan with the location of damaged blades is presented in Fig. 10. Visual inspections and fractographic assessments revealed that the sequence of fracture for the broken blades has been blade No. 1, blade No. 8 and blade No. 11 respectively (Sameezadeh, 2005).

Figure 8. Beach marks on the fracture surface near the leading edge of the blade

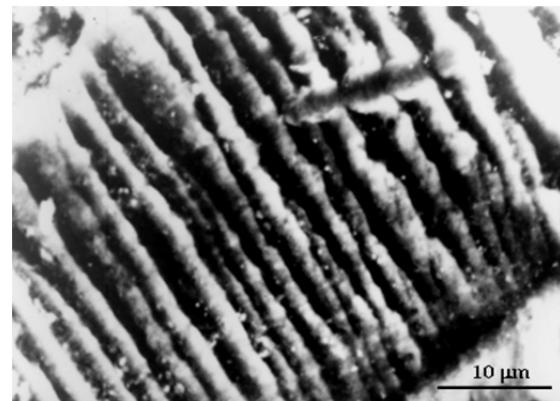
Figure 9. SEM fractograph showing parallel fracture surface markings

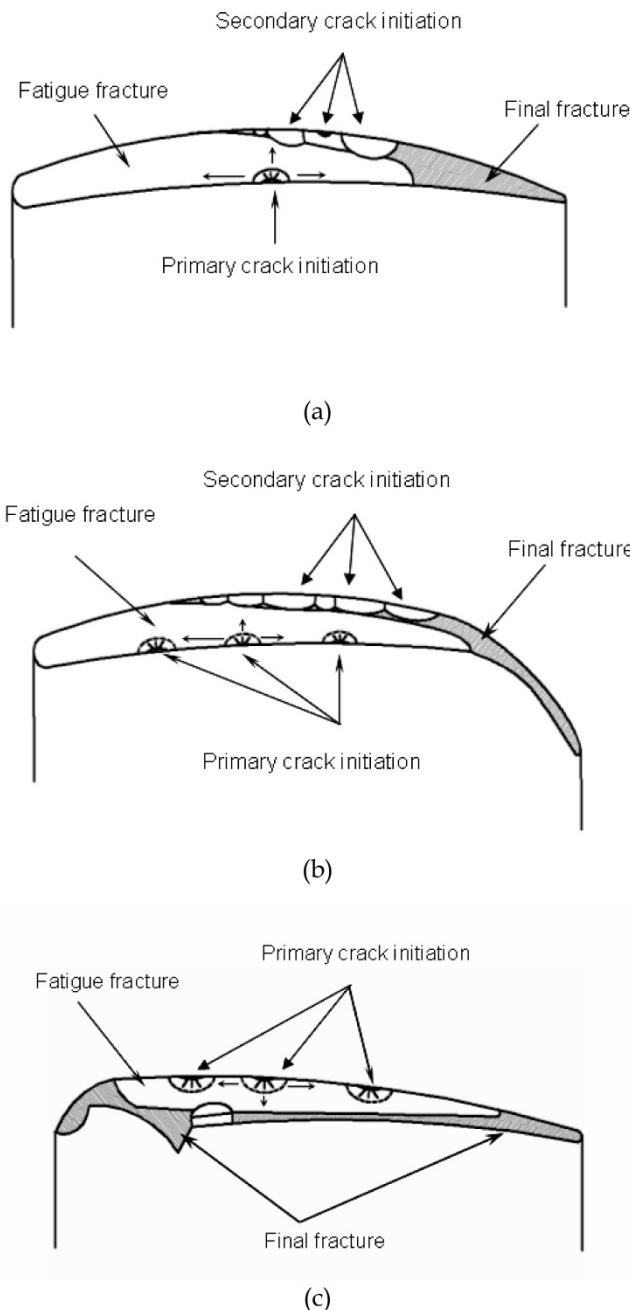
Table 3 shows the crack lengths which are measured on the surface of cracked blades. Schematic drawings of the fracture surfaces of three broken fan blades which show multiple crack initiation sites as well as the macroscopic crack growth paths are presented in Fig. 11. Also, For the first and the second fractured blades (blades No. 1 & No. 8), primary crack initiation sites are located on the concave side of the airfoils near the centre where the cross-sectional area is high. Primary cracks have coalesced during fatigue crack growth to form shallow semi-elliptical crack geometry and have propagated to reach the final cracks. In

addition, several small semi-elliptical cracks are also shown to have initiated from the opposite convex side of the airfoils.

According to Fig. 11 the presence of shallow semi-elliptical cracks on both concave and convex sides of the airfoils is indicative of the influences of considerable bending stresses during crack propagation.

Figure 11. Schematic drawings of the fracture surfaces: (a) blade No. 1, (b) blade No. 8 and (c) blade No. 11

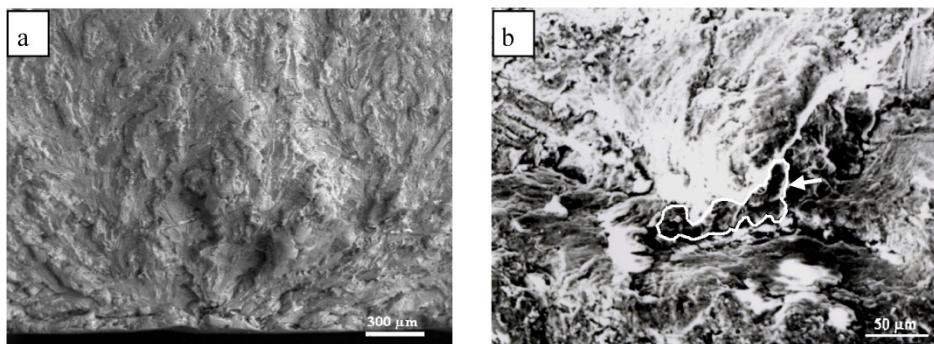
An SEM micrograph showing one of the typical primary crack initiation sites is presented in Fig. 12a. A secondary electron mode micrograph of this region revealed a large second phase particle with a length of about 100 µm at the crack origin as shown in Fig. 12b. The EDS spectrum of this particle identified that its composition is very similar to the intermetallic particle. Presence of the large particles at the origin of the crack have been shown to act as preferred fatigue crack nucleation sites in such alloys, despite the fact that they represent a small fraction of the particle population (Kung, 1979; Merati, 2005).

Figure 12. (a) Typical micrograph showing a primary crack initiation site and (b) a crack nucleating particle at the origin of the crack

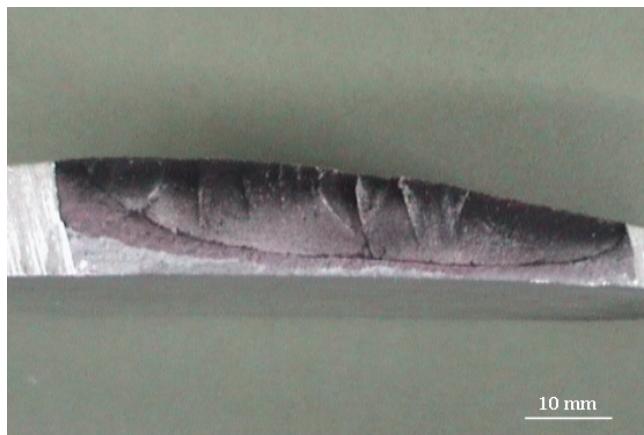
Dye penetrant non-destructive testing that was carried out on the blades after the accident identified that some of the non-fractured blades have been cracked. The crack surface of one of these blades (blade No. 7) was disclosed as shown in Fig. 13 by cutting the remaining cross-section of the airfoil and opening carefully. In this figure the semi-elliptical fatigue region is obvious. The crack surface is covered by the penetrant material and a higher magnification view identifies the transition of the penetrant material out of the fatigue region that has different microscopic features, so it can be recognized as the final fracture zone. Therefore, the final fracture stage could not be completed because of the generator stoppage after the fracture of the three blades.

Figure 13. Opened crack surface of blade No. 7

Crack initiation and growth from the convex side and also decrease in the fatigue region in comparison with the fractured blades, prove that the fluctuation of the stresses and the maximum stress had been highly increased during the accident probably due to excessive vibrations.

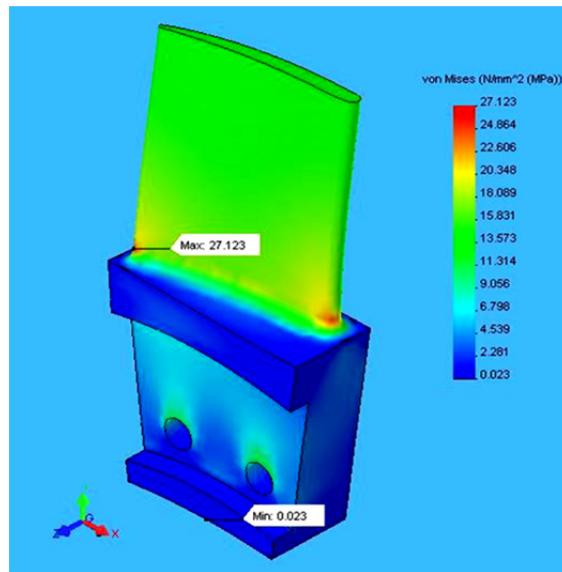
A 3D finite element model was used to simulate the normal operation of the fan blades. The results revealed that the maximum total stress acting on the blade under normal condition was about 27 MPa which occurred close to the transition radius between the airfoil and the root where the cracks initiated in fractured blades (Fig. 14) (Ataei, 2006). The bending stress introduced by the action of the air flow pressure are less important (Cohen, 1987) and was estimated as about 7 MPa. According to the results, the steady state stresses are very low in comparison with the strength of the blade material therefore, it can be concluded that the fracture accident was happened during an abnormal condition.

Figure 14. Finite element simulation of the fan blade, which shows the stress distribution under normal operating condition (Ataei, 2006)

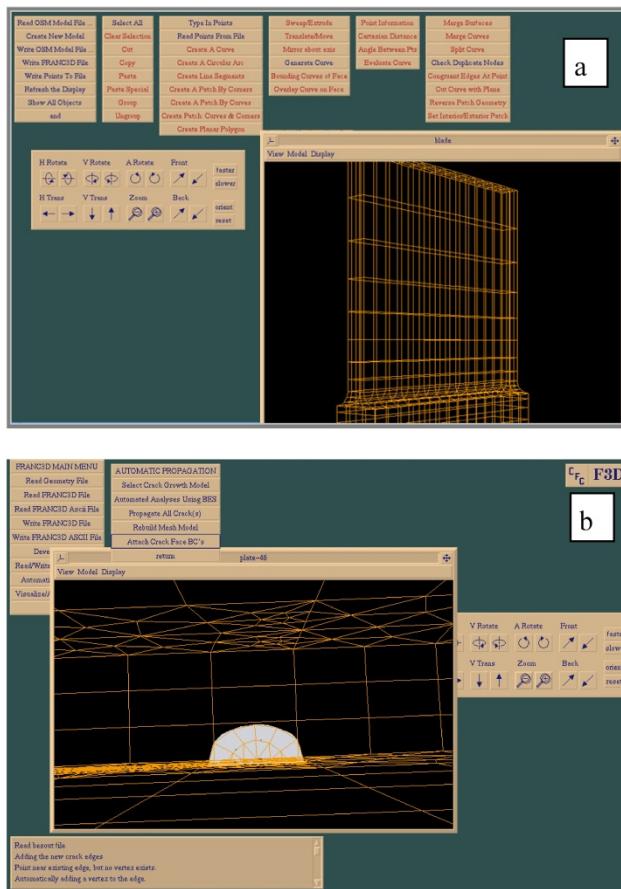
Based on the stresses applied by the model boundary conditions, the initial crack was grown in a series of crack propagation steps. Fig. 15a is a simplified 3D model of the airfoil that was meshed 2D (Boundary elements) in FRANC3D for simulating fatigue crack growth in fractured blades. Fig. 15b shows simulated fatigue crack in blade No. 8 after three steps of propagation.

Figure 15. (a) A 3D model of the airfoil with 2D mesh for simulating fatigue crack growth in FRANC3D software and (b) simulated fatigue crack in blade No. 8 after three steps of propagation

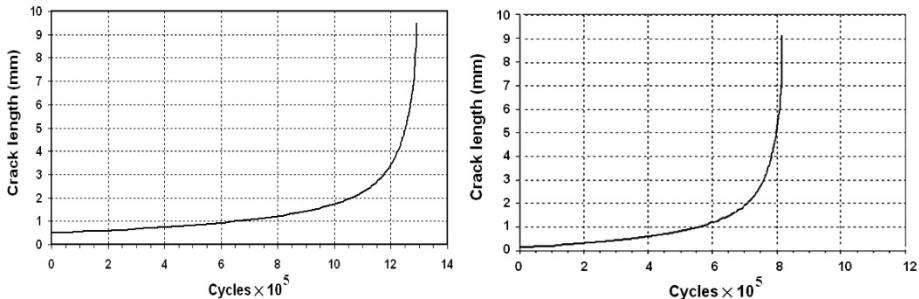
The empirical constants C and n were computed by fitting the near threshold crack growth data for AA 2124 aluminum alloy (Department of Defense, 1998) as $C = 9.5 \times 10^{-13}$ m. $(\text{MPa}\sqrt{\text{m}})^{-n}$ and $n = 4.9$ for da/dN expressed in m.cycle^{-1} at a load ratio of $R = -0.1$ assumed in this case. The results of crack growth simulations in the first and the second fractured blades, where initial cracks are grown in small steps to their final dimensions are plotted in Fig. 16. These curves show the crack size as a function of the number of applied stress cycles. It can be seen that the number of cycles required to propagate initial cracks to their final dimensions for the first and the second fractured blades are just about 1.3×10^6 and 8×10^5 cycles respectively.

Figure 16. Crack length as a function of number of cycles in: (a) the first fractured blade (blade No. 1) and (b) the second fractured blade (blade No. 8)

Thus the total fatigue crack growth time is about one hour. This lifetime is within the 11 hours of actual operating period following the last overhaul, which ended with the failure of fan blades.
