# Contribution to the Evaluation of Silicon Carbide Surge Arresters

Arnaldo Gakiya Kanashiro and Milton Zanotti Jr.  
*University of São Paulo  
Brazil*

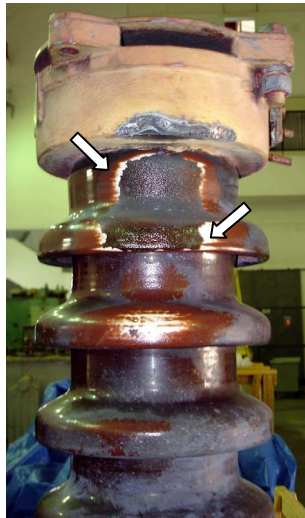
In some of the 88 kV arresters, surface erosion was observed which is a typical sign of electric arc damage on the porcelain, as shown in Fig. 1. Also, most of them had some degree of corrosion in their metallic parts, as shown in Fig. 2. Finally, in order to check the viability of measuring the leakage current in the field, some SiC surge arresters installed at Paraibuna substation were chosen. After this, due to the explosion of one 88 kV SiC surge arrester at Mairiporã substation, leakage current measurements were also performed in this substation.

Fig. 1. Typical sign of electric arc damage on the porcelain of the surge arrester.

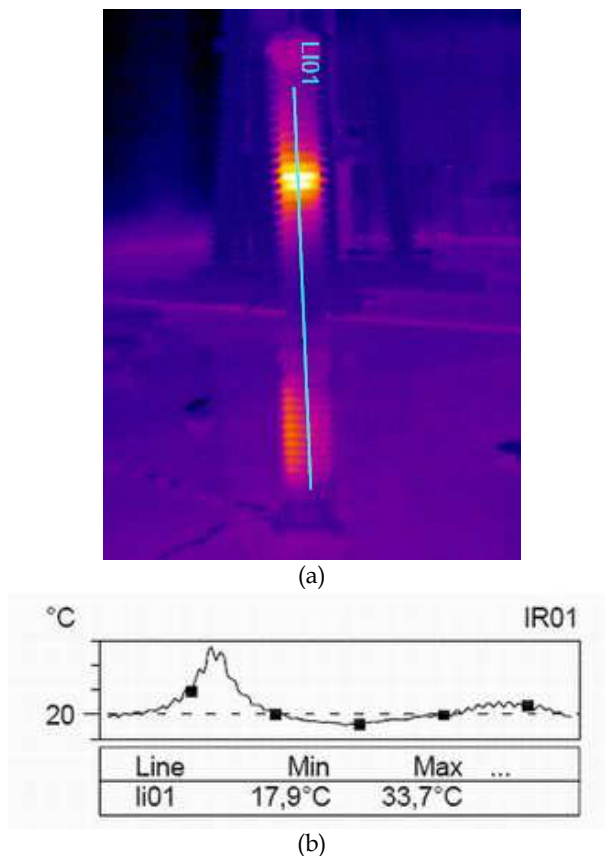
Fig. 3. Example of a thermal image measurement, (a) thermal image of the surge arrester and (b) temperature along the surge arrester.

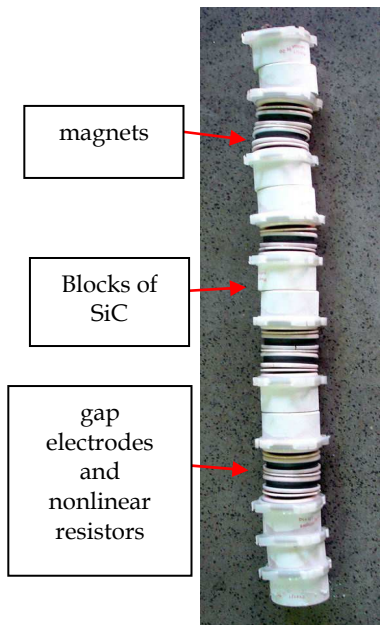
Fig. 4. Surge arrester of manufacturer A.

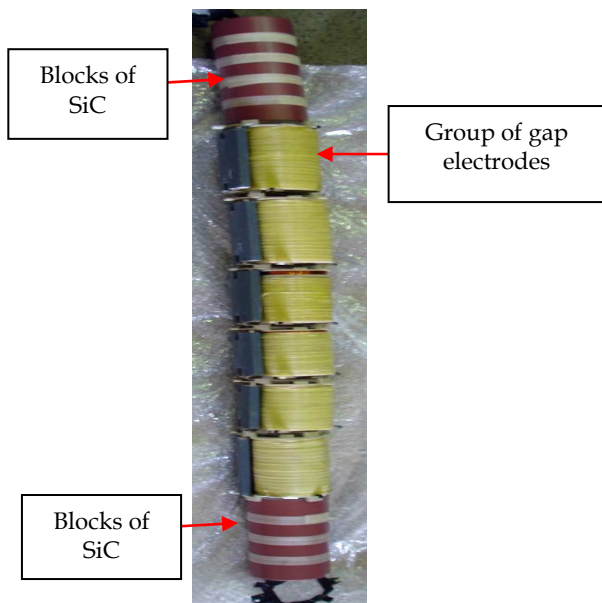
Fig. 5. Surge arrester of manufacturer C.

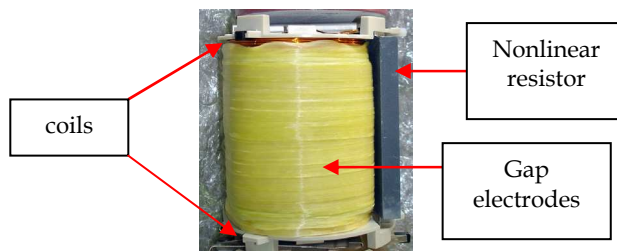
Fig. 6. Group of gap electrodes of surge arrester C.

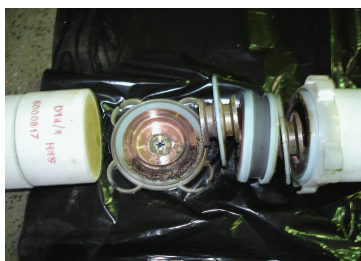
In general, it was noticed that moisture was presented in the internal components of the arresters. Some traces of discharges on the surface of the blocks were also observed. Some of the surge arresters presented signs of discharges in the gap electrodes. During the visual inspection, it was also observed that some nonlinear resistors were damaged.

The surge arrester A6 (manufacturer A) was more degraded in comparison with A2 and A4. The arrester C5 (manufacturer C) was the worst in comparison to the surge arresters C1 and C3.

As a general conclusion, it was observed that the surge arresters of manufacturers A and C presented evidence of ingress of moisture and signs of discharges. Moisture ingress may have deteriorated the SiC material (McDermid, 2002) and (Grzybowski, 1999).

Fig. 7. Surge arresters of manufacturer A, (a) blocks: signs of discharge, (b) gap electrodes: signs of discharge, (c) block: presence of moisture and (d) gap electrode: signs of discharge.

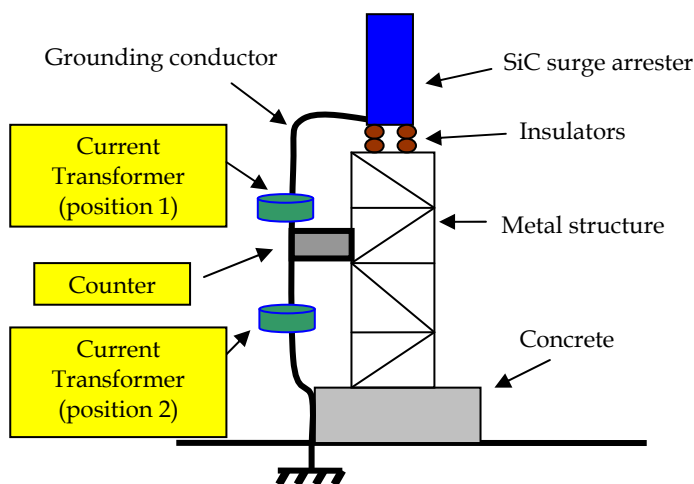
Fig. 9. Leakage current measurement at the substation.

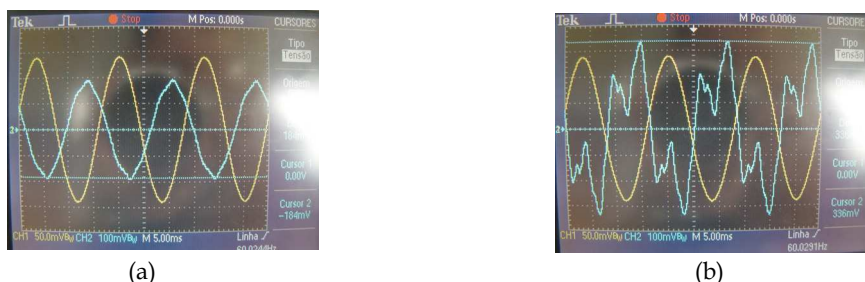
Leakage current measurements in 88 kV SiC surge arresters, in service, were performed in the Paraibuna substation first, aiming to check the viability of this technique. Details of the SiC surge arresters installation were considered, such as presence of counter discharges, grounding cable of the surge arresters, the presence of insulators in the assembled surge arresters, etc. These aspects have important influence on the results. A device, consisting of a current transformer (CT) and a digital instrument, was used in the field. The CT was placed in the grounding cable, between the discharges counter and the bottom part of the surge arrester (position 1) or after the discharge counter (position 2), as shown in Fig. 9. The aim was to investigate the interference of the installation in the results. The leakage current was measured using 60 Hz and 180 Hz frequencies. When the CT was placed in the position 2, there was interference, as shown in the oscillograms of Fig. 10.

Fig. 10. Waveforms of the leakage current (blue) and of the applied voltage (yellow), (a) CT in the position 1 and (b) CT in the position 2.
