# **Power System Protection Design for NPP**

Chang-Hsing Lee and Shi-Lin Chen

# 2. Taipower "318 Event"

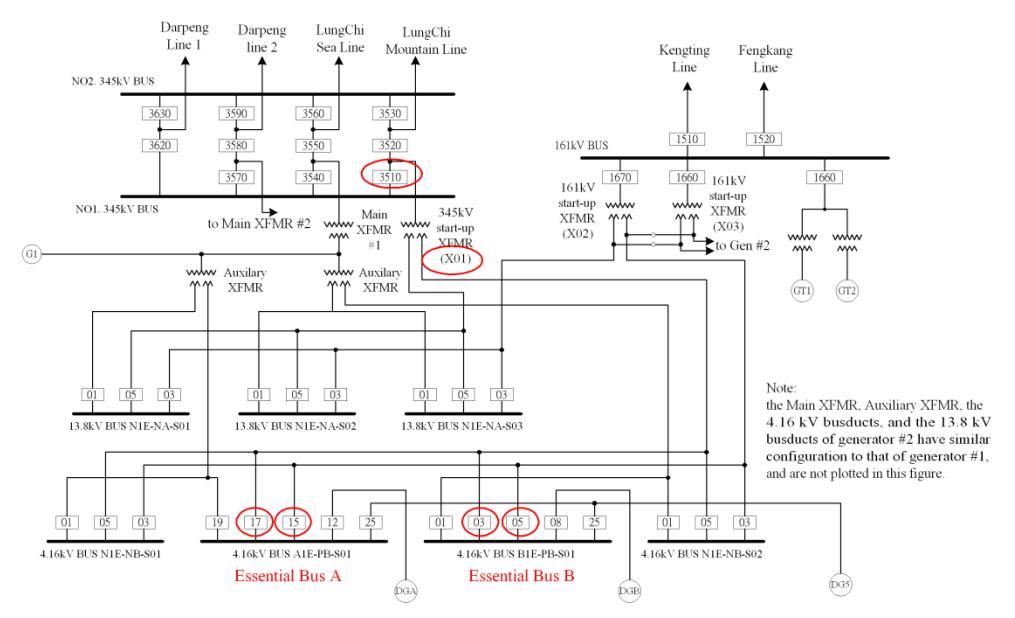
Figure 1. System Configuration of the NPP

Figure 1 shows the configuration of Taipower 3<sup>rd</sup> nuclear power plant. The NPP has two 951 MW generators which are connected to the local 345kV gas-insulated substation (GIS) in oneand-half breaker configuration as shown in Fig. 1. The NPP is then connected to the power grid via four 345 kV overhead power lines (Darpen 1, 2 and Lunchi Sea/Mountain) to the Darpen and Lunchi 345kV EHV (Extra High Voltage) substation and two 161kV overhead lines (Kengting and Fengkang) to Kenging and Fenkang 161kV HV (High Voltage) substation.

It is important to note that there are three 13.8 kV buses (in the middle) and four 4.16 kV buses (at the bottom) for plant utility. Among these buses, the two 4.16 kV buses in the middle are responsible for feeding the safety-critical equipment such as cooling pumps and are designated as "essential buses". (The 2<sup>nd</sup> 4.16kV bus from the left where "DGA (Diesel Generator A)" is connected is designated as "Essential Bus A". The one next to it, where "DGB" is connected to, is "Essential Bus B".)

Another notable but subtle feature of this configuration is the use of 3-phase gas-insulated line (GIL) design with the 3 phases enclosed in a single duct of approximately 340 meters for the connection of the generation units and auxiliary systems, (located at the foot of a hill) to the 345kV GIS (on the top of the hill) due to topography feature of the location. This feature has implication on the generation and propagation of switching transients which will be explained in later sections.

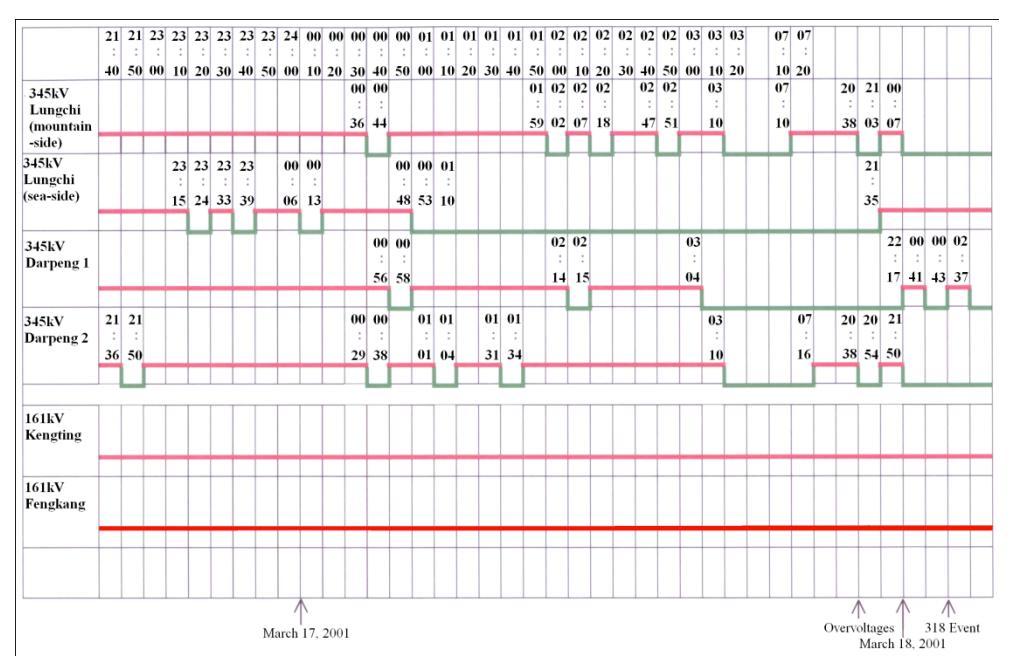
Figure 2. 345kV and 161kV Overhead Line Switching Event Log

Figure 2 shows the switching event log of the four 345kV and two 161kV lines connecting to the NPP. After reviewing the event log, it was found that CB#17 on Essential Bus A broke down when one GIS switching operation was occurring. The event log also showed that there were 37 EHV switching operations during the 48-hour period prior to the event due to salt-fog influence in the plant area. Because of the unstable offsite power, the GIS switched between different offsite power to acquire the stable power sources.

From Fig. 2, it can be seen that there were 37 switching operations during the 48-hour period prior to the breakdown. This unusually high number of switching operation can create lots of switching surges (with magnitude of around 7 times the rated line-to-ground peak voltage in the medium voltage system) which, when propagating through the NPP local power network, can degrade the insulation level or even cause breakdown of CB's in the local power network [8,9].

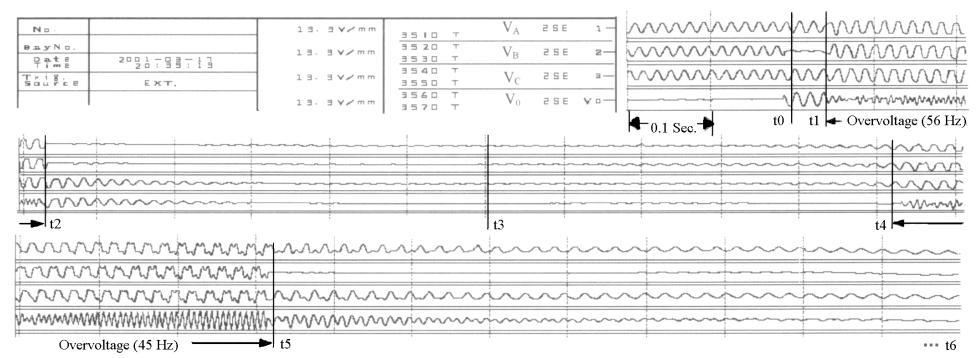
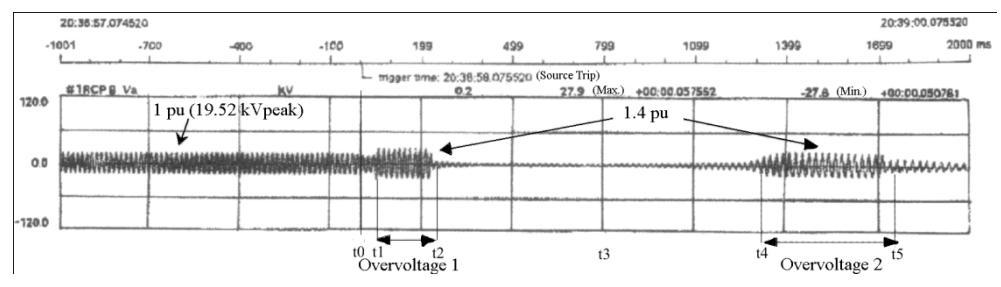
Figure 3. Overvoltages at 20:38 in March 17, 2001

Figure 3 shows the transient recording of overvoltages for both the 345kV bus and one MV (medium voltage) bus at 20:38 in March, 2001. At t0, the flashover on the 345kV line occurred leading to its subsequent tripping at t1. The tripping took place on the remote end of the 345kV line thus overvoltage can still be observed at the NPP between t1 and t2 due to "motor-generating effects" to be explained in the following section of this Chapter. The overvoltage on the 345kV line eventually caused flashover from Phases A and B to ground pulling down the line voltage and all motors on the 4.16kV bus were tripped by their respective under voltage relays at t3. At t4, the flashover from Phases A and B to ground was cleared and the "motor-generating effects" start to build up the voltages again with the two remaining motors on the 13.8kV bus.

(b) Line-to-Line Voltage Transient Recording of one 13.8 kV motor, Recycle Colling Pump B

The transient recorder in Fig. 3(a) recorded 2 abnormal overvoltages (at 56 Hz and 45 Hz, respectively) after the last 345 kV-transmission line connecting to the NPP was tripped on the remote end which turned the NPP into an electrical island. As will be explained in the next section, the 1<sup>st</sup> overvoltage was caused by the over-excitation of the motors (e.g. recycle water pump) in the plant who, with terminal voltages supported by large line capacitance, now operated as induction generator after loss of external power.

The 2<sup>nd</sup> overvoltage is caused by a different mechanism. After a few cycles the low voltage relays tripped many of the plant motors leaving only 2 biggest motor (now operating as induction generator) still connected and were supported by a comparatively much larger capacitance leading to not only over-excitation but also magnetic saturation of both the motors and transformers. This created a condition very close to ferroresonance resulting in even bigger overvoltage.

It can be seen from Figure 3 that overvoltage were observed not only on the line conductors of phase A, B, and C but also on the neutral. As will be explained in the next section, neutral voltage transfer can occure through 2 different mechanisms: electromagnetic and capacitive transfer.

It can be seen from Fig. 3(a) that, during 1<sup>st</sup> overvoltage the neutral voltage gradually roses to 200 kV<sub>rms</sub> while during 2<sup>nd</sup> overvoltage the neutral voltage rose to 626 kV<sub>peak</sub> (Note: the voltage waveform became very non-sinusoidal during 2<sup>nd</sup> overvoltage, we thus use peak value instead of rms value). The source of both overvoltages in the neutral was due to motor and transformer saturation resulting in 3<sup>rd</sup> harmonic voltages at the neutral however during the 2<sup>nd</sup> overvoltage the waveform is much more distorted with higher harmonic content.

As indicated by Fig. 3(a), the neutral on 345kV side does not appear to have been effective grounded possibly due to grounding failure. The result is that very high neutral voltage was established on the 345kV neutral and if the 4.16kV neutral was not grounded it will see a neutral voltage (through capacitive neutral transfer) of

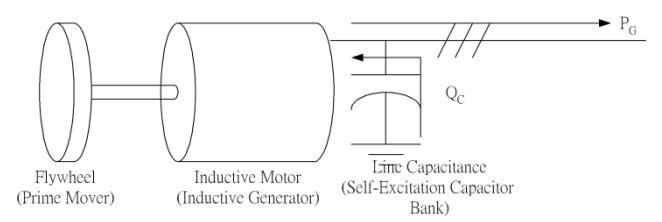
Figure 4. Equivalent Circuit of Motor-Generating Effect.

Figure 4 shows the 2 essential condition for induction motor generating effect: large capacitance and continuous rotating motor. When an induction motor lost its external voltage source, the flywheel with large inertia will keep the motor rotating and the capacitance of transmission line will provide the necessary voltage support for the induction motor to act as a generator. The magnitization curve of the motor and the amount of capacitance will jointly determine the overall motor generating effect as shown in Fig. 5. If the capacitance is too small to provide enough magnetizing current (curve C0 in Fig. 5), the terminal voltage of motor will decay exponentially and the generating effect will not sustain. However, if the capacitance is large enough, the motor generating effect will sustain and the terminal voltage is determined by the intersection of the capacitance and magnetizing curve such as (V1, C1) and (V2, C2) in Fig. 5.

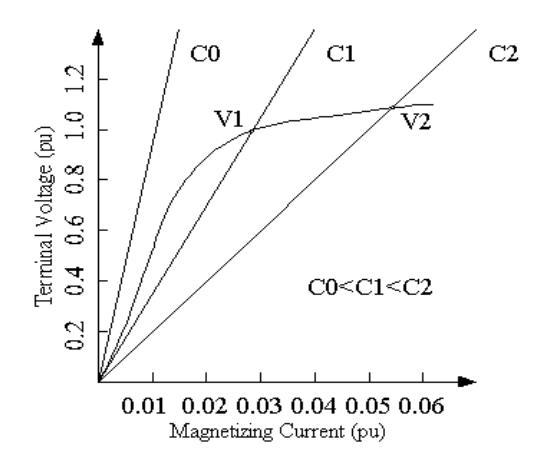
**Figure 5.** Relationships between Motor Terminal Voltage, Magnetization Curve, and External Capacitance

At "t1" in Fig. 3(a), the last 345kV transmission line connecting to the NPP was tripped on remote end due to a flashover on the line turning the NPP into an electrical island. As the local end of the 345kV line did not trip, a motor generating condition equivalent to Fig. 4 was formed with the 127kM transmission line providing sufficient capacitance to support the voltage of the various motors in the NPP. As can be seen in Fig. 3(b), the terminal voltage is increased to 1.4 p.u. and the overall resultant frequency is 56 Hz.

During this first overvoltage period, the terminal voltage of motor was about 1.4 p.u. (Fig. 3(b)) but the line voltage was about 1.29 times the rated line-to-ground peak voltage (Fig.

3(a)). This implied that the power transformers have saturated. As a result, a lot of harmonics were produced and the zero sequence components of them would be integrated into the neutral voltage resulting in unexpected high neutral voltage. This period ended at "t2" in Fig. 3(a) when the flashover grounded both phase A and B.

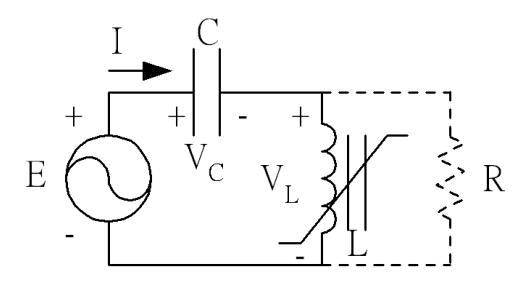
Figure 6. Equivalent RLC Circuit

Figure 6 shows the four essential conditions for a ferroresonance to occur: voltage source, capacitance, nonlinear inductance (ferromagnetic and saturable), and low losses. The R in the RLC resonant circuit in Fig. 6 is very large due to the "low losses" condition and can often be ignored. The nonlinear inductance L is the magnetizing curve of the motors and transformers in the system and the capacitance is provided by the transmission line.

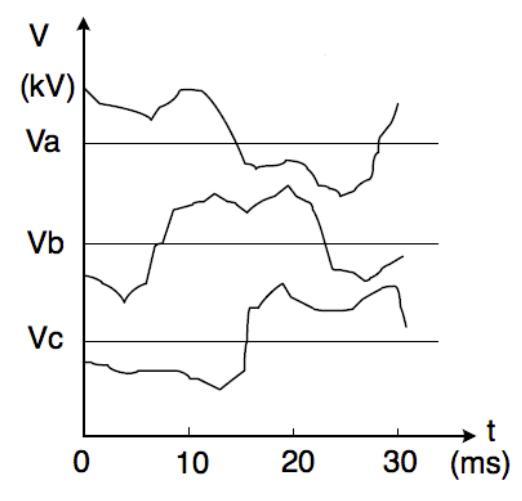
Figure 7. Zoom-in of The 4 Cycles prior to t5

expect the terminal voltages to be higher than those during the first overvoltage stage according to Fig. 5. However, due to deep saturation of the motors and transformers, the overvoltage magnitude in Fig. 3(b) during the 2<sup>nd</sup> overvoltage is only slightly higher than the previous stage. This can be further seen from the fact that at the beginning of "t4" in Fig. 3(a), there were no overvoltage and no distortion of waveforms. As line voltage increased, the harmonics increased and after a few cycles the amplitude of voltage remained but voltage waveform distorted dramatically. Figure 7 shows the waveform at 4 cycle prior to t5 with its Fourier components summarized in Table 2 [10].

It can be seen from Table 2 that the voltage of fundamental frequency was about 1.5 times the rated line-to-ground peak voltage, which is slightly larger than the previous overvoltage. The large DC and even-order harmonics indicate the deep saturation of the start-up transformer. In Table 2 the total of 3<sup>rd</sup> harmonics is 554.7 kV<sub>peak</sub> (Note: The 3<sup>rd</sup> harmonics are in-phase therefore can be added up directly.) Comparing this figure with the neutral voltage of 626 kV<sub>peak</sub> in Fig. 3(a), this indicates that 3<sup>rd</sup> harmonics is the main source of neutral voltage during the second overvoltage period.

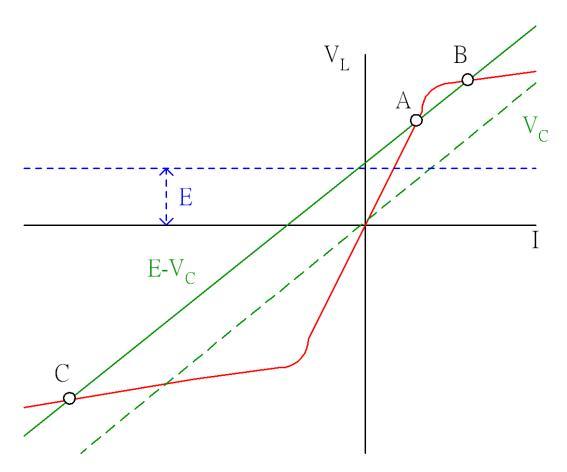
Figure 8. Ferroresonance Phenomenon Explanation

As the inductances in the systems are now deeply saturated, there is a possibility that ferroresonance can occur. (Note: Ferroresonance is nonlinear resonances in power system where the voltage and current may change from normal steady state to another steady state with large harmonic distortion.) The phenomenon can be best understood from a circuit perspective using Figure 6 as example. In Fig. 6, the total equivalent impedance of the circuit is (jXL - jXC). When the inductance is saturated and current further increases, it will drive the inductor into deeper saturation where the inductor impedance jXL will reduce when current further increases. A critical point will be reached at Point B in Figure 8 when (jXL - jXC) becomes zero. Any current increase beyond Point B will cause the total impedance change from a positive value to a negative value causing resonance effects near this operating point[7].

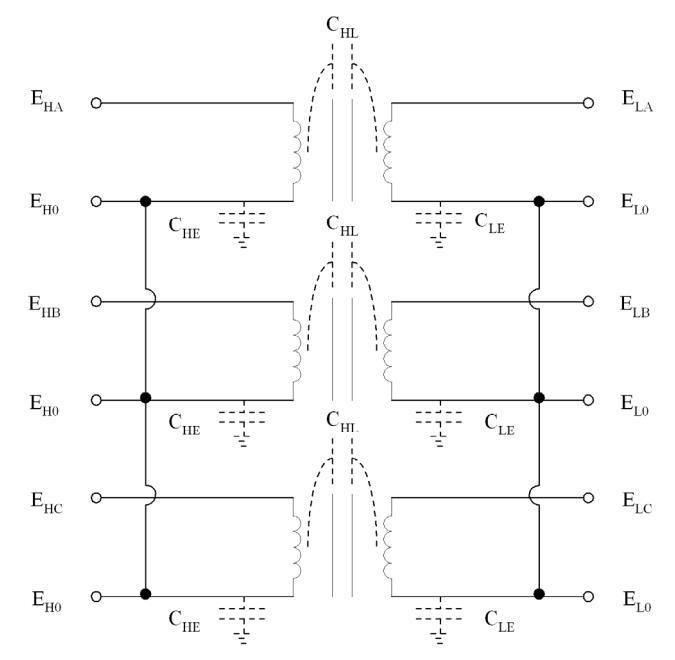
Figure 9. Voltage Transfer Diagram of 345 kV/4.16 kV Transformer

In Fig. 9, CHE and CLE depict the stray capacitance between high voltage (HV) winding to ground, and low voltage (LV) winding to ground, respectively, while CHL depicts the stray capacitance between HV and LV windings. Typical stray capacitances for the 345/13.8/4.16kV power transformer are shown in Table 3.

In the presence of transformer core saturation, 3<sup>rd</sup> harmonic neutral voltage will be present on the windings through electromagnetic transfer as long as the neutrals of the respective windings are not grounded. Once the neutral voltage is established on any side of the neutrals, the stray capacitance provides a further path for it to transfer to other neutrals according to Equation (1)

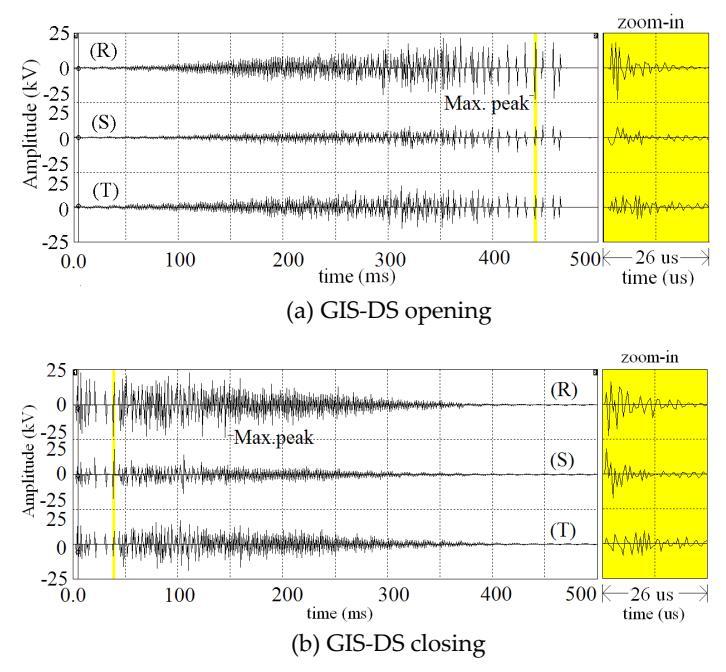
Field test result [9] shows that after switching the DS of EHV GIS, multiple 25 kV-level restrikes (approximately 7 times the rated line-to-ground peak voltage) were measured on the 4.16kV bus indicating VFTO can be transferred from the EHV side to MV side. It also indicates that the maximum peak voltages measured on the 4.16kV bus occur neither on the first strike nor on the last strike, and this behaviour is quite different with that in EHV system. The measurement results are shown in Fig. 10.

**Figure 10.** Switching Surge Measured on 4.16kV Bus by Operating EHV GIS Disconnect-Switch. (Note: The bandwidth of the measurement system was 2MS/s, the highest achievable in 2003)

After the "318 Event", a recommendation was made to Taipower No. 3 Nuclear Power Plant in 2003 for the installation of surge absorbers ( $0.8\mu$ F capacitor specially designed for surge absorption installed right close to the start-up transformer for each of the three phases) on the MV side in Fig. 1 [9,23]. The recommendation was adopted by Taipower in March 2005 and a subsequent measurement in March 2006 plus one-year monitoring indicated that there were no further VFTO exceeding rated line-to-ground peak voltage on the MV system.

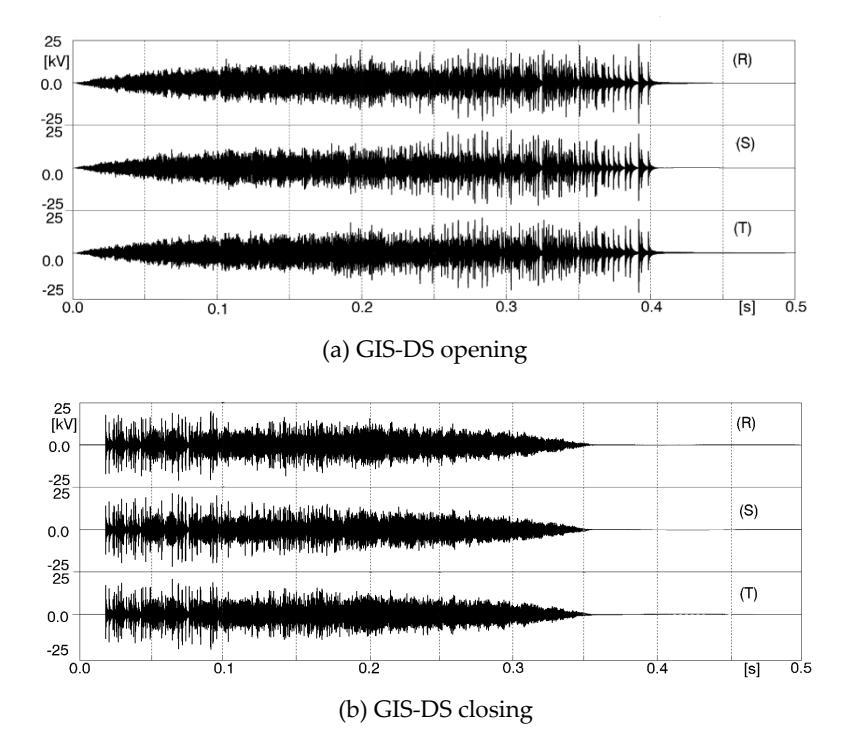
Figure 11. Simulation of VFTO at the Field Measurement Point

To further appreciate VFTO transfer mechanism, numerical simulation model was built [23]. To validate this simulation model, the field test condition for Fig. 10 was reconstructed and the simulation result is shown in Fig. 11. It can be seen from Fig. 11 that the waveform envelope are consistent with measurement for both DS opening and closing and that the maximum VFTO on the essential bus occurred neither at first nor at last strike.

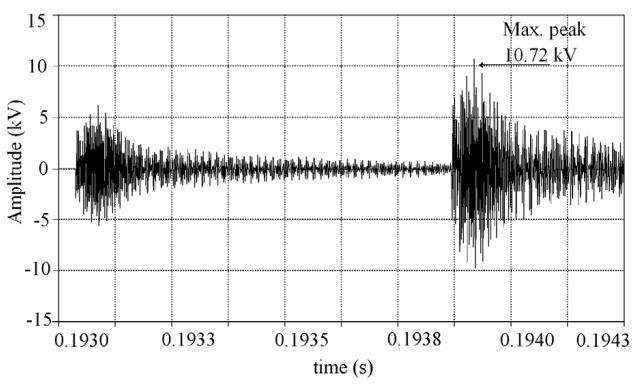
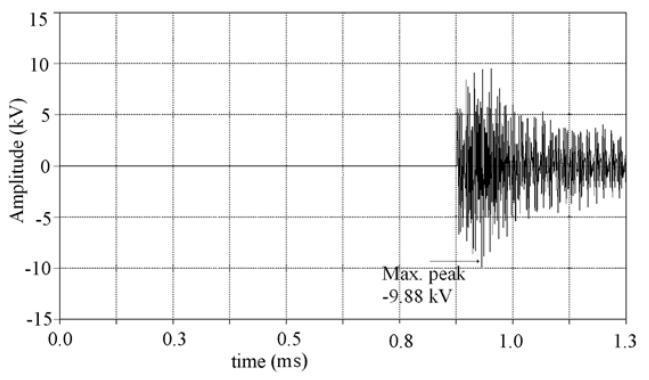
Figure 12(a) shows two consecutive restrikes from a multiple-restrike simulation and Fig. 12(b) shows its counterpart single-strike simulation. It can be seen from Fig. 12(a) that the Vosc initiated by the first restrike is superimposed to the second restrike resulting in a higher peak voltage (10.72 kV vs. the single strike one of 9.88kV).

(a) Two consecutive restrikes taken out of multiple-restrike simulation of DS opening

**Figure 12.** Oscillation Voltage (Vosc) Initiated by a Strike or Restrike Can Be Superimposed to Subsequent Restrike Voltages.
