Metallographic Etching of Aluminium and Its Alloys for Restoration of Obliterated Marks in Forensic Science Practice and Investigations

R. Kuppuswamy

*Forensic Science Programme, School of Health Sciences, Universiti Sains Malaysia
Malaysia*

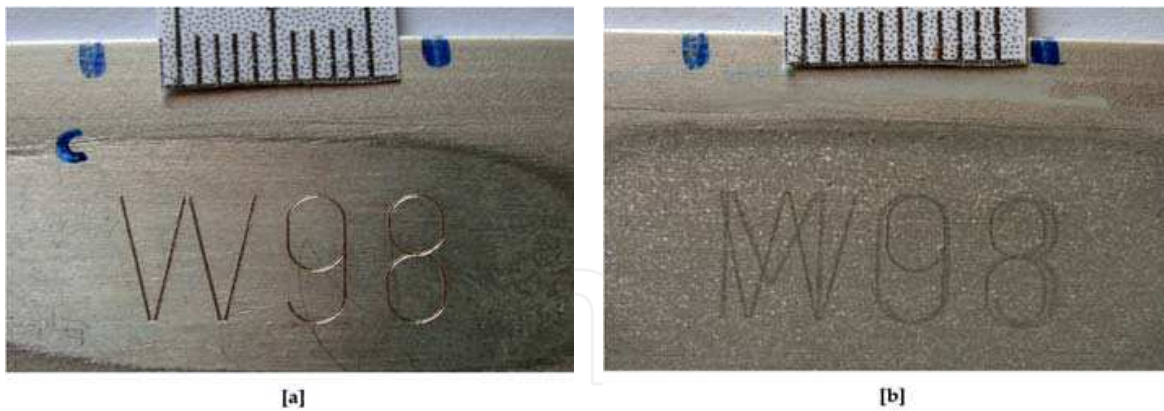
Fig. 2. a) Original engraved marks MO3 on Al (99% purity) surface were erased (hence not seen) and a new marks W98 were engraved over the erased area. b) The original marks MO3 were restored in the presence of the new marks W98. Note partial overlapping of the original digits "0" and "3" respectively with the new ones "9" and "8". Etching reagent: Alternating swabbing of 60% HCl and 40% NaOH. Etching time: 20 min.
