Chapter from the book *Modern Pacemakers - Present and Future*

# Common Pacemaker Problems: Lead and Pocket Complications

Enes Elvin Gul and Mehmet Kayrak  
*Selcuk University,  
Meram School of Medicine,  
Cardiology Department Konya,  
Turkey*

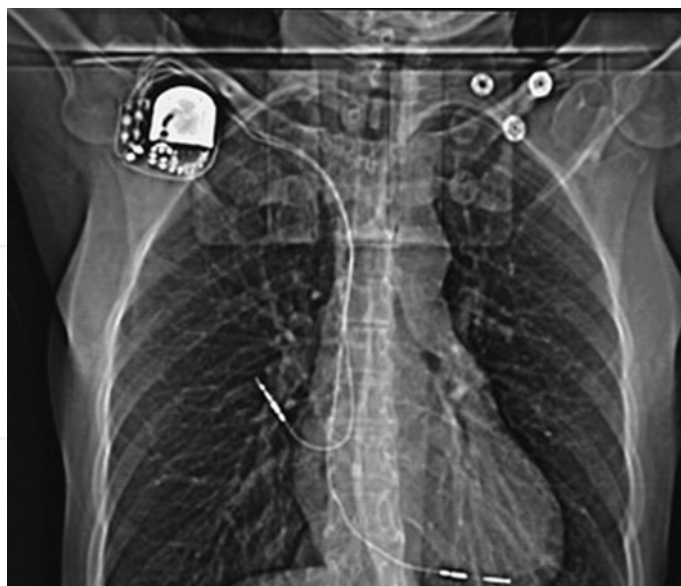
Fig. 5. Chest X-ray demonstrating severe lead perforation due to implantable cardioverter-defibrillator implantation.

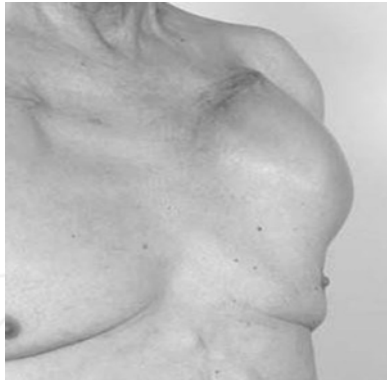
Fig. 8. Pocket hematoma

Hematomas occurring at the pacemaker pocket site can vary from a small ecchymosis to large and tense swelling (Figure 8). The risk of haematoma is increased in patients taking antithrombotic or anticoagulant drugs (Goldstein et al., 1998). Most small hematomas can be managed conservatively with cold compress and withdrawal of antiplatelet or antithrombotic agents. In patients requiring oral anticoagulants (warfarin), to take INR of about 2.0 at the time of implantation is safe (Belott & Reynolds, 2000). Unfractionated heparin or low-molecular-weight heparin are always discontinued prior to device implant and ideally avoided for a minimum of 24 hours post implantation. Administration of anticoagulants can be resumed within 48-72 h after implantation if there is no evidence of substantial hematoma formation. Occasionally, large hematomas that compromise the suture line or skin integrity may have to be surgically evacuated. Evacuation of the hematoma is very rarely needed (<0.5% of cases). Needle aspiration increases risk of infection and should not be done. Aspiration should be considered only if there is continued bleeding, potential compromise of the suture line or skin integrity, or pain refractory analgesics (Pavia & Wilkoff, 2001).

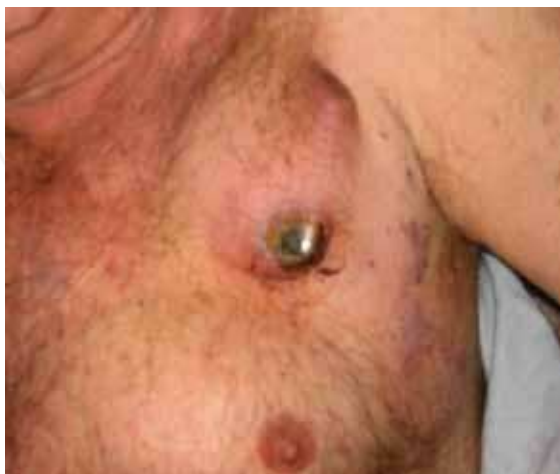
Fig. 9. Erosion of the automated implantable cardioverter-defibrillator (AICD).
