Common Pacemaker Problems: Lead and Pocket Complications

Enes Elvin Gul and Mehmet Kayrak
*Selcuk University,
Meram School of Medicine,
Cardiology Department Konya,
Turkey*

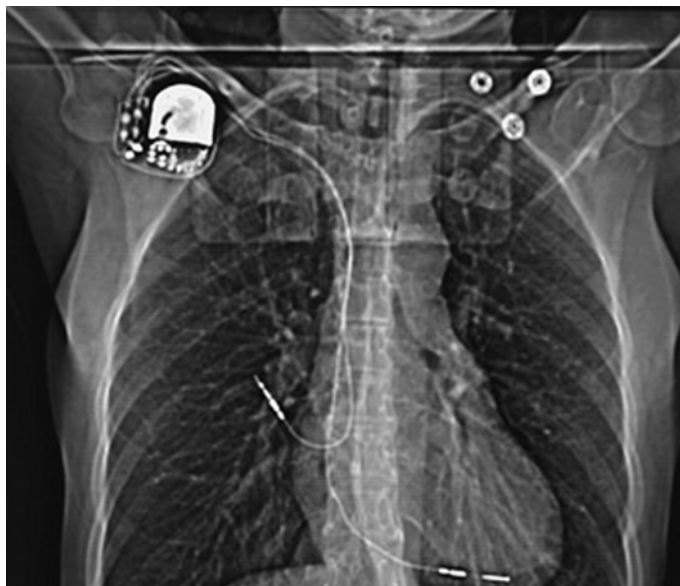
Fig. 5. Chest X-ray demonstrating severe lead perforation due to implantable cardioverter-defibrillator implantation.

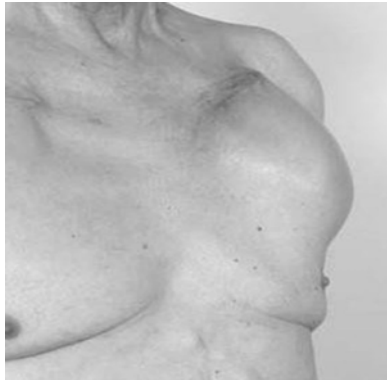
Fig. 8. Pocket hematoma

Hematomas occurring at the pacemaker pocket site can vary from a small ecchymosis to large and tense swelling (Figure 8). The risk of haematoma is increased in patients taking antithrombotic or anticoagulant drugs (Goldstein et al., 1998). Most small hematomas can be managed conservatively with cold compress and withdrawal of antiplatelet or antithrombotic agents. In patients requiring oral anticoagulants (warfarin), to take INR of about 2.0 at the time of implantation is safe (Belott & Reynolds, 2000). Unfractionated heparin or low-molecular-weight heparin are always discontinued prior to device implant and ideally avoided for a minimum of 24 hours post implantation. Administration of anticoagulants can be resumed within 48-72 h after implantation if there is no evidence of substantial hematoma formation. Occasionally, large hematomas that compromise the suture line or skin integrity may have to be surgically evacuated. Evacuation of the hematoma is very rarely needed (<0.5% of cases). Needle aspiration increases risk of infection and should not be done. Aspiration should be considered only if there is continued bleeding, potential compromise of the suture line or skin integrity, or pain refractory analgesics (Pavia & Wilkoff, 2001).

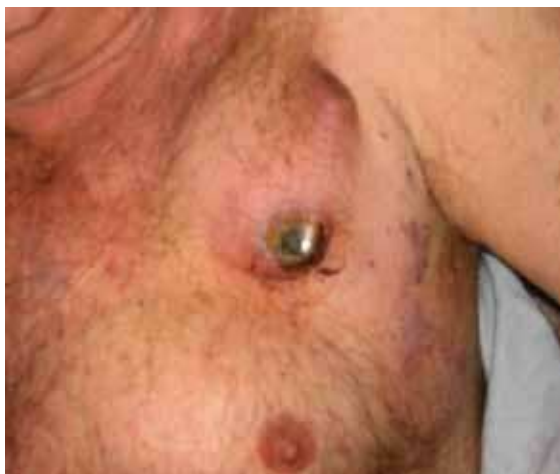
Fig. 9. Erosion of the automated implantable cardioverter-defibrillator (AICD).
