Material Characterization and Failure Analysis for Microelectronics Assembly Processes

Chien-Yi Huang^{1,2}, Ming-Shu Li¹,
Shan-Yu Huang¹, Cheng-I Chang¹ and Min-Hui Huang¹
*¹Process Technology Enabling & Materials Characterization Div. Operations,
Wistron Corporation, Hsinchu 300, Taiwan,*
*²Department of Industrial Engineering and Management,
National Taipei University of Technology, Taipei 106, Taiwan,
R.O.C.*

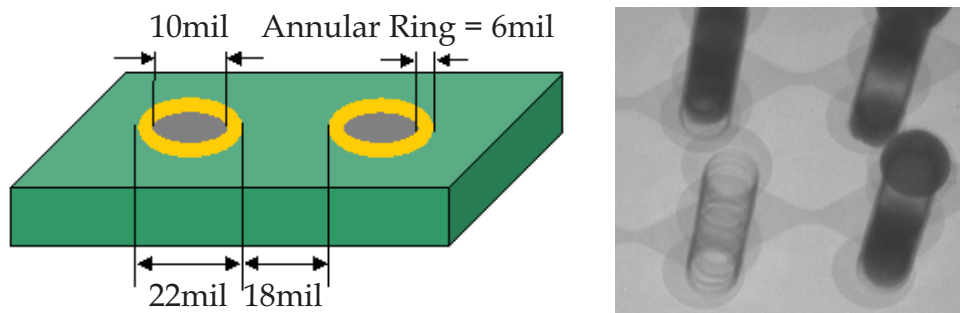
Fig. 1. PTH on the test board

The surface finish of the PCB is organic solderability preservatives (OSP). Sample boards are composed of eight layers with a thickness of 1.6 mm and length and width of 224 mm x 114 mm, respectively. There are eight samples on each test board, and each sample has a total of 1922 PTHs. The PTH is 10 mils in diameter, with 40 mil spacing; the width of the annular ring is 6 mils (Figure 1). The large dimensionality combined with fine spacing simulates the worst-case scenario. The thickness of copper in the PTH is in the range of 0.8 mil and 1.0 mil to ensure that no damage occurs during the PCB fabrication process.

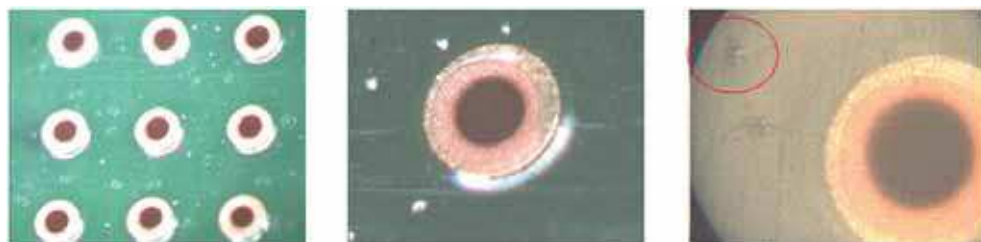
Fig. 2. Surface of the HD samples

The test boards are subjected to the Standard Inspection Process (SIP) which includes the incoming quality control (IQC) for inspection of trace, solder mask, labelling, board thickness, warpage, electrical resistance, and PTH dimension. The HD (high Tg / Dicy, HD) sample shows blisters on the board surface (Fig. 2).

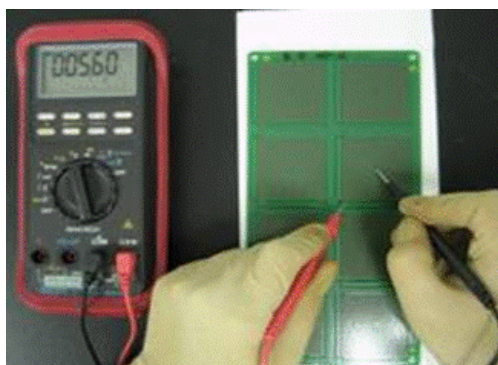
Fig. 3. Resistance measurements for the test vehicles

The meter used for measuring the resistance is correct within 0.02% (Fig. 3). The average resistances are: ND= 5.77 Ω , NP= 5.66 Ω , HD= 5.55 Ω , HP= 5.50 Ω . The normal Tg (ND, NP) material shows a higher resistance compared to the high Tg material (HD, HP). Failure is defined as: the value of resistance increased by 15%. Failed samples are then cross-sectioned for failure analysis. Samples are then subject to two tests. In the first test, heat resist-abilities of different PCB materials are evaluated. The second test involves the simulation of potential environments through thermal shock testing followed by a failure analysis.

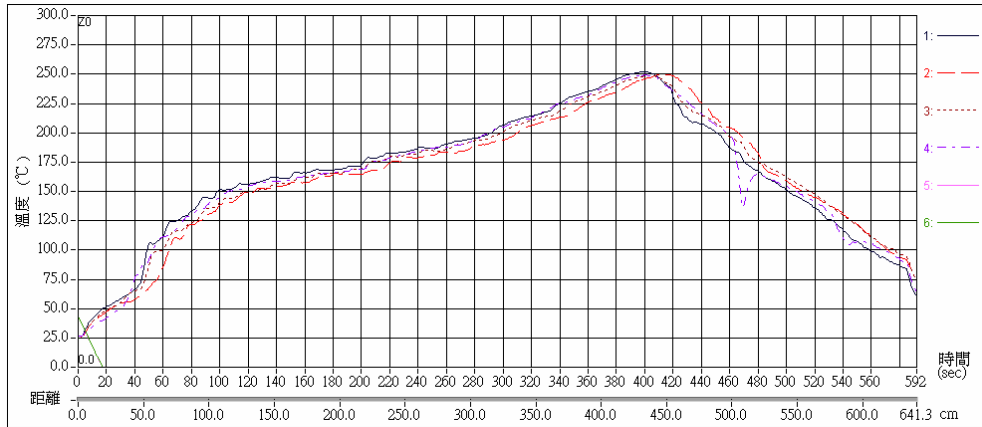
Fig. 4. Reflow temperature profile

The assembly process includes two reflow cycles (for two sided PCBs) and one wave soldering. The reflow oven has nine temperature zones. The conveyor velocity is 65 cm/min. TAL (time above liquid) is 90 s while process spec is between 40 s and 90 s (Fig. 4). The oxygen level is 350 ppm. During the wave soldering process, the conveyor velocity is 50 cm/min. The dwell time is 10 s while process spec is between 4 s and 6 s. The soldering temperature is 265°C. The preheat temperatures are 170°C, 190°C and 210°C (Fig. 5). A profile board is made to ensure that the desired temperature profile is achieved (Fig. 6). Thermal couples are attached at locations near the conveyor edge, the center of the oven, the PCB top side, and the PCB bottom side. The temperature variation across the board is within 10°C.

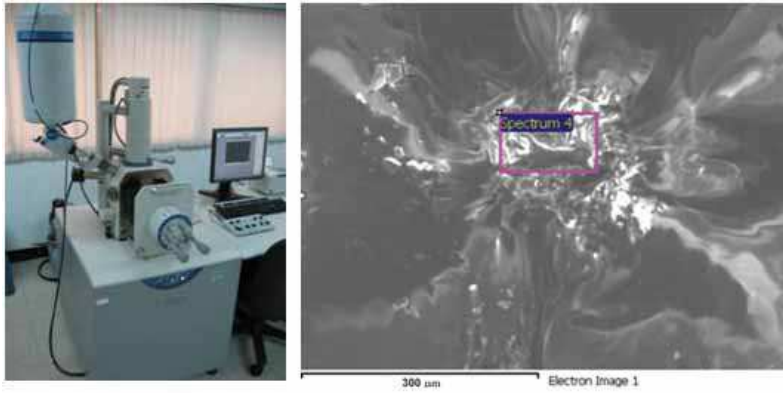
Fig. 7. SEM analysis

The crack of solder mask is observed in samples of the above mentioned four types of PCB materials. A black attached substance is also observed at the edge of the samples. The analysis through scanning electronic microscope (SEM) equipped with the energy dispersive spectrometer (EDS) indicates that the substance is carbide (Fig. 7). The results of resistance measurement show that the variation in resistance increases as the assembly process progresses, but all within the 15% criterion.

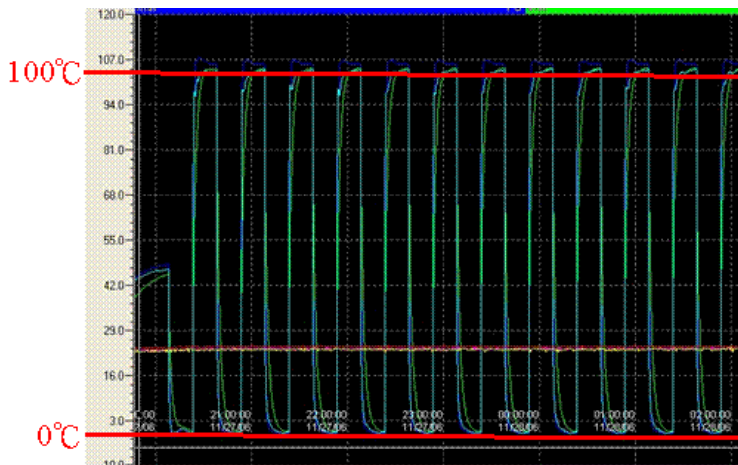
Fig. 9. Temperature profile during thermal shock test

The thermal shock test simulates the change of environmental temperatures that the electronics products may encounter during field service (Bevilacqua, 2004; Jayatilika, 2003; Zhao, 2004). Each material is represented by a total of 48 samples (6 test boards). Samples are subject to the two reflow and one wave soldering profiles prior to the thermal shock test. The temperature ranges from 0°C to +100°C (temperature change within 3 min) and the time at both extreme temperatures is 12 min. A total of 900 cycles with real time temperature monitoring systems are used (Fig. 8). Samples are removed from the chamber after every 12 temperature cycles for resistance measurement (Fig. 9).

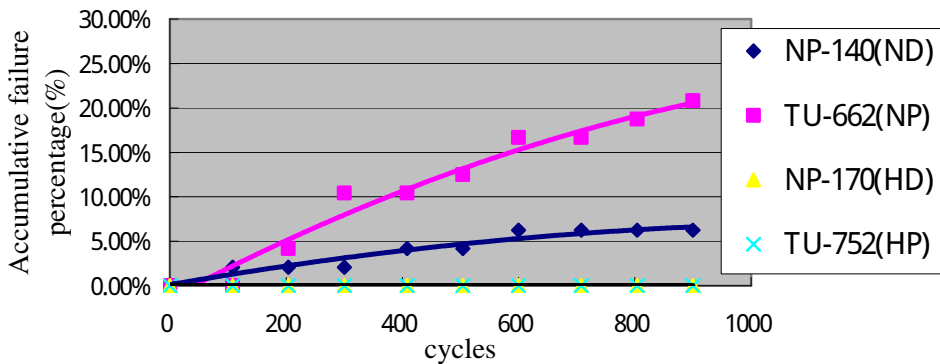
Fig. 10. Accumulative failure percentages after 900 thermal shock cycles

Solder mask cracking is the only symptom observed during the appearance check within the 900 temperature cycles. The measured resistance shows that failure only obtained in the normal Tg PCB (ND = 6.25%, NP = 20.83%). High Tg PCB shows better performance during the thermal shock test (Fig. 10). Cross-sectional analysis of the normal Tg PCB also shows that delamination and cracking occurred at the ND inner layers (Fig. 11). These defective scenarios did not occur to either Dicy or Phenolic of the high Tg PCBs.

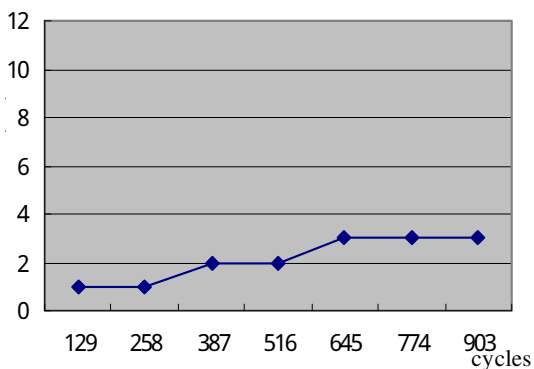
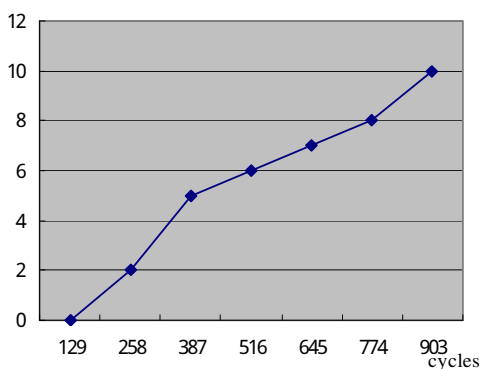
There are three and ten failed samples for the ND and NP PCBs, respectively. The accumulative failure data are shown in Figs. 12 and 13. The Weibull probability plots are used to estimate the parameters of the failure distributions (Figs. 14 and 15).

Fig. 12. Accumulative failure data for the ND PCBs

Fig. 13. Accumulative failure data for the NP PCBs

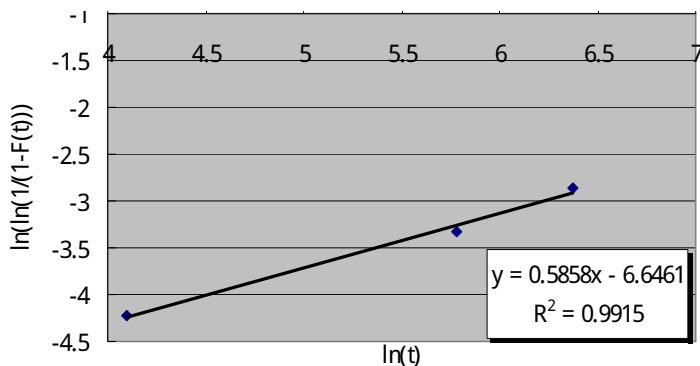
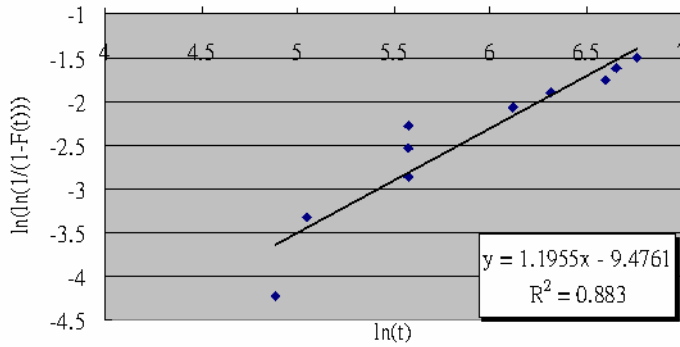
The shape parameters β and characteristic life θ of the ND PCBs are found to be 0.5858 and 84570 cycles, respectively. For the NP PCBs, β and θ of the ND PCBs are 1.1955 and 2770 cycles, respectively. Through the use of Gamma function, the expected life for ND and NP PCBs are 129,027 cycles and 2,603 cycles of testing. Finally, the modified Coffin Mason formula is used to calculate the accelerated factor (AF). Assuming that the normal-use environment is within the temperature range of 25°C~40°C, and the frequency of temperature change is five, the AF is found to be 40. As a result, the expected life for ND and NP PCBs are 2,557,142 h and 51,580 h during their normal service environment.

Fig. 14. Weibull probability plots of ND PCBs

Fig. 15. Weibull probability plots of the NP PCBs

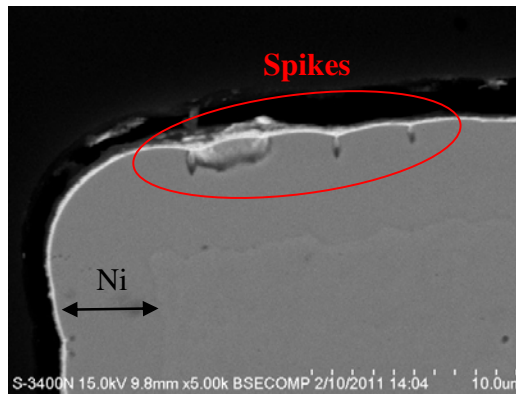
Fig. 16. Black pad symptom, cross-section view

Figure 16 presents the black pad symptom occurring on the ENIG surface finished from raw materials. Through a cross-sectional analysis using scanning electron microscopy (SEM) equipment, several spikes can be observed on the Ni layer and which have penetrated into the Ni layer around 25% of the total thickness. Based on author's experience, ENIG soldering pads with this symptom can be wetted by solder, but their reliability performance may have been decreased to one-half or one-third of its original. As it stands, there are no criteria with which to judge this symptom. A careful company usually screens out the potential risk factors through reliability tests before mass production.

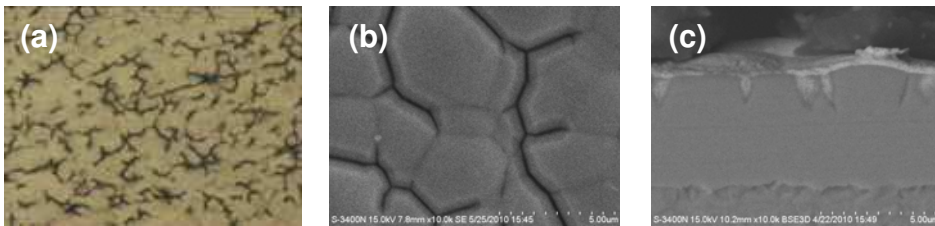
Fig. 17. (a) Plane view, Ni layer (b) plane view, Ni layer (c) cross-section view

Figure 17(a) presents the Ni surface after removal of the Au layer using a chemical etching method. Several dark lines can be seen on the Ni surface. A more detailed magnification is shown in Fig. 17(b). Compared with the cross-sectional view of raw material shown in Fig. 17(c), these dark lines were groove structured and penetrated into the Ni layer. Several studies have indicated that this symptom was caused by corrosion during the Au plating process (Bulwith et al., 2002; Xu et al., 2008). PCB vendors claim that a Ni layer without this spike symptom is not achievable. Based on the literature as well as our practical experience,

Ni layers with fewer corrosion symptoms could obtain better performance in reliability tests (Zeng et al., 2004).

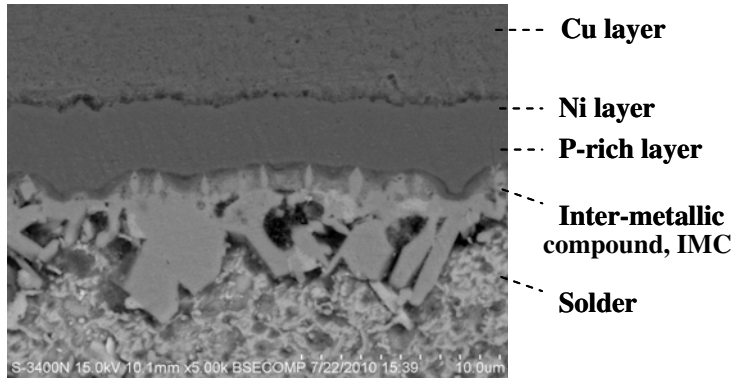
Fig. 18. Solder joint structure, cross-section view

A typical cross-sectional view of the solder joint structure is shown in Fig. 18. The microstructures from top to bottom and sides were the Cu soldering pad, the Ni layer, and the IMC layer, respectively. These spikes observed from raw material remained on the Ni layer after the soldering process. Additionally, a thin dark layer between the Ni layer and inter-metallic compound (IMC) was observed; this layer was a P-rich layer. A P-rich layer was actually developed during the Au plating process due to Ni atoms nearby. The Ni layer surface was replaced by Au atoms, but P atoms within the Ni layer did not act in the Au

plating bath which resulted in an increased P concentration. After the post-assembly process, the P-rich layer will increase in thickness again due to Ni atoms diffused in the solder. Normally, a P-rich layer is composed of P concentrations with 15~25 w.t.% and the Ni element. Figure 19 presents the component fall-off issue during the drop test. This view presents the soldering pad from the component side as it was supposed to be jointed with the PCB after the assembly process. The solder joint between this component and PCB were unable to endure external stressing during the drop test which resulted in component fall-off issues.

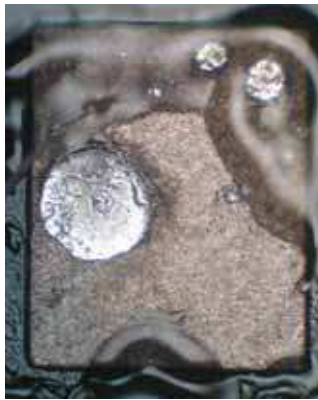
Fig. 19. Fracture appearance

Through cross-sectional analysis (not shown in this article), we found that the fracture was located between the P-rich layer and the IMC layer. Several studies have reported that the ENIG with black pad was fractured at this layer, and that its failure mechanism was not clearly defined (IPC-7095A, 2004; Zeng et al., 2004). PCB manufactures have eliminated the threat to the product's durability and solderability issue by developing several new technologies to avoid P-rich layer formation, for instance, electroless Ni/electroless Pd/immersion Au, ENEPIG.

Figure 20 shows a more detailed view than Figure 19. We can observe several moiré on the soldering pad. This phenomenon may be attributed to deeper spikes forming on the Ni layer during the Au plating process.

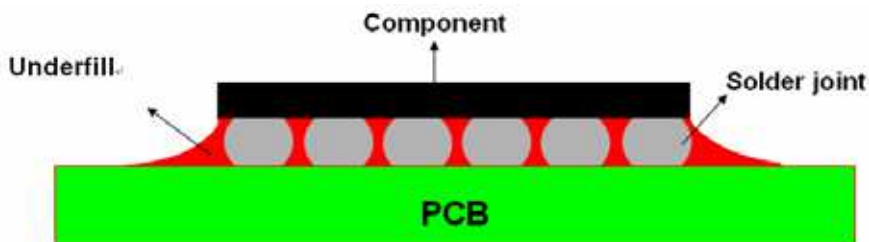
Fig. 21. Illustration of underfill enhancement

Figure 21 illustrates a method for enhancing solder joint strength. The free space between the component and the PCB were filled with an underfill material which becomes solid after the baking process. This kind of reinforced method is commonly used in PCB assembly for enhanced bonding strength in bigger components. So far, there has been no published academic research related to using underfill enhancement for improved solder joint strength when assembly plants encounter black pad symptoms. Hence, we have performed the test to understand whether underfill enhancement is suited to mitigate the influence of the black pad phenomenon. The testing component for the drop-test was prior diagnosed as the black pad symptom, and the defect rate was almost 100%. Before drop-testing, we enhanced the bonding strength for this component by pouring underfill material into the free space between the component and the PCB.

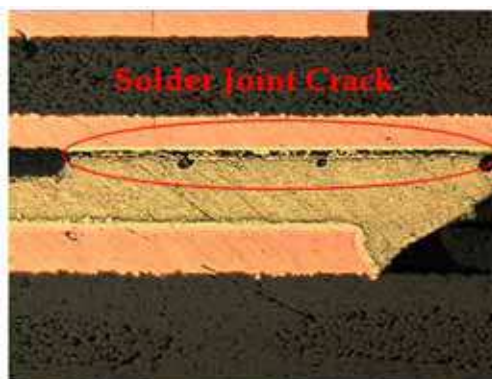
Fig. 22. Solder joint crack after drop-test

The drop-test resulted in failure; the suspected component was still attached to the PCB during drop-testing. Through cross-section analysis, we could found that the crack penetrated the entire solder joint at the component side, Fig. 22. This implied that the underfill enhancement was unable to eliminate the black pad threat.

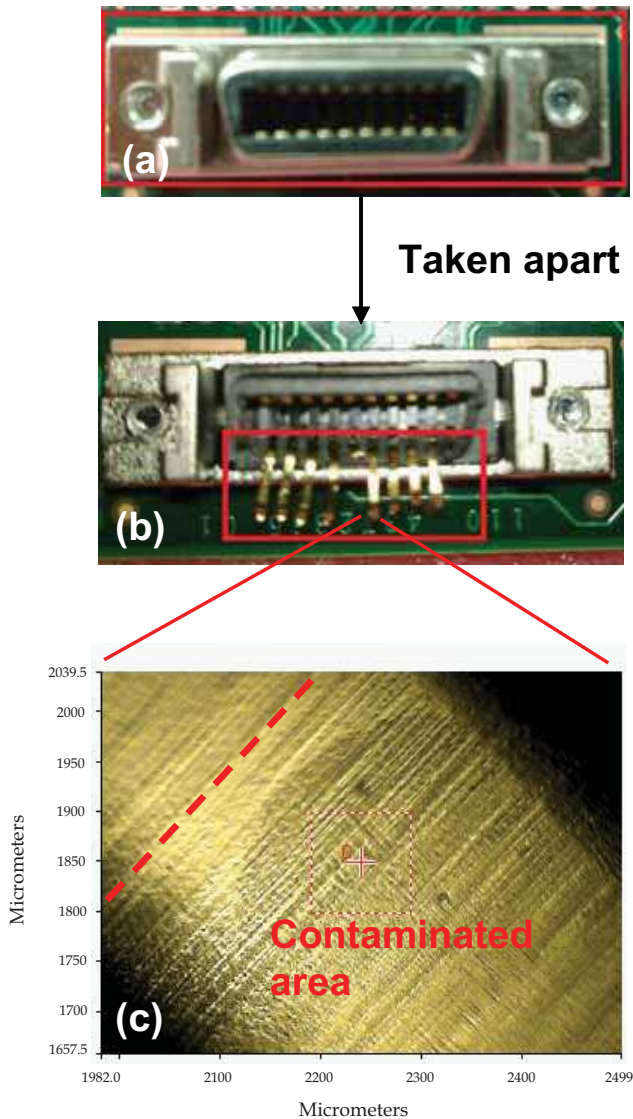
A failure symptom of open contact was found to the JPSPK connector of the audio station bed connector (ASBC) main board. This had resulted in in-circuit test (ICT)/automatic test equipment (ATE) testing failure after the test fixture was attached (or during the basic electric conduction and functional tests). The failure rate for the connector test is about 15%. The connector pin unit can be dislocated from the plastic holding and metal housing (outer layer), as shown in Figs. 23(a) and (b). The appearance observation by OM and CCD shows severe residues on the connector pins. This also indicates the obvious difference in color between the clean and the contaminated areas in Fig. 23(c).

The chemical analysis was carried out to examine the residual substances that may impact the electrical conductivity of the contact. The contaminated areas of the connector pin unit for micro FTIR analysis are shown in Fig. 23(c).

Fig. 23. JPSPK connector (a) plastic holding with metal housing, (b) pins unit, (c) contaminated area on pin for micro FTIR analysis

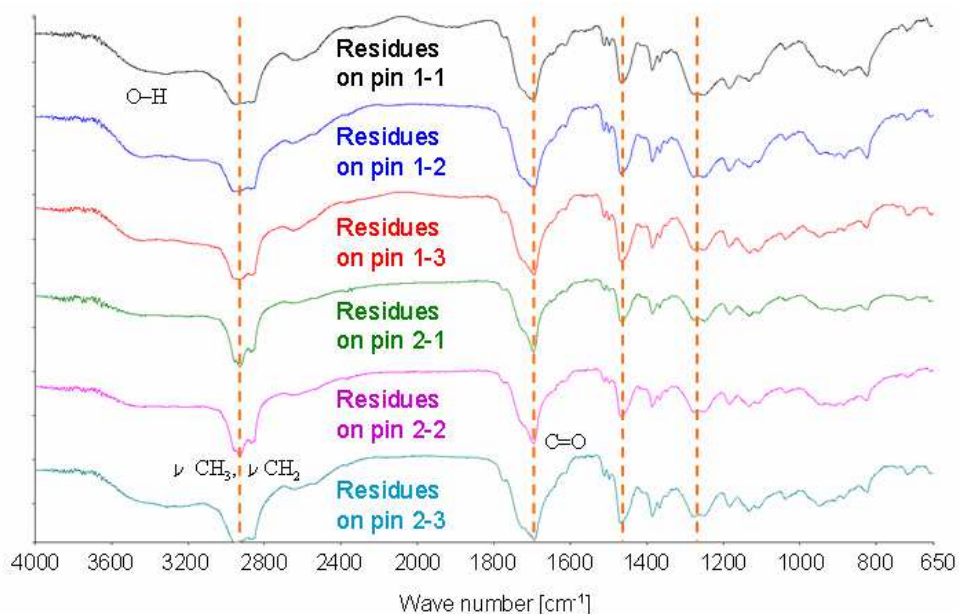
Fig. 24. Micro FTIR spectra of the contaminated connector pin 1 and 2 from different locations (marked dash -1 to -3)

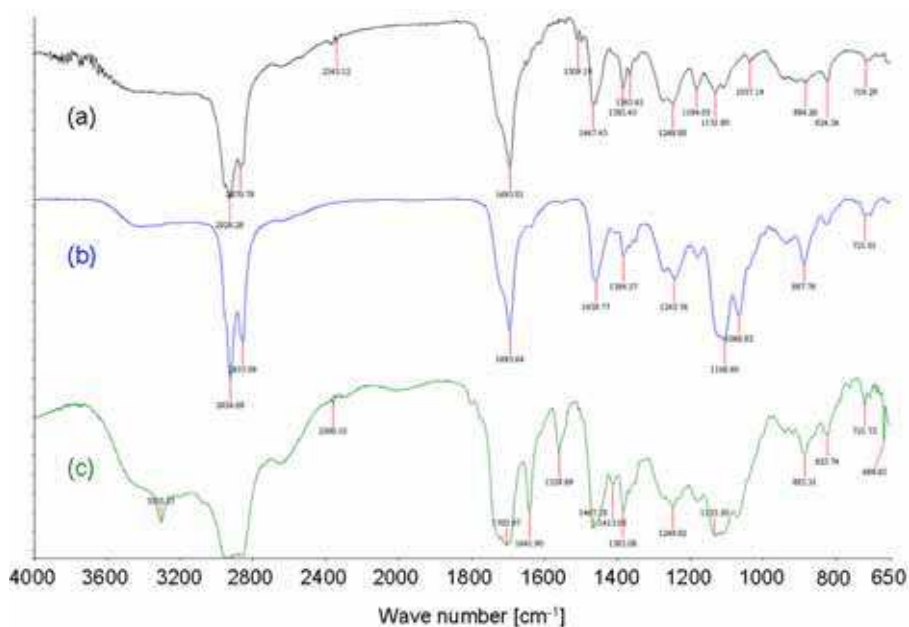
Two different solder pastes (a sticky mixture of powdered solder and flux) were used in reflow soldering during the assembly process, namely paste P1 and P2, respectively. Contrary to metal solders, organic fluxes have the absorption characteristics of molecules with respect to IR radiation. After comparing with the FTIR spectra database, the spectra of the contaminated areas seem to be consistent with that of the paste P1 in Figs. 25(a) and (b)

(sorted by the similarity of chemical structures). Their characteristic functional groups appeared at the same absorption peaks. The paste P2 showed similar structures, but showed few differences compared with the paste P1 (Fig. 25(c)). This suggests that the residues on the connector pins are attributed to the flux from the solder paste used in the assembly processes. Therefore, the micro FTIR was found to be an effective tool to identify the root cause of the micro residue left on the connector pins (Huang et al., 2009).

Fig. 25. Micro FTIR spectra of the (a) contaminated connector pin, (b) paste P1, and (c) paste P2

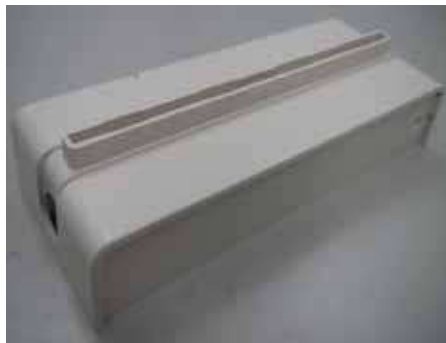
Fig. 26. The appearance of the plastic housing

Incoming quality control (IQC) and supplier quality management (SQM) found that the suspected spray-painted plastic housings had mixed in, with the raw materials, primary colors. The defect rate is about 6% for this discoloration issue after sorting. The suspected housings presented darker surfaces than the normal incoming conditions. It is difficult to recognize the difference in color between the two kinds of housings through visual inspection. Therefore, an instrumentation analysis was applied to help confirm the properties and compositions that caused the cosmetic variation. An FTIR analysis was performed to investigate the chemical structures and compositions from the housing surfaces. It is important to find out whether improper or unnecessary processes were done for the incoming materials. Clients usually attach great importance to the surface textures and dispositions of their products. The appearance of the plastic housing is shown in Fig. 26.

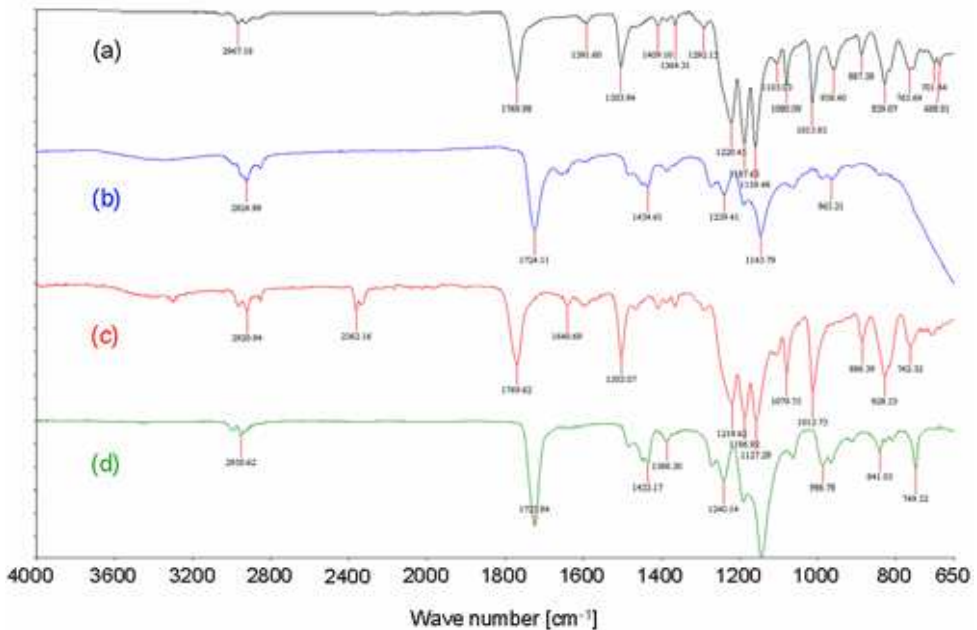
The FTIR spectra under analysis with ATR mode from two different plastic housing surfaces are shown in Fig. 27. IR analysis was carried out at three adjacent locations for each surface to confirm the uniformity of the chemical structures. This showed very similar results from the various locations. The spectra were then compared to the FTIR built-in standard database (Fig. 27). The raw plastic housings with primary colors showed a bright surface and consistent spectrum (chemical structures) with PC (polycarbonate). The spray-painted plastic housings showed a little dark surface and consistent spectrum with acrylic ester.

Fig. 27. FTIR spectra of the (a) raw plastic housing surface, (b) suspected spray-painted plastic housing surface, (c) PC (polycarbonate), and (d) acrylic ester

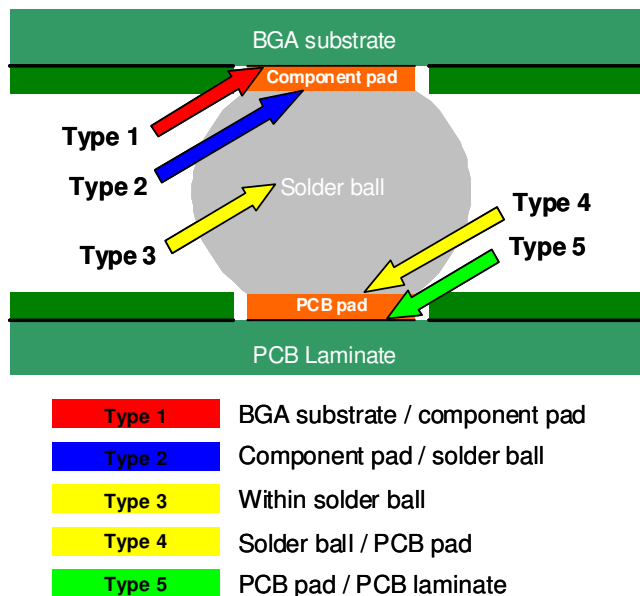
Fig. 28. Failure mode classification for a solder joint

The failure mode of a solder joint can be classified into five types, as illustrated in Fig. 28. Type 1 indicates that the fracture is between the BGA substrate and the component pad. Type 2 shows that the fracture is between the component pad and the solder ball. Types 3 and 4 both show that the fracture is within the solder ball and the solder ball/PCB pad, respectively. A fracture between the PCB pad and the PCB laminate indicates Type 5. The magnitude of the dye penetration for each solder ball shows the degree of the crack propagation and can be classified into four types. Type A is such that the magnitude of dye penetration for a solder ball is below 25%. Type B falls between 26% and 50%. 51% to 75% indicates Type C. Type D has over 76% dye penetration.

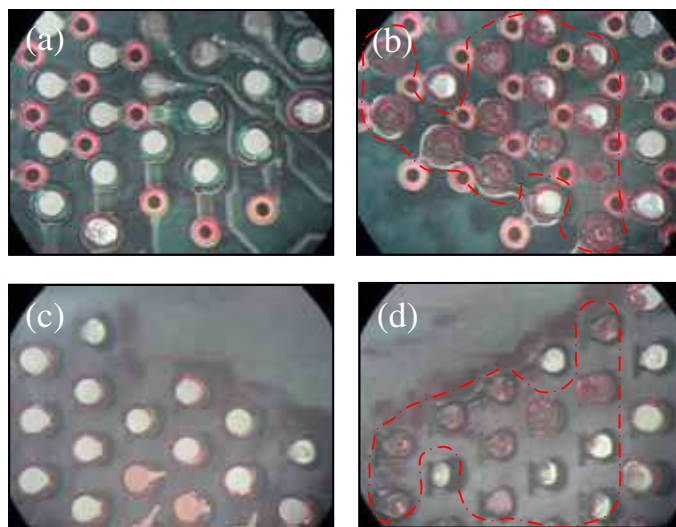
Fig. 29. Optical picture of (a) PCB pad side of 1st corner (b) PCB pad side of 2nd corner (c) component BGA side of 1st corner (d) component BGA side of 2nd corner after dye staining process

Figure 29 is an optical picture taken after the dye staining process. In order to accurately interpret the dye staining results, two photos from the PCB pad side and component BGA side are compared together to find out the right failure mode of the dyed areas. For example, Fig. 29(a) corresponds with Fig. 29(c). Dye propagation and magnitude from both sides provide the main judgment criteria regarding whether cracks occur. Following the dyeing process, the failed solder joints are identified and the failure mode classification can be defined.

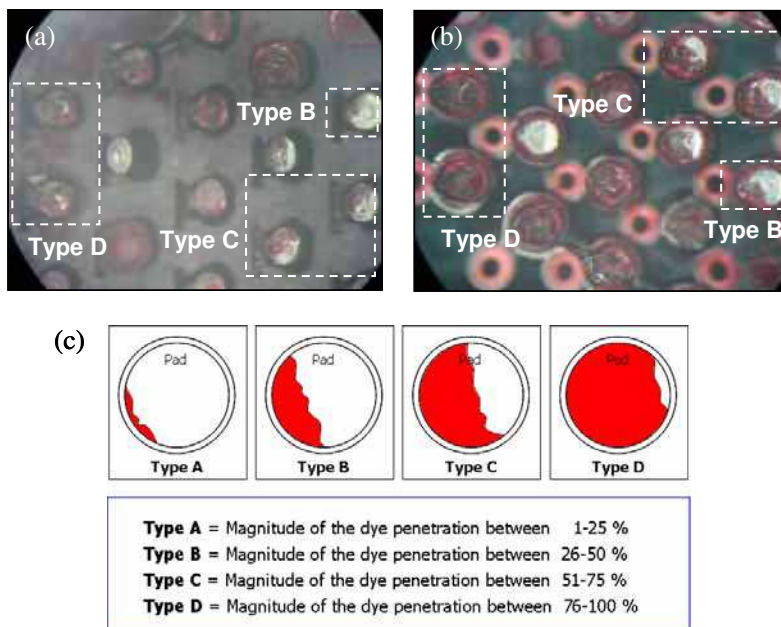
Fig. 30. (a) Enlarged picture of PCB pad side of 2nd corner (b) enlarged picture of component BGA side of 2nd corner (c) the classification of magnitude regarding dye penetration for each solder balls (crack size)

Figs. 30(a) and (b) are enlarged photos showing several failed solder joints. The failure mode of these solder joint cracks is between the component pad and the solder ball, which is Type 2, based on the classification of failure mode. Figure 30(c) shows the classification of the magnitude of the dye penetration. With respect to the magnitude of the dye penetration, Types B, C, and D of high percentage crack sizes can be seen in the photos indicating severe solder joint cracks occurring after a slight variation to the ICT fixture.
