Tropical Storms as Triggers for Intensified Flooding and Erosion Processes in Southernmost Mexico

Thomas Dekarski¹, Markus Praeg¹,
Dirk Wundram² and Michael Richter¹

¹University of Erlangen, Department of Geography,

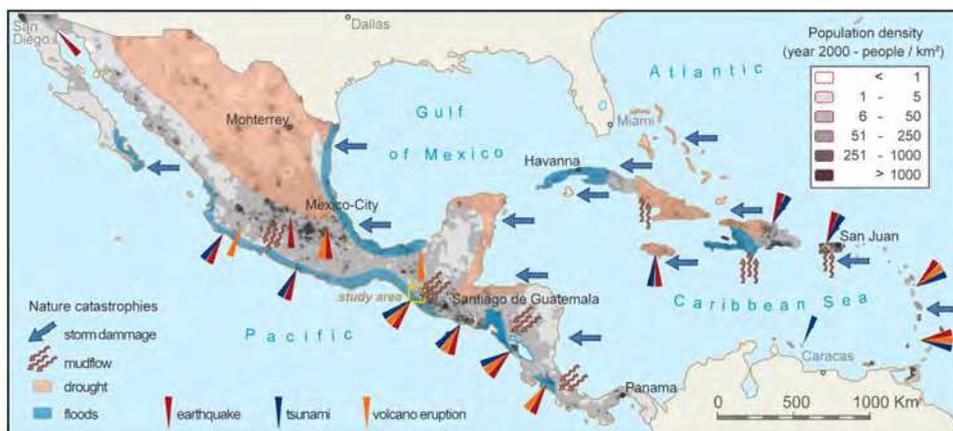
Fig. 1. Main nature risks and population density in Middle America (Richter & Adler 2007, modified) including the position of the study area

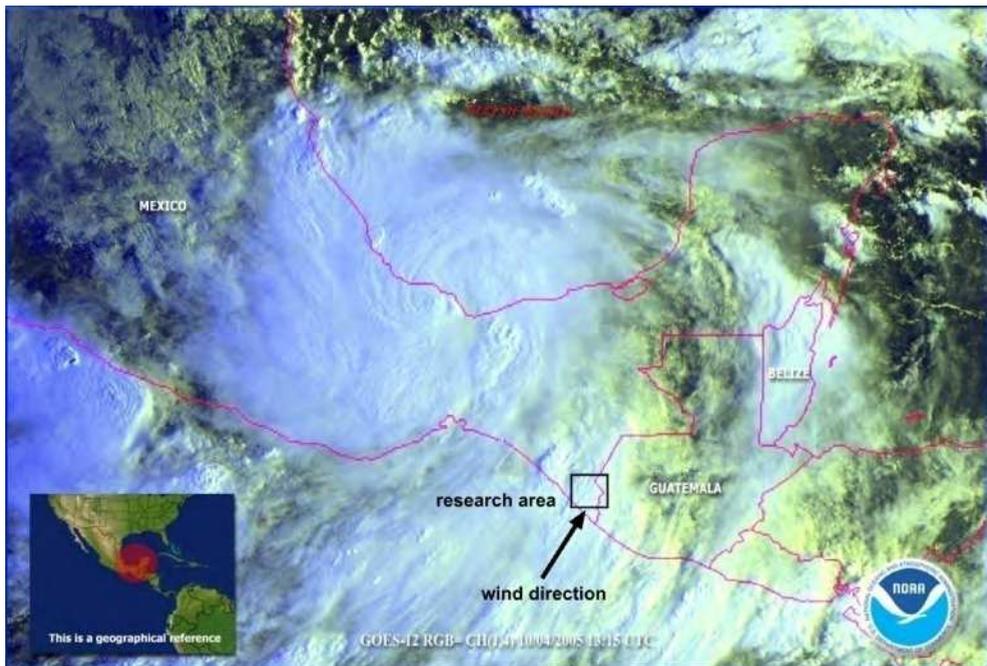
Fig. 2. The NNE-drift of humid air masses towards southern Chiapas and Guatemala during hurricane Stan ; supplemented source: <http://www.osei.noaa.gov>

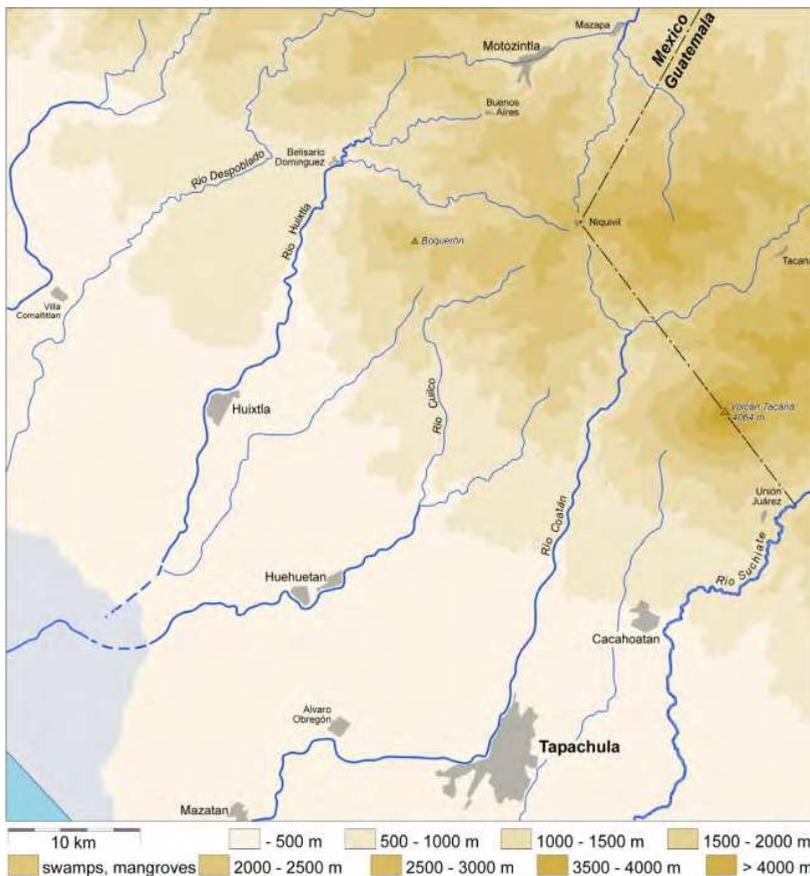
Fig. 3. Overview map of the research area in southernmost Chiapas (position s. fig. 1)

Summarized in tab. 1, the southern tip of Chiapas is differentiated into five prominent landscape-types between the Pacific Ocean and Volcano Tacaná, i.e. the highest point culminating in 4064 m a.s.l. (fig. 3). The coastal plain of Soconusco as well as the gently

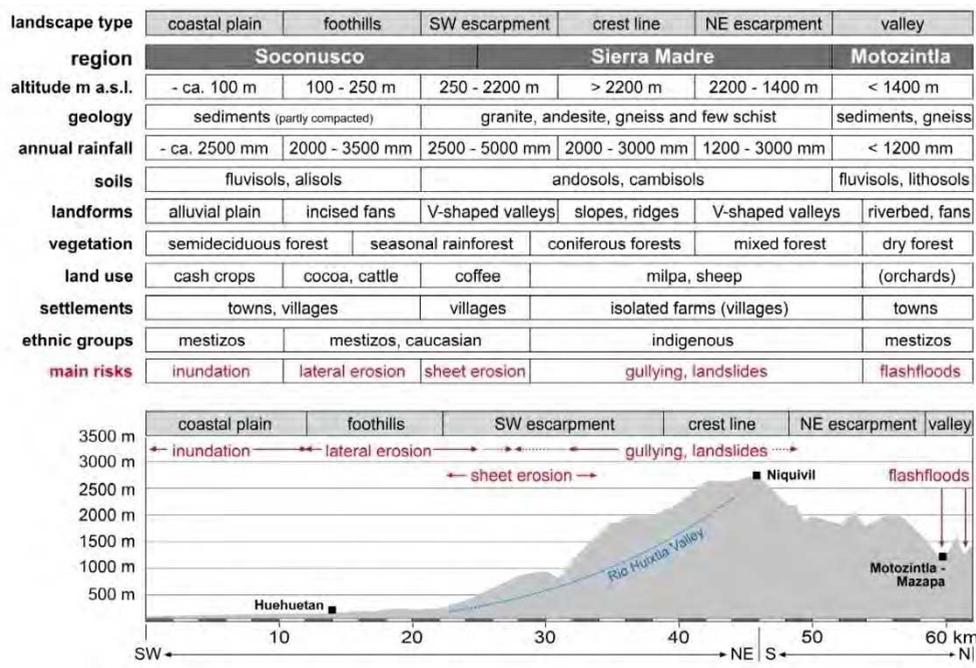
Table 1. Landscape subdivision along a profile from the Pacific coastal plain towards NE and N through the Sierra Madre de Chiapas, including an approximate overview of the extensions of most prominent geographical features (erosional and denudative processes marked by reddish terms)

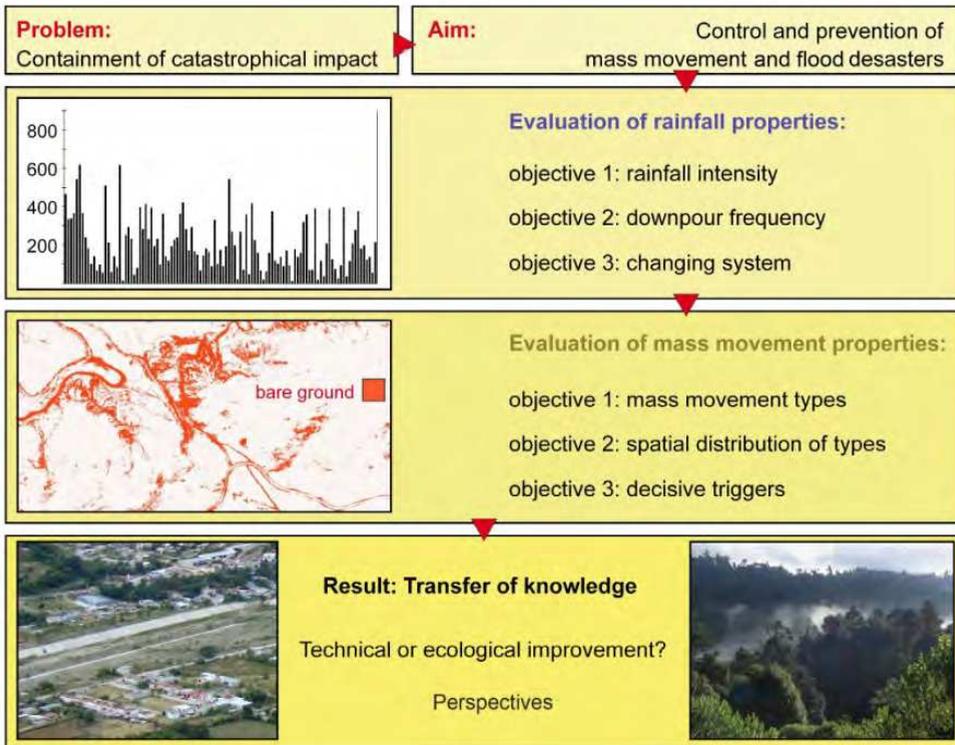
Fig. 4. Concept of the methodological approach

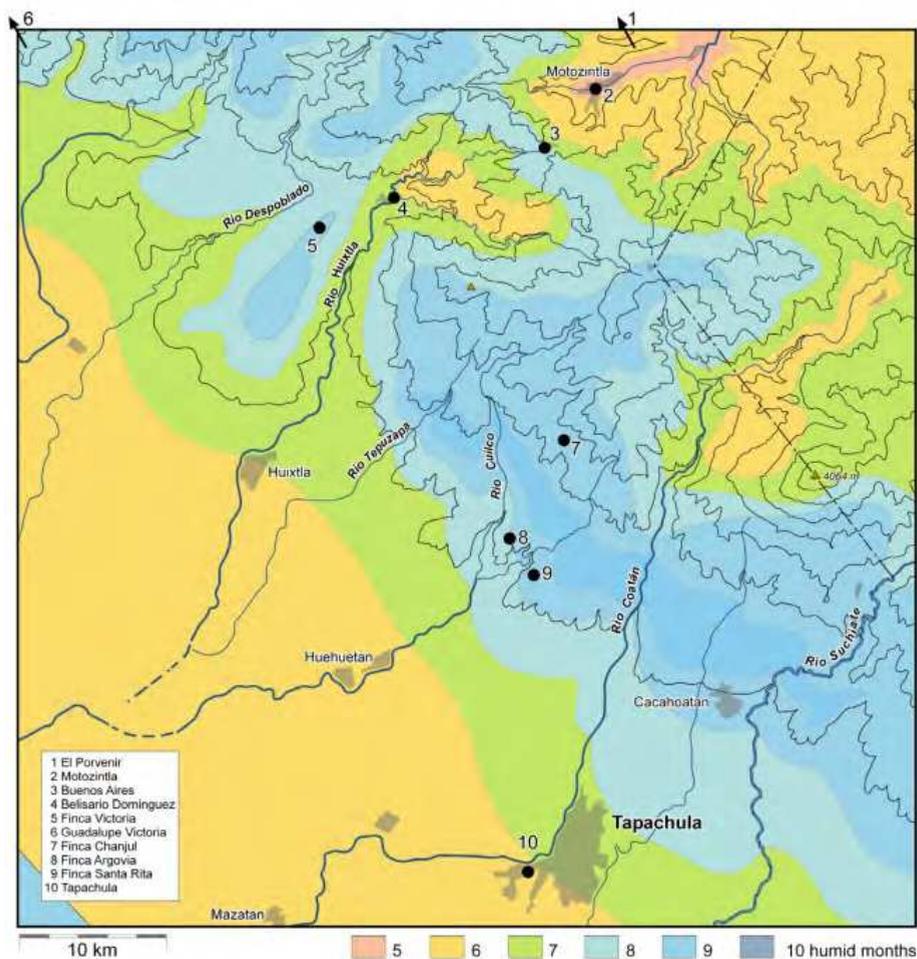
Fig. 5. Mean amount of humid months per annum documenting the Sierra's general role as decisive rain barrier, while less prominent side crests like those of Tacaná and Boquerón (s. triangles) can pose as secondary rain barrier on the windward side. Rain stations documented in fig. 7 and 8 (lower part) are indicated by numbers

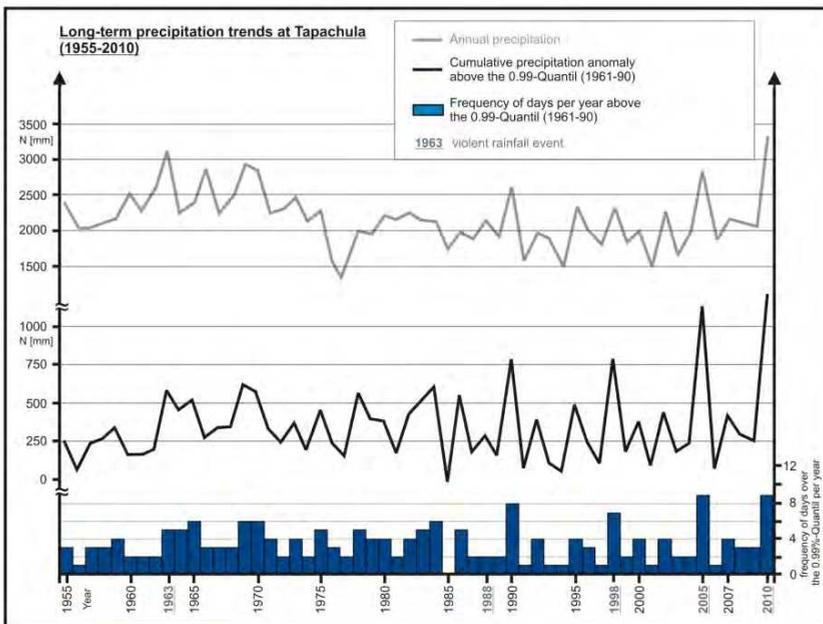
Fig. 6. Rainfall characteristics (annual amounts, anomalies, frequencies) during the last 57 years at Tapachula (179 m a.s.l.)

Concerning the rainfall intensity (mm/h), at Tapachula the most intensive shower activity during the prevailing monsoonal regime has been 81 mm/h in 2010, i.e. a magnitude which the local storm water system could barely cope with. The classified violent rainfall rates (>50 mm/h) are more likely to occur during downpours within a monsoonal trough. Again the analyses of the hourly data from the Tapachula weather station points out that the September has the highest number of heavy rainfall events (>25 mm/h). The conditions for such events are favourable in the end of the wet season, because the SST is high enough for significant moisture transports into the atmosphere, which already starts to cool down. In addition to the monthly rainfall amounts, statistical studies revealed that the ITCZ shifts northward until its northernmost position in September (Hasenrath 2001). Therefore, the maximum occurrence of "Temporales" and the precipitation totals on the Pacific side of Southern Mexico are connected with the annual cycle variations of the intertropical convergence zone.

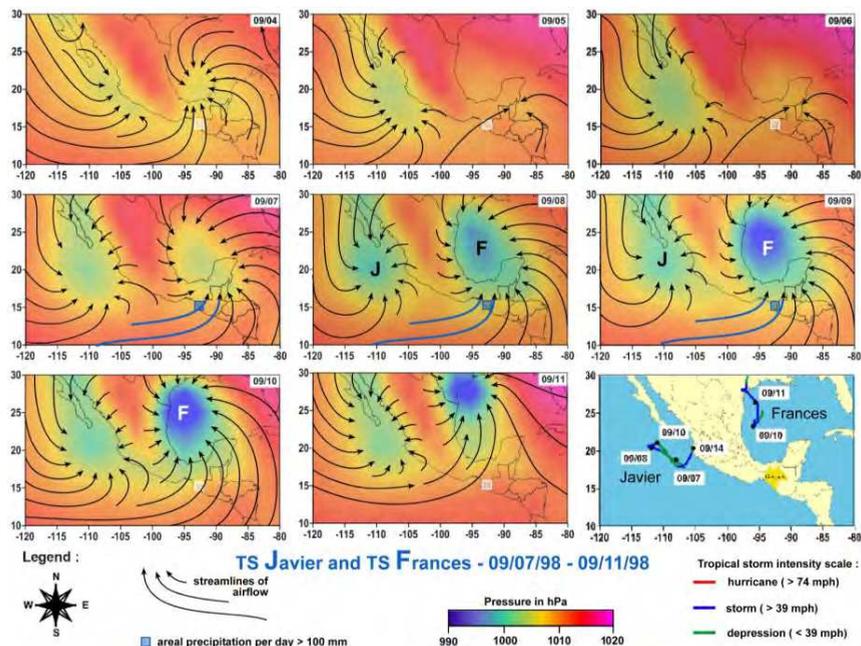
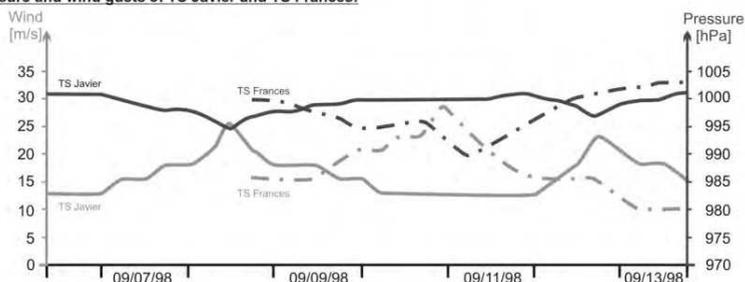
Pressure and wind gusts of TS Javier and TS Frances:

Weather Station	Altitude (a.s.l.)	LTMAP*	9/1/98	9/2/98	9/3/98	9/4/98	9/5/98	9/6/98	9/7/98	9/8/98	9/9/98	9/10/98	9/11/98	9/12/98
Motozintla	1210m	845	11	0	2	6	5	18	175	130	27	10.1	0	0
Buenos Aires	1720m	1141	0	0.5	10	0.4	80	270	30	20	40	35	40	45
Belisario Dominguez	860m	1964	92	1	0	15	25	117	298	280	150	0	0	8
Finca Charjul	1255m	4138	22	0	2	50	29	115	310	210	130	20	0	0
Finca Victoria	989m	2474	8	0	5	75	24	48	315	255	232	38	0	8
Santa Rita	680m	4228	30	110	0	18	34	40	234	170	124	14	6	2
Finca Argovia	620m	4160	23	94	1	10	27.5	30	163	177.5	196	11	3.5	4
Guadalupe Victoria	130m	2580	40	100	175	195	190	401	Station breakdown					
Tapachula	179m	2037	5.6	0.4	0	27.5	20.7	92.7	145.5	140.2	92.1	0.5	0	0

Fig. 7. Coloured maps: Pressure development and air flows during tropical storm activity of Javier and Frances from Sept. 4th to 11th 1998; blue stream lines indicate the direction of main humidity transfer during wet days (derived from NCEP/NCAR Reanalysis data). Black and white diagrams: Wind speeds and pressure (NOAA) as well as rainfall amounts from several stations during the 12-day period (CONAGUA, and private stations). Note the double effect by the traverse of two storms

Tropical storm Frances was formed out of a broad area of low pressure and widespread showers in the southern Gulf of Mexico and the western Caribbean. The existence of three poorly-defined tropical waves in the area may have contributed to the formation of a tropical depression on 8th September. In addition, the close interaction between larger systems of rainstorms (Javier) developed over the Pacific. The rain fell in torrents for at least three days until the tropical system moved slowly northward and the humidity transfer into the mountainous region of the Sierra ended. At the windward station of Guadalupe Victoria concentrated deep convective showers account for the stations breakdown (fig. 7, table). The influence of tropical storm Javier on the prolonged rainfall in the Sierra was only marginal. But it contributed to a broader area of disturbed weather that persisted over the tropical eastern Pacific. Note that the dark blue colour of Frances hints to lower pressures than in case of Stan. Nevertheless, the potential of 2005 was never reached because the constellation was different (extension of the whole complex as well as vigorousness of the storm centre; compare diagrams in fig. 7 and 8).

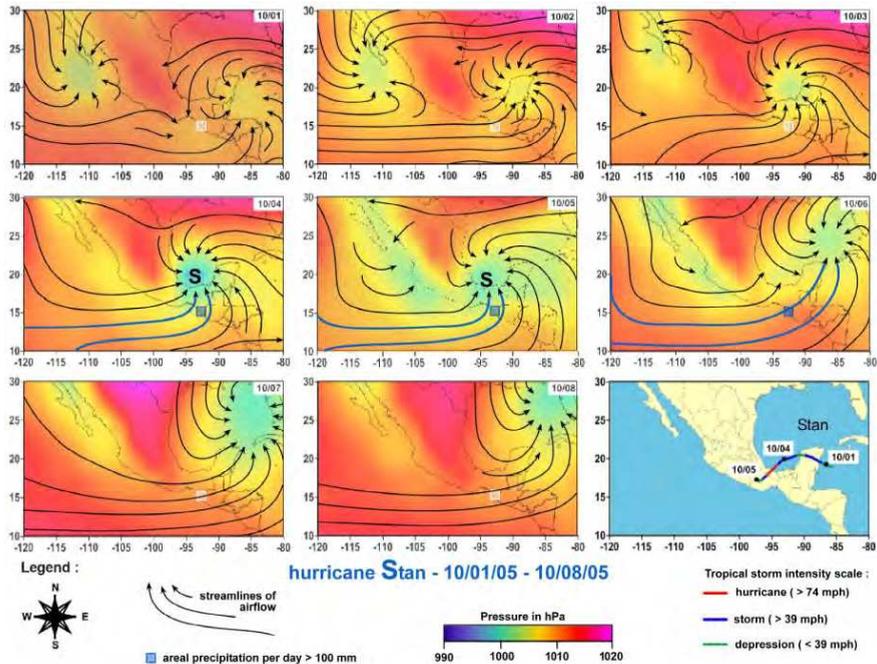
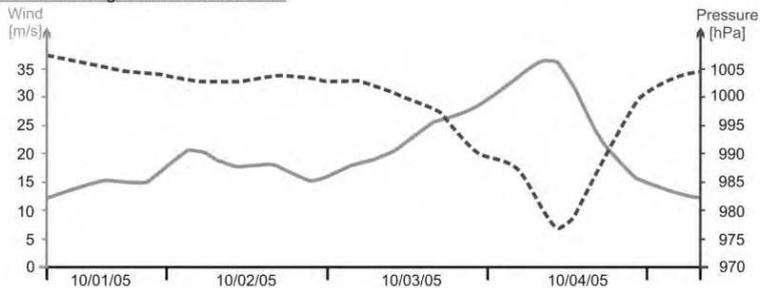
Pressure and wind gusts of Hurricane Stan:

Weather Station	Altitude (a.s.l.)	LTMAP*	9/29/05	9/30/05	10/1/05	10/2/05	10/3/05	10/4/05	10/5/05	10/6/05	10/7/05	10/8/05	10/9/05	10/10/05
El Porvenir	2730m	1813	14	15	28	29.5	37.5	348	165	124	37.5	33	21	12
Motozintla	1210m	845	11	9	0	0	100	43	320	55	4	1	0	0
Buenos Aires	1720m	1141	0	18	0	0	95	180.7	160	105	75	0	13.5	0
Finca Chanjul	1255m	4136	69	10	15	30	130	406	380	150	25	0	15	10
Finca Victoria	989m	2474	32	2	0	9	146	405	340	150	0	0	14	23
Santa Rita	680m	4228	30	15	115	33	110	434	410	164	5	50	15	15
Finca Argovia	620m	4160	22	15	84	21	74	373	320	109	4	48	6	12
Guadalupe Victoria	130m	2580	15	0	19.6	111	170	415	552	236	125	148	66	1
Tapachula	179m	2037	6.6	10.9	36	0	133.6	145.2	155.5	119.4	12.8	15.2	11.1	0.6

Fig. 8. Coloured maps: Pressure development and air flows during passage of hurricane Stan from Oct. 1st to 8th 2005; blue stream lines indicate the direction of main humidity transfer during wet days (derived from NCEP/NCAR Reanalysis data). Black and white diagrams: Wind speeds and pressure (NOAA) as well as rainfall amounts from several stations during the 12-day period (CONAGUA, and private stations)

Veracruz, when the hurricane achieved its lowest barometric pressure of 977 hPa. The track into the southwest caused an interaction with a broad, deep-layer cyclonic circulation in eastern Mexico. The diagram in fig. 8 shows that on October 3 the prolonged heavy rainfall began on the western escarpment, in the dry valleys and in the mountains around El Porvenir. This northernmost area served as a barrier and stopped the overflow of the convective showers and on October 4 most of the study area was exposed to excessive rain. Next day the remnants of hurricane Stan contributed to the highest daily amounts and led to the catastrophic outcome of the abnormal weather situation (Vasquez 2008).

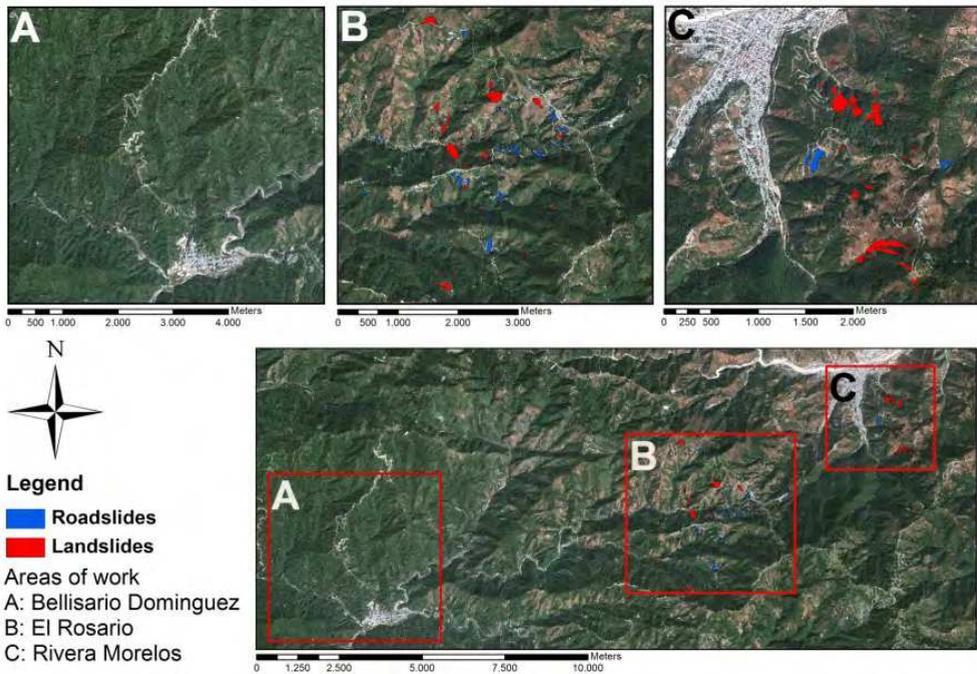
Fig. 9. Overview and detail of the research areas with road- and landslides derived from satellite images presented by GoogleMaps (recording date 12/19/2010)

Same as off-road landslides, the hot spots of road slides concentrate on drier sections of the Sierra Madre. In some cases they even exceed the number of out-of-the-way slides as interpretable by the red-blue patchwork in Fig. 9 (extract b). The slope failures depicted in Fig. 16 exist since several years, are quasi-permanently active, and some of them can be divided in a lower dump section and an upper excavation part. In the first case the forest sites below the road are dissected by lamellar debris (e.g., between the creek and the unpaved road in the middle of fig. 16, right). In case that a slide is located just in the uppermost part of a catchment of a stream like in the upper right half of fig. 16 (left), dump deposits are removed during rainy phases and hence, accumulation succeeds alongside the

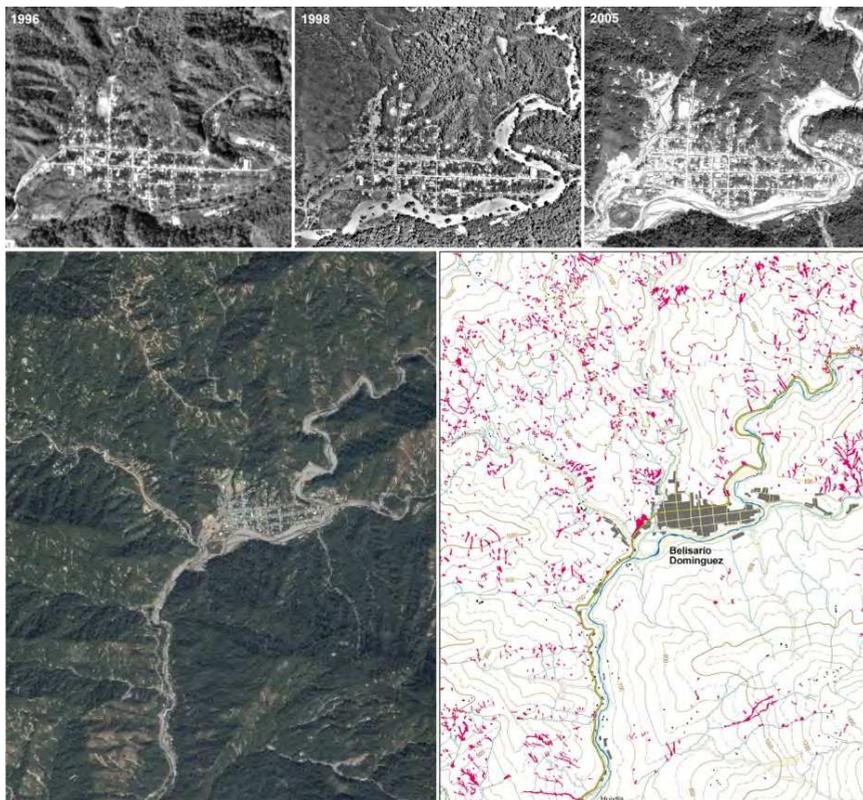
Fig. 10. Top: Aerial pictures of Belisario Dominguez in 1996, 1998, 2005 from INEGI. Below: The surroundings of the same town affected by small and shallow landslides after hurricane Stan 2005 (Quickbird image from DigitalGlobe, recording date 15/12/2005)

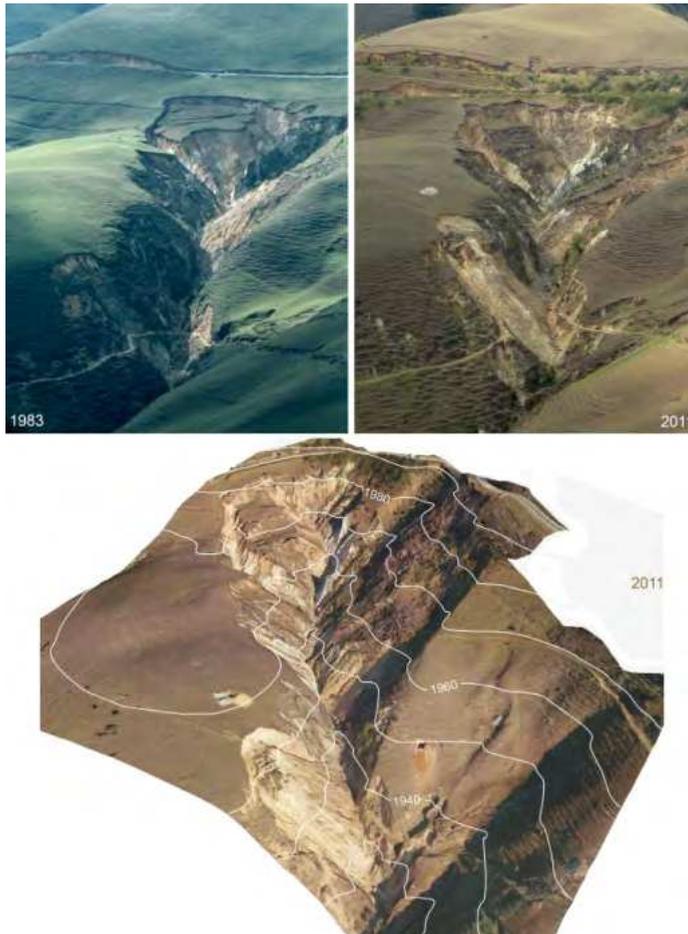
Fig. 11. Development of a landslide near the watershed at Las Cruces. 3D-image derived from aerial images taken by an octocopter; contour lines derived from GPS-measurements on site

area. The complex slides within an arroyo (dry creek) of slow retrograde erosion exist for more than three decades and some of its sections are slowly altering their aspect. A comparison of the two photos of 1983 and 2011 indicates, for example, that the rotated blocks below the uppermost scarp are meanwhile more dissected, slightly slipped off and covering only half of their former size. Additionally, few side scarps within the arroyo hardly expanded during the three decades. However, on the other hand the two pictures point to a surprisingly stable situation which contrasts completely to a nearby form, that is developing further.

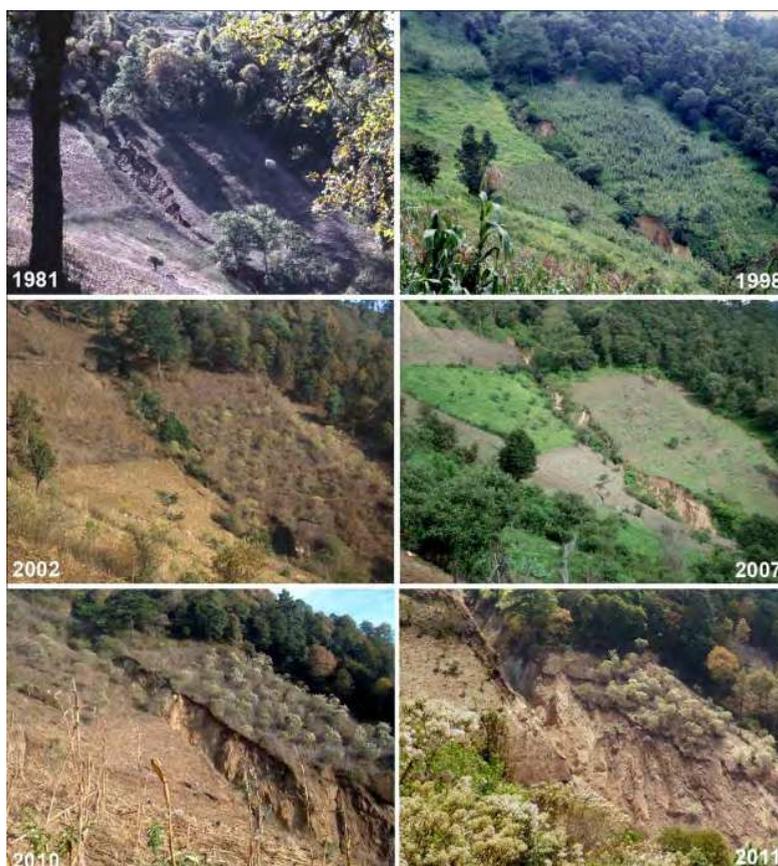
Fig. 12. From gully towards valley – ongoing erosion effects near Morelos above Motozintla through 30 years (photographs by M. Richter)

This is the study area of Rivera Morelos beyond the watershed, where small devastations are nearly absent and large denudation forms of more than 10,000m² are characteristic. The height above sea level of 1300 to 1900 m a.s.l. is almost the same as in El Rosario, but the annual precipitation is less. Here, gully erosion is the dominant mass movement process. Situated in the north east of the study area (fig. 9 C) the old gully form in fig. 12 (upper left)

is developing towards an enormous valley in the lower right of the sequence of the same site. The specific characteristic of this area is an ongoing and vivid development of mass movement forms. Only three vaster erosion scars, e.g. the gully in fig. 12, existed before hurricane Stan. Until today their number rapidly increased, their outlines expanded and the baselines deepened. In contrast to the other study areas fresh mass movements occurred during the rainy season in 2010 when heavy rainfalls intruded by the tropical depression 11-E. Most of the processes were once again gullying, in some cases accompanied by rotational sliding and toppling through undercutting. The anthropogenic influences combined with a micro-climatically enforced physical weathering of meta-granodiorites as parent rock, which leads to coarse-grained substrate, are reasons for a growing instability in this region and can explain the meanwhile huge gullies as a dominant mass movement form. It is no surprise that the deforested pine forest area is the main new hazard source. The growing problem here is the development from gullies towards valleys, which means a lot of land will be lost and a stabilisation by reforestation measures on the slopes of the completely bare and deeply dissected new V-shaped arroyos becomes an illusion.

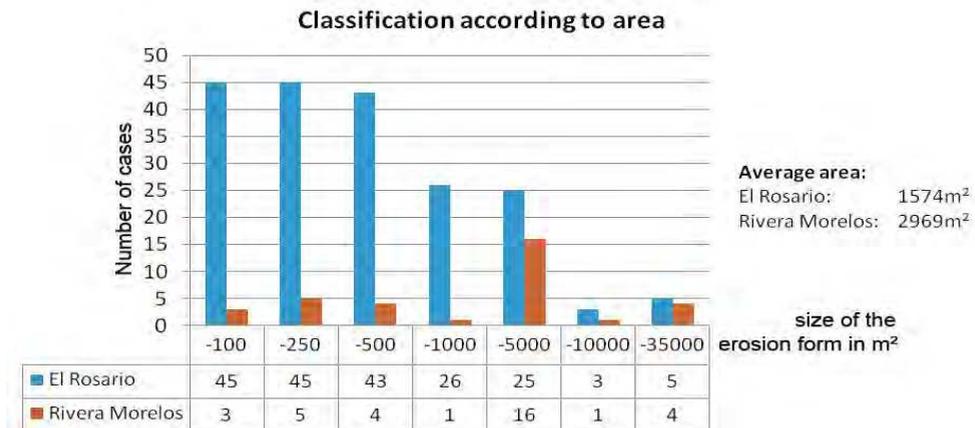
Table 3. Landslide classification according to size and number at two study sites

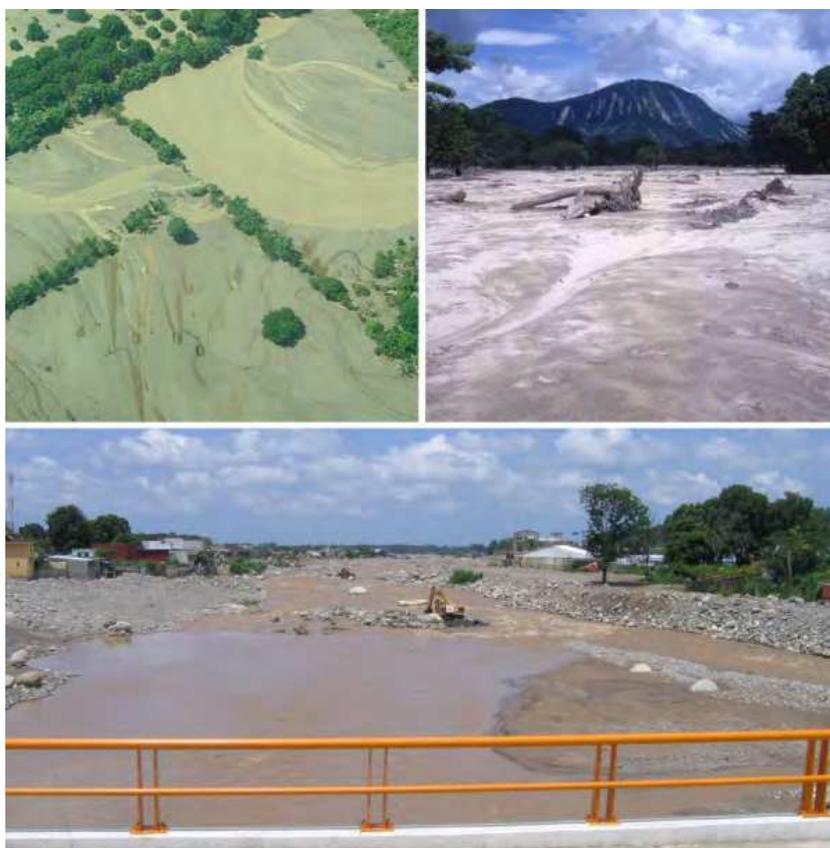
Fig. 13. Inundation and sedimentation in the surroundings of Rio Coatán near Tapachula caused by hurricane Stan (2005, left) and of Rio Novillero near Mapastepeque after tropical storm Frances (1998, right). View from the Rio Huixtla bridge after the Stan floods (below)

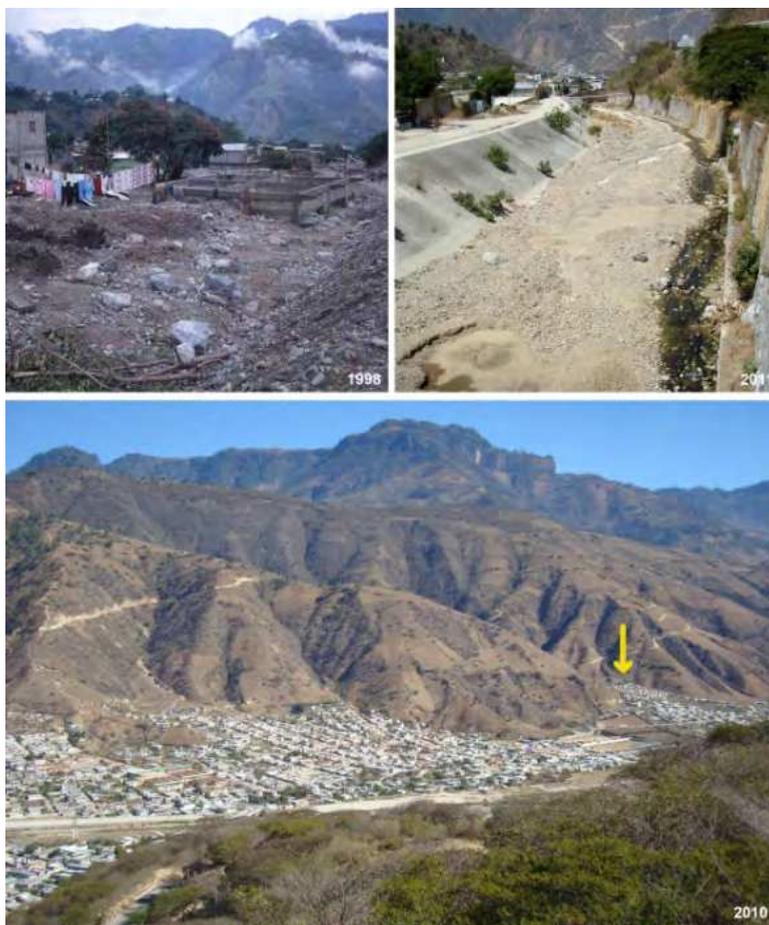
Fig. 14. A mostly dry channel of a tributary creek passing through Motozintla (upper left after the disaster in Sept. 1998, upper right in Feb. 2011 after channelling) and overview on those suburbs of the town which were installed mainly after the 1998 event; the yellow arrow marks a recently established quarter highly endangered by flash floods

Nevertheless the death toll during the 2005 event was a little less (28 fatalities) although the rainfall amounts were higher yet and the floods larger than in 1998 (375 mm in two days and more than half of the average annual input during four days, i.e. 518 mm versus 845 mm). The slightly lower impact is partly due to the dammed tributary creek shown in fig. 14, which did not yet exist before 1998 and was still too small before 2005. Many of the casualties in 1998 were attributed to overflows and debris accumulations along the meanwhile channelled tributary (fig. 14, left and right upper part), where the solid reinforcement protects the lower parts of town from massive flooding. But as channel stabilization was performed with only the 1998 flood as the design event, a strong 2010 storm (tropical depression 11-E, Sept. 4 and 5, rainfall data not yet available at date of submission) banked up heavy debris loads alongside and beyond the concreted creek wall.

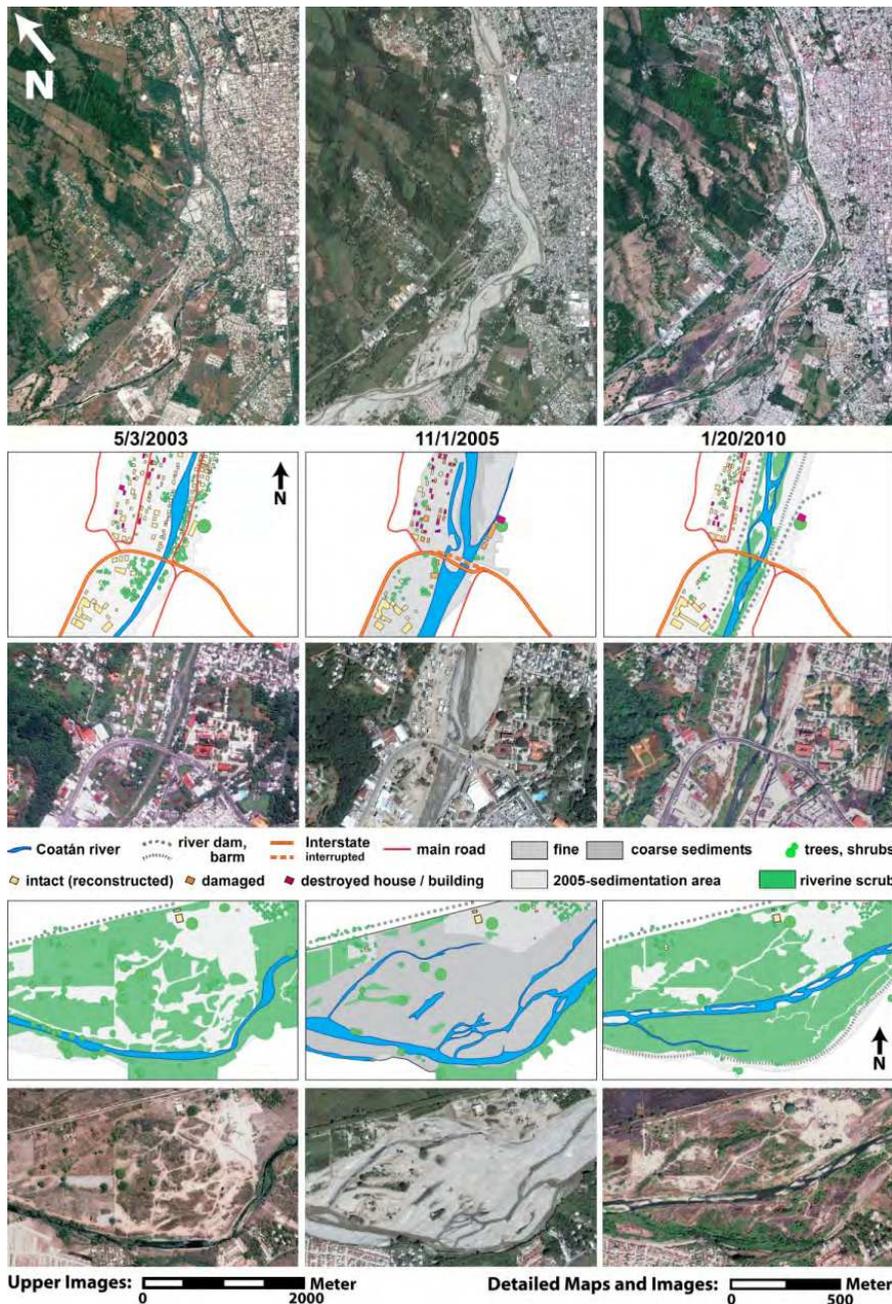
Fig. 15. Effects of the floods along the Rio Coatán at Tapachula in consequence of the hurricane Stan event in Oct. 2005 presented by satellite images before (left row), three months after (middle) and 40 months after the event (right)

The 2005 event was probably the worst disaster that ever hit the city. Four bridges and the railway were carried away cutting the town into two parts. The photo sequence in Fig. 15 proves that main parts of the city were isolated from major transport links to the north of the country. 10 barrios were heavily damaged and 12 were flooded with mud deposits. More than 2,000 homes were destroyed and nearly 100,000 people affected (Murcia & Macías 2009). The figure shows also the fast recuperation in the river bed, where many areas are inhabited by plants once again although the short distance between the high mountain range and the lowland favors the flood danger. In the upper parts of the Rio Coatán for example about 8653 ha are partly or totally deforested. This leads to an erosion rate up to 9t/ha higher than mountain slopes with endemic forests (Mundo Molina 2010). In the case of Tapachula the 4064 m a.s.l. high Tacaná Volcanic Complex in the backcountry enlarges the sediment load.

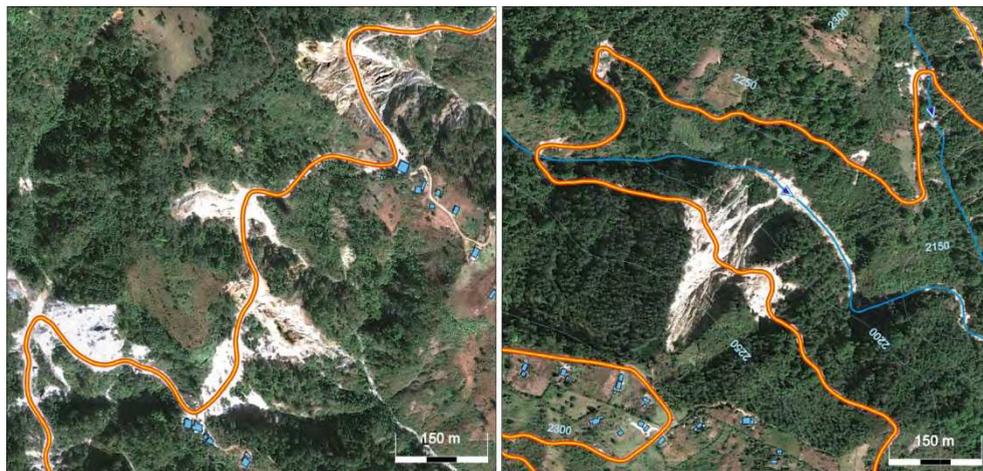
Fig. 16. Roadside slides above Buenos Aires (left; locality Las Flores Buenavista, road towards Porvenir) and below Niquivil (right; locality Tuxchamén, dirt road towards Pavencul). Blue quadrates = houses and sheds, blue line = creek with arrow of flow, red-yellow lines = roads (source Google maps, date taken November 2010)

ditch. The just mentioned example in the picture forms a rotational slide which is well recognisable by multiple slide blocks due to a disruption of the initial and principle scar. Here, fault scarps and fractures create a continuous slope instability causing frequent slip and toppling failures leading to extended roadblocks during the last two decades.

In contrast, the example on the right (fig. 16) stands for an enormous translation slide with a height of approximately 100 m and an extension of about 300 m, which gradually develops since the early 2000s and deepens stepwise by repeated gully erosion processes. Here, solely road construction is responsible for the sliding process, since before the intervention the environment was governed by a dense mountain forest. Same as in the Buenavista example, the Tuxchamén sliding resulted from an artificial excavation of the underlying stratum without the establishment of a firm fundament. In consequent, close-by home- and farmsteads become endangered like several premises below or also above the road slides, respectively, marked by blue rectangles in both aerial pictures in fig. 16. Spillage and fall risks of roads and houses in the Sierra are not only given by heavy rainfalls but also by relatively frequent earthquakes of a maximum magnitude between 3 and 5 or by a combination of waterlogged substratum and temblors.

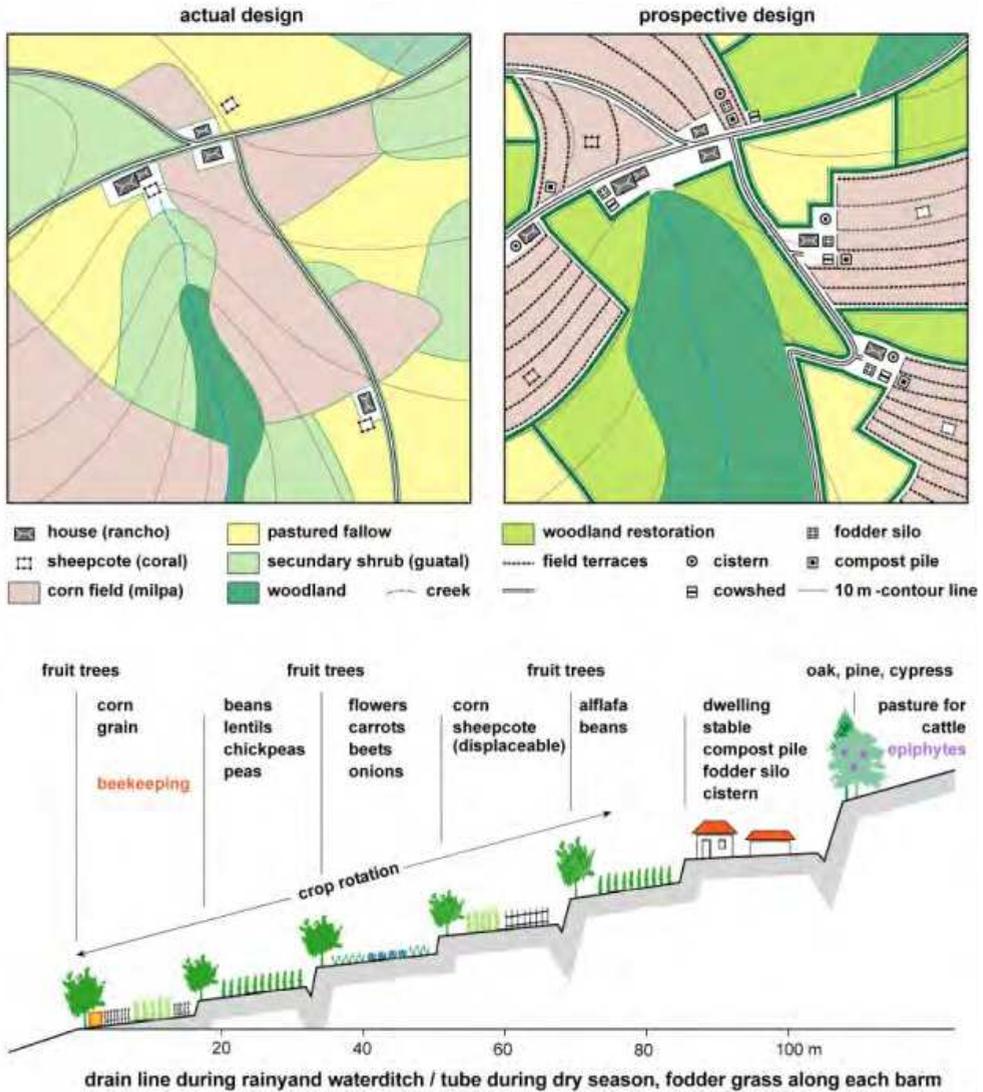
Fig. 17. Current situation of primitive subsistence agriculture (upper left) and target situation of land use management in the milpa zone (upper right) including a scheme of a sustainable crop rotation system for a same hillside environment (below)

instead of field-rotation to reduce mass movement risks as much as possible and to prevent land consumption by yield increases and minimisation of farmland. This advisement bases on ecological and economical experience in several nearby Guatemaltecan valleys of a relatively expanded dry period as given around Totonicapan or in places around Huehuetenango and Quetzaltenango. Here, the markets offer a larger food supply than in the semihumid and semiarid regions on the Mexican part of the Sierra Madre and the farmland is characterised by a multiple variety of products for growing consumer requests.
