Finite Element Analysis Applications in Failure Analysis: Case Studies

Ahmad Ivan Karayan, Deni Ferdian, Sri Harjanto,
Dwi Marta Nurjaya, Ahmad Ashari and Homero Castaneda

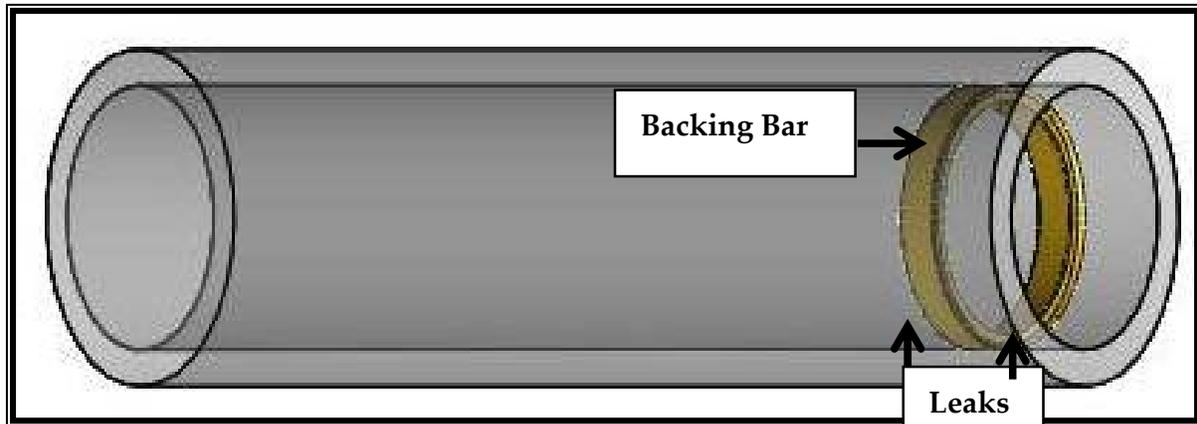
Figure 1. Big and small leak near the backing bar at about 6 o'clock position viewed from the inner side of seawater inlet pipe.

Karayan *et al.* [18] studied the failure of a seawater inlet pipe. The failure was first characterized by a small leak at approximately the 4-8 o'clock position. A schematic drawing of the inlet pipe showing the backing bar near the leak location is shown in Figure 1. This backing bar was installed on the welded surface. The visual examination of this failed pipe is shown in Figure 2. In order to find out the root cause of failure, a number of laboratory tests were performed. The results showed that the failure was caused by cavitation, as evident by the presence of a crater-like surface near the backing bar (Fig. 3). These localized craters seemed unusual since they were only noticed near the backing bar. An additional tool such as finite element analysis was used to determine why this was the case. A finite

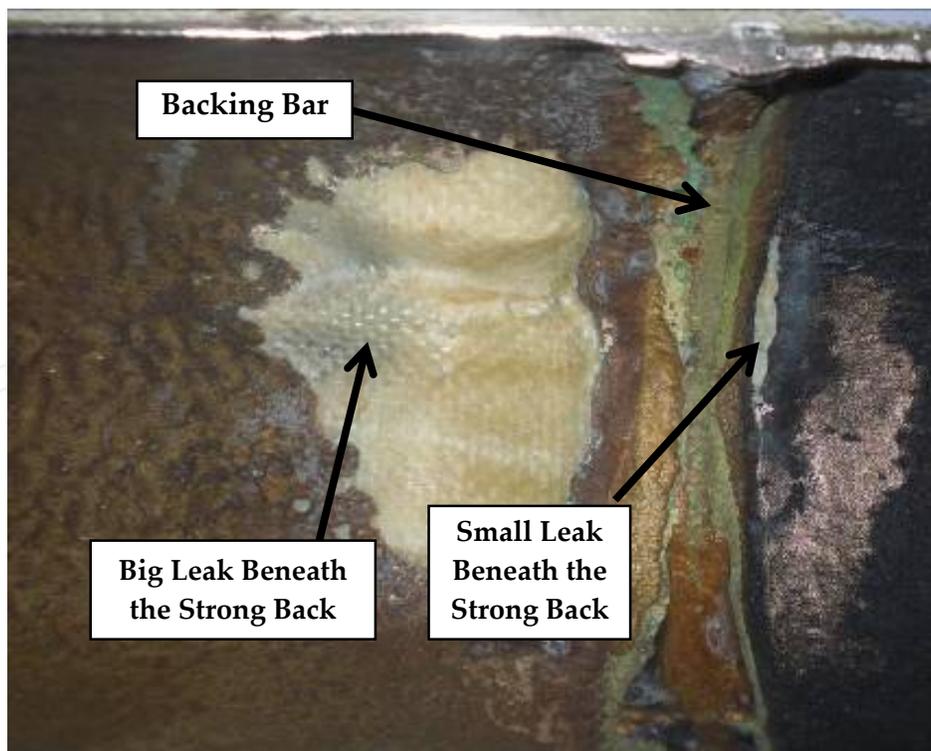
Figure 2. Big and small leak near the backing bar at about 6 o'clock position viewed from the inner side of seawater inlet pipe.

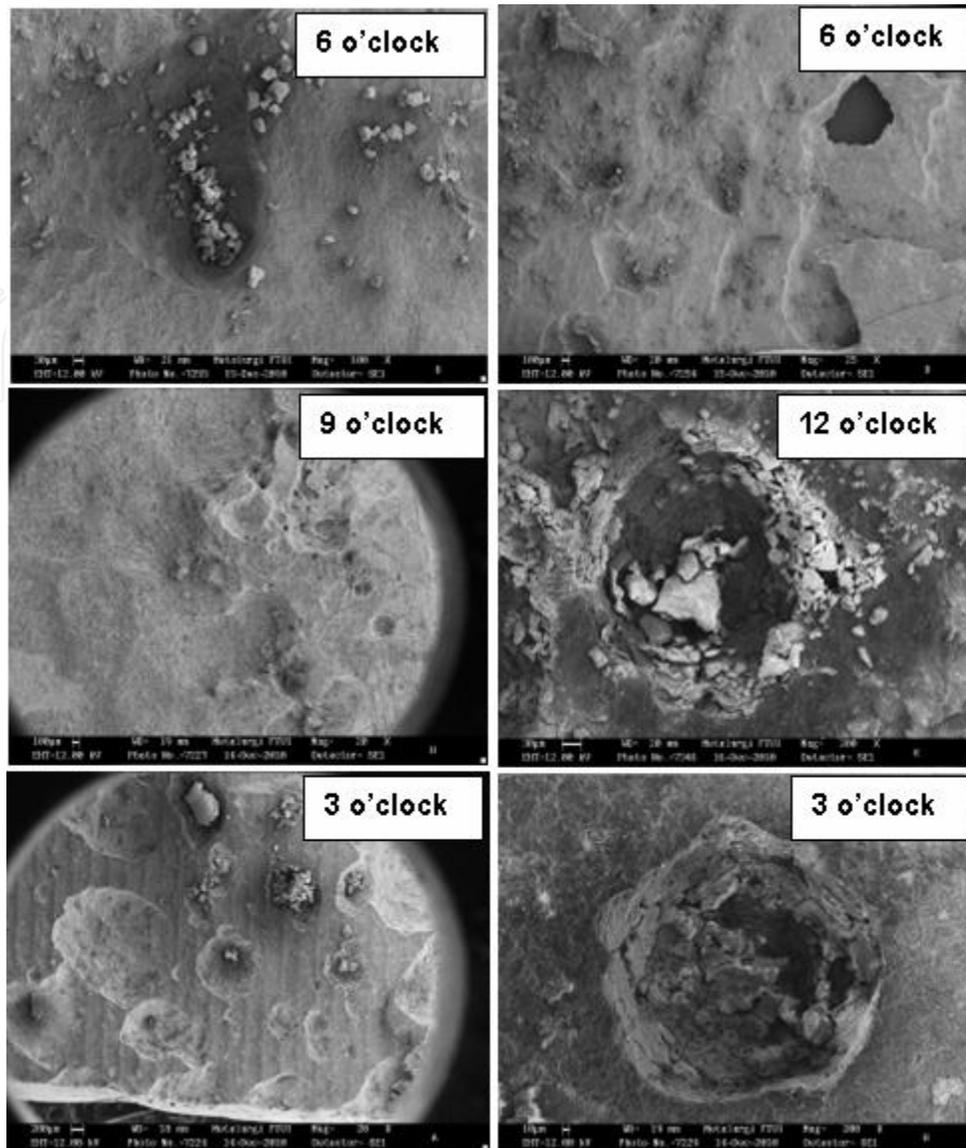
Figure 3. Surface morphologies of brown crater – like surface taken from 6 – 3 o'clock position.

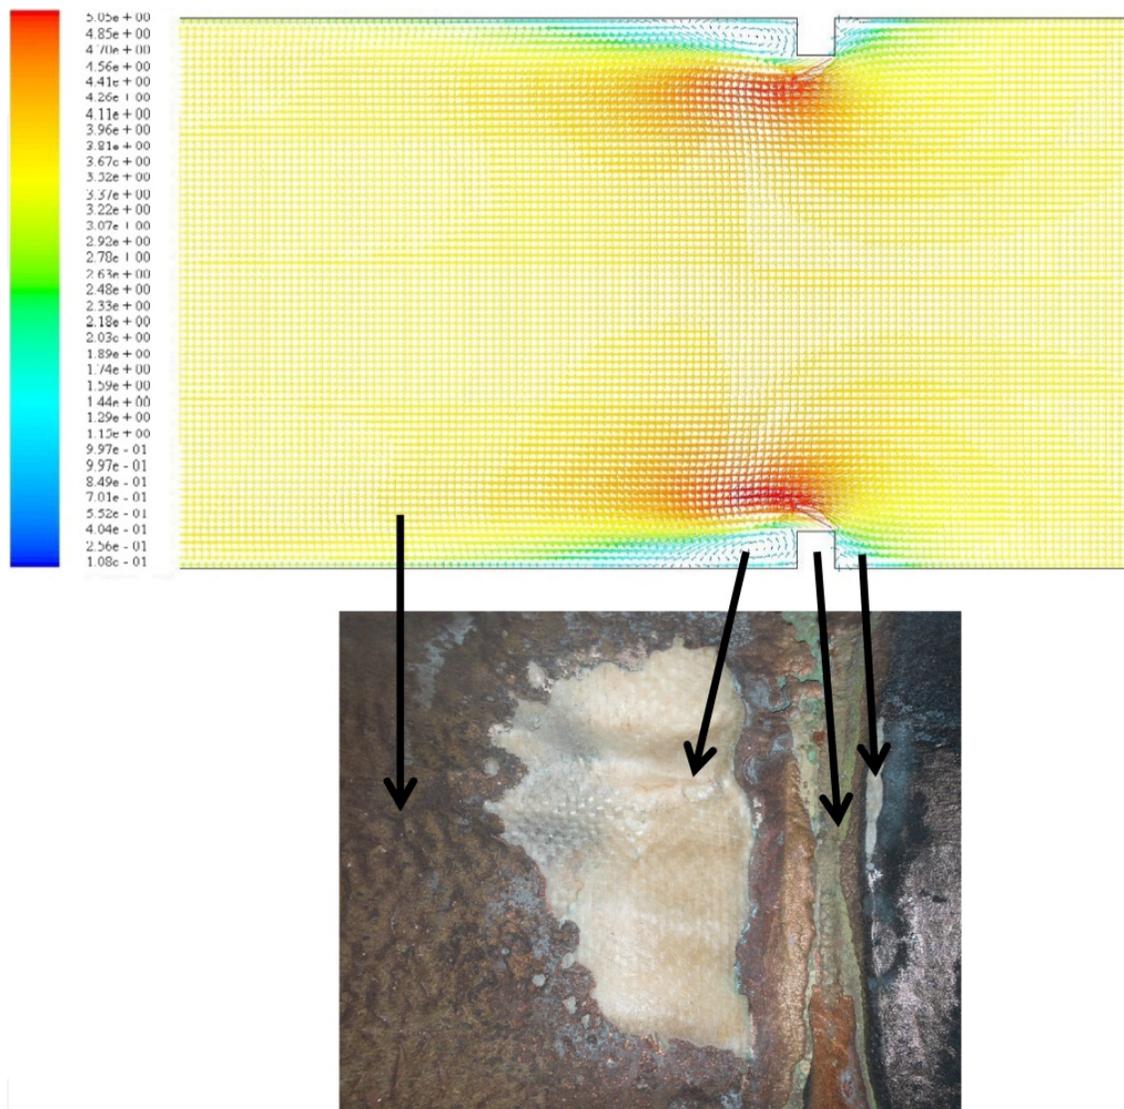
Figure 4. Finite element analysis of the inner pipe showing the orifice effect and the eddy zone near the backing bar correlated with the actual leaks on the inlet pipe.

element analysis was executed based on the pipe dimension and actual fluid conditions such as velocity, pressure, temperature, and implicit parameters. Because there were no data for the initial height of the unwanted backing bar, the authors assumed that the initial height was the highest backing bar found on the specimen. Interestingly, the failure location predicted by the finite element analysis matched up with the actual evidence (Fig. 4). It precisely showed that the failure could be located around the backing bar where the eddy zone was formed in this area. This suggests that sometimes the results obtained from laboratory tests cannot explain why a failure occurs, although evidence indicates the existence of a certain problem. In this case, a finite element analysis is the only tool that can help a failure analyst find the root cause of failure. As can be seen from Figure 4, the leaks and crater-like surfaces found in the area near the backing bar were attributed to the formation of eddy zones in this area. The length of the eddy zone predicted that the area that might suffer from a flow-induced attack.

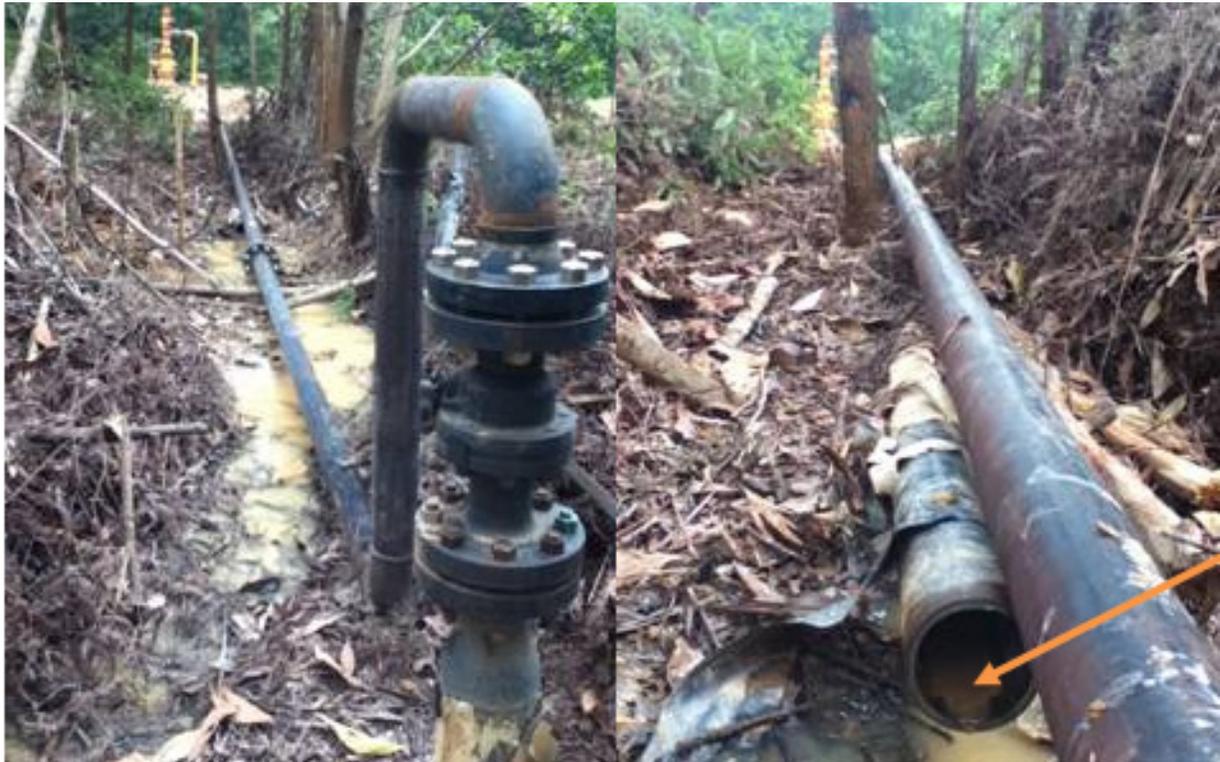
Figure 5. The specimen sent to the laboratory for analysis is indicated by arrow

The last case is a trunkline that burst during service [19]. This incident produced a significant impact on the gas production of the company and also on the environment. The failure was characterized by a mesa-like attack and wall thinning at the 5-7 o'clock position on the inner surface. The location of failure is shown in Figure 5. A reddish brown corrosion product was noticed on the surface, but there with no indication of the occurrence of an H₂S attack found in the material. This trunkline, carrying the gas with a total pressure of 905 psi, spanned across the jungle in the descending position. The analysis of the gas composition is listed in Table 1. The topography and characteristics of the soil in which the trunkline was located and also the material specification data is listed in Table 2.

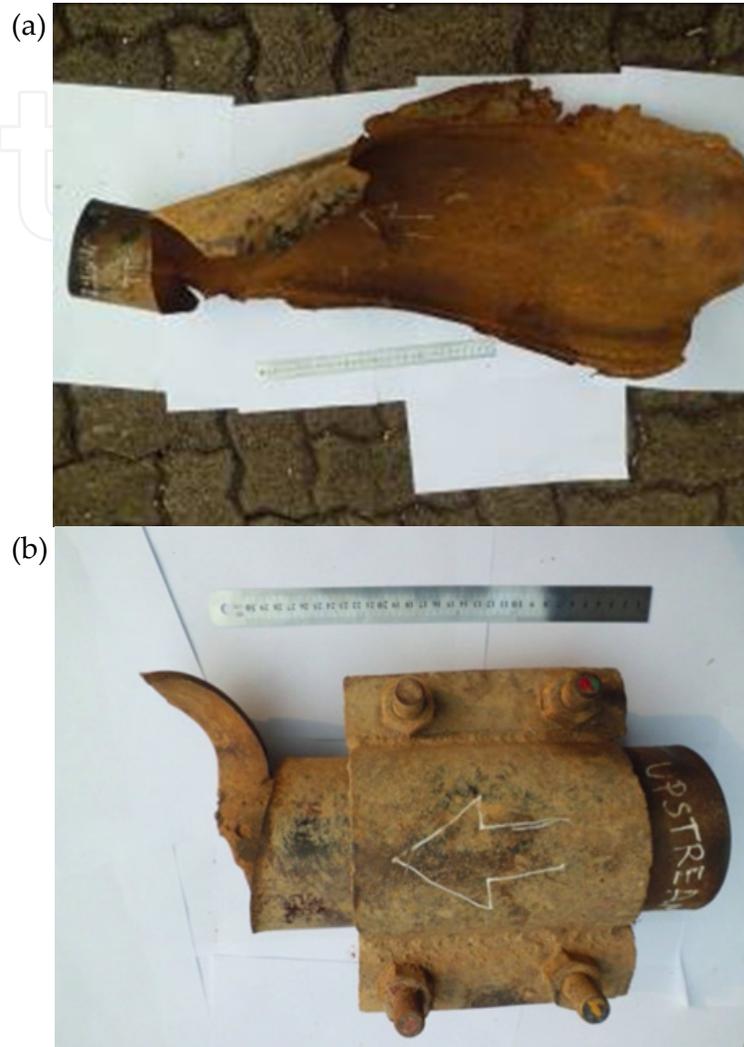
Figure 6. (a) Downstream part and (b) upstream part showing the burst located at 6 o'clock position.

A visual examination showed that the burst area was located at the 6 o'clock position of the (a) downstream part and the (b) upstream part (Fig. 6). Some points on the inner surface of the downstream part at the 5-7 o'clock position showed surface degradation with wall thinning and pits (Fig. 7). Some points on the inner surface of the upstream part at the 5-7 o'clock position also showed surface degradation with wall thinning and pits (Fig. 8). A uniform attack at the burst area from the 5-7 o'clock position is shown in Figure 9.

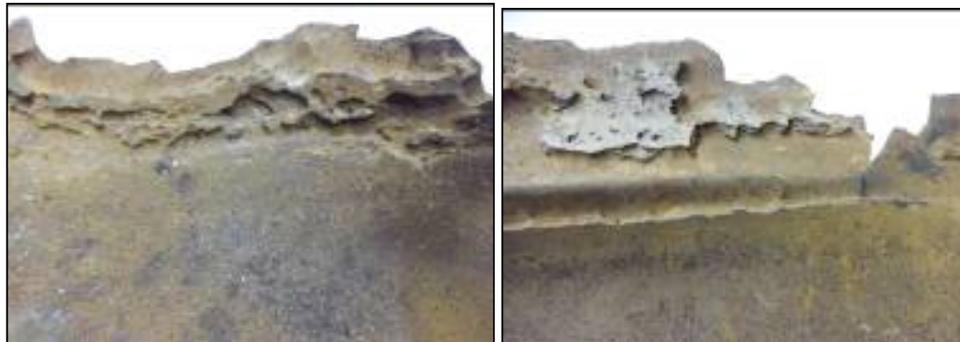
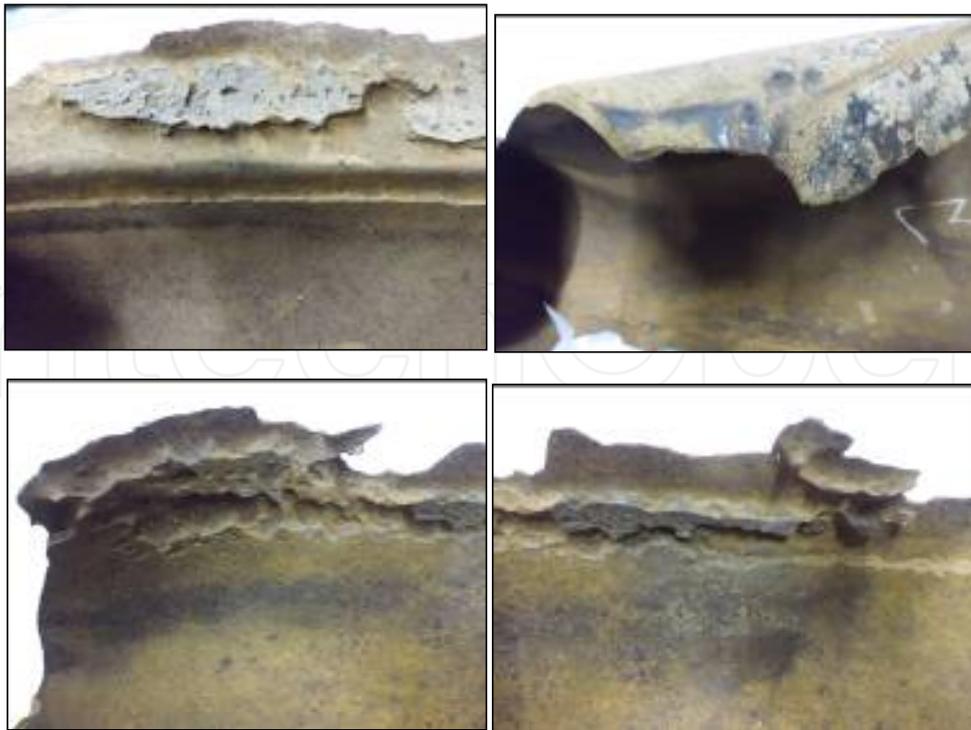
Figure 7. Wall thinning and pits at 5 – 7 o'clock position of downstream part.

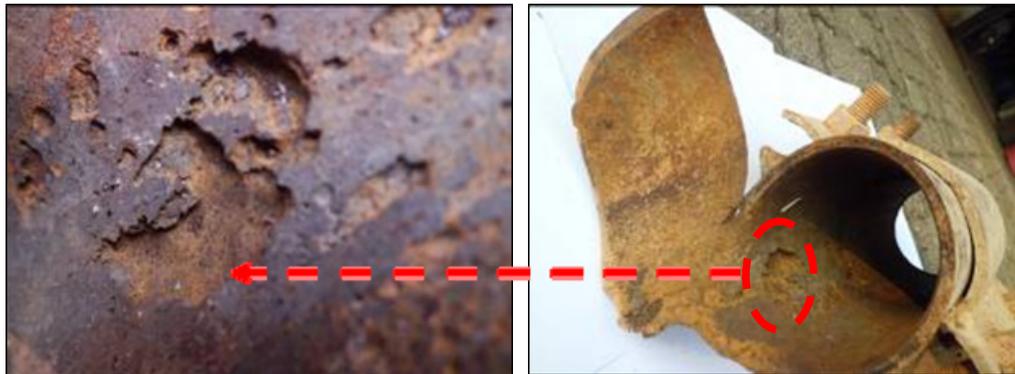
Figure 8. Wall thinning and pits at 5 – 7 o'clock position of upstream part.

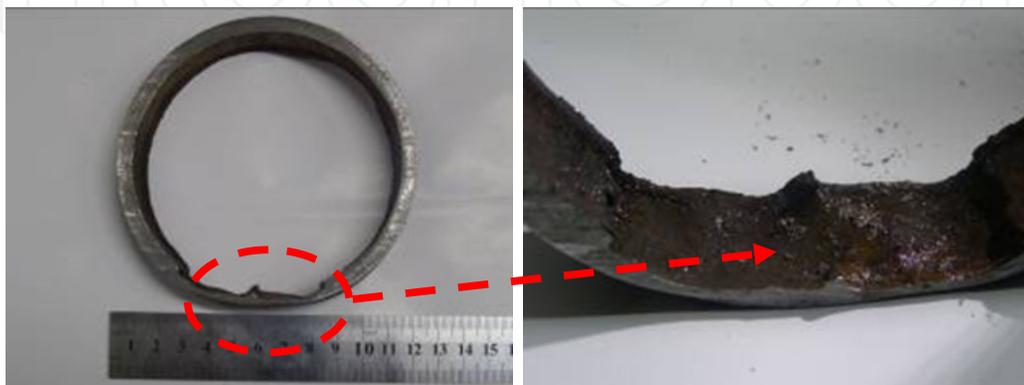
Figure 9. Uniform attack at the burst area from 5-7 o'clock position.

The metallographic preparation and macroetching were performed on the perimeter of the trunkline, and the results showed that the trunkline was made of seamless pipe (Figs. 10 and 11). The thinning area shown in Figure 9 was an ERW (electric resistance welding)-free area (Fig. 10). This information indicates that the failure could not be attributed to the ERW pipe issue.

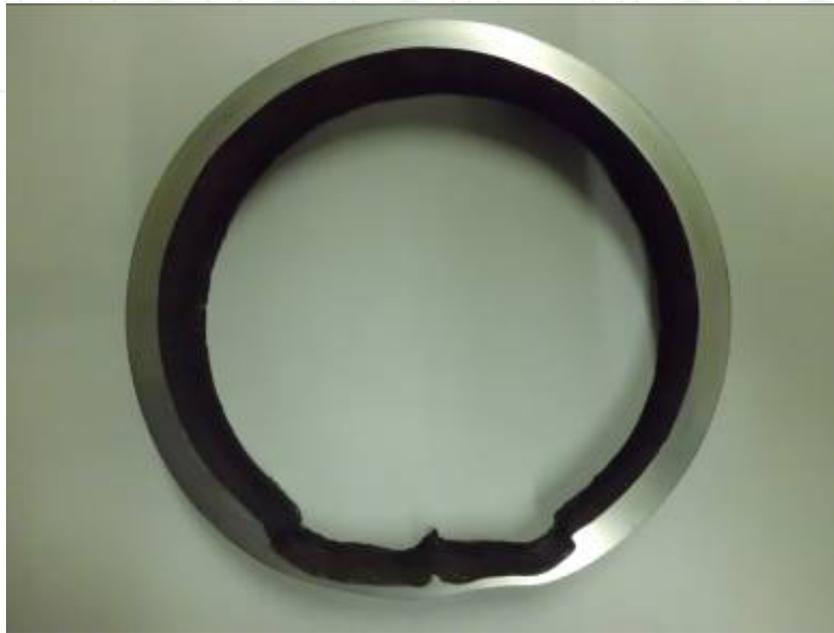
Figure 10. Results of macroetching showing the absence of ERW.

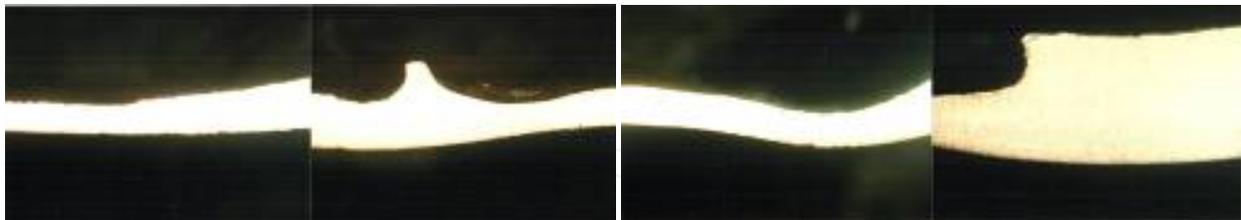
Figure 11. Macrograph of 5-7 o'clock position showing the absence of ERW.

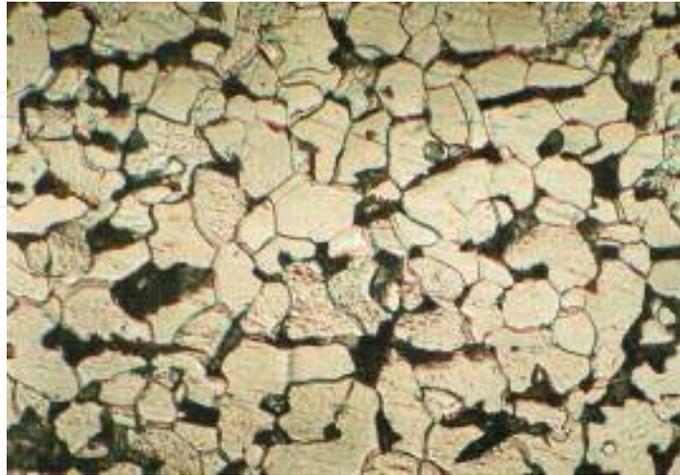
Figure 12. Microstructure of trunkline showing a typical seamless microstructure with equiaxed grains. The dark phase is pearlite and the light one is ferrite.

The microstructure of the trunkline was taken from the cross-section, and the results are displayed in Figure 12. As can be seen, the trunkline is composed of ferrite (light phase) and pearlite (dark phase) with equiaxed grains, which is typical of seamless pipe. The chemical composition of the trunkline was tested using an optical emission spectrometer and the results (Table 3) show that this trunkline is composed of an API 5L X60 steel [20]. Due to the insufficient geometry of the trunkline, the mechanical property of the trunkline was only examined by hardness testing. In order to verify that the specification of this material was API 5L, the resultant hardness values were converted to tensile strength (Table 4).

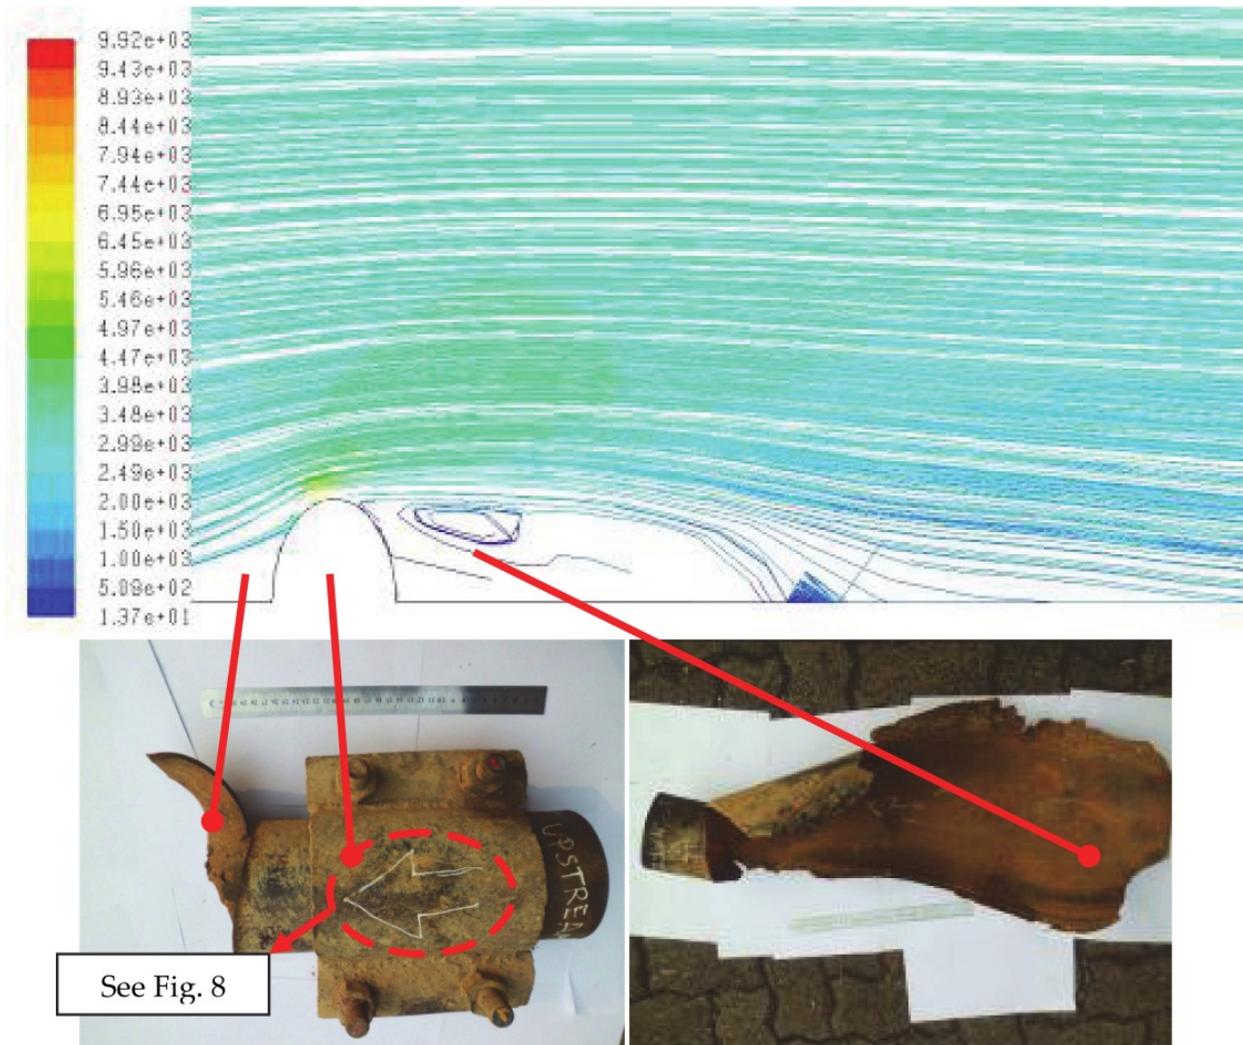
Figure 13. Finite element analysis showing the eddy zone due to overfill in comparison with the actual failed area of pipe.

The finite element analysis was executed around the overfill, and the results (Fig. 13) showed that the area at which the pipe burst had a dead or eddy zone due to the excessive overfill (Figs. 14 and 15). Because there was no information about the initial overfill height, we assumed an overfill height of 1 cm for the finite element simulation. This selection was based on the fact that there was one point at the remaining overfill that had a height of 1 cm. The other areas were mostly degraded, with heights of less than 0.5 cm. Severe corrosion was noticed on every peak of overfill.

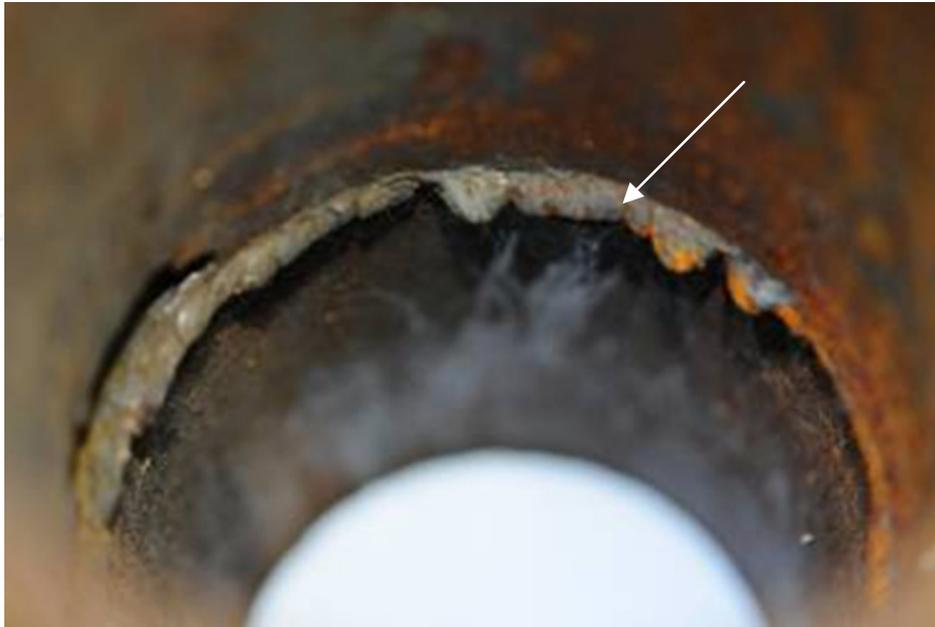
Figure 14. The inner side of circle area in Fig. 11 showing an excessive overfill (arrow) in the failed pipe at 12 o'clock position.
