Experimental Study of Flow-Induced Vibrations and Scattering of Roof Tiles by Wind Tunnel Testing

Satoru Okamoto
Shimane University
Japan

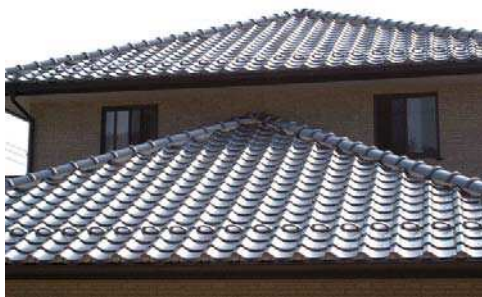
Fig. 1. Japanese residence and roof tiles

Flow-induced vibration of roof tiles usually appears just before they are scattered. The flow-induced vibration (aeroelastic instability) of structures is an important phenomenon for the following two reasons: (1) strong lateral self-excited oscillations can develop at a certain wind velocity (onset velocity) as a result of the lateral aerodynamic force component and (2) these vibrations have a tendency to affect the behavior of the structure prior to the onset velocity because they produce negative aerodynamic damping that can considerably reduce the total damping available to the structure (Naudascher et al., 1993). However, the flow-induced vibration of roof tiles prior to scattering has been given very little attention. This study investigates the nature and source of the vibrating and scattering behavior of the roof tiles in order to provide better insight into this mechanism. This paper presents the first results of studies on the wind-inducing mechanism in roof tiles, which are widely used for roofing Japanese wooden dwellings (Fig. 1).

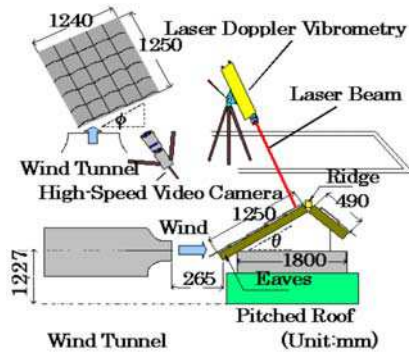
Fig. 3. Experimental apparatus

Fig. 3 illustrates the general layout of the apparatus used in this experiment. The experiments were conducted in an open-circuit wind tunnel that was driven by an axial flow fan. The nozzle of the wind tunnel had a 500 mm \times 1,300 mm cross section. The maximum velocity of flow from the nozzle was approximately 50.0 m/s. The representative wind velocity was measured by a hot-wire anemometer and a linearizer on the exit nozzle of the wind tunnel. Approximately 10.0% of the flow's streamwise turbulence intensity was

25 roof tiles were set up in 5 rows \times 5 columns on a pitched roof in the downstream flow of a wind tunnel (Fig. 3). The roof tiles were tested by the air flow, which barely covered the entire exposed area of the tiles. They were made of clay, and each weighed approximately 2.8 kg. The tiled pitched roof was fitted similar to a real roof arrangement with a plenum underneath the tiles, which acts as a roof cavity. This plenum was sealed with a clay pad. The internal pressure in this plenum was monitored and regulated by a pressure transducer placed underneath the tiles. The vibrations of the roof tiles were measured by a laser Doppler vibrometer (LDV, OMETRON VS1000) and an accelerometer (ONO SOKKI NP-3560, Fig. 4 (a)), and the normal natural frequencies of the roof tiles were analyzed using an impulse force hammer test. The vibration velocity could be measured up to 1,000 mm/s by a 1 mW LDV, and the range of the vibrational frequency was from 0 to 50 kHz. One roof tile was equipped with an accelerometer (Fig. 4 (b)). The accelerometer was used to measure the dynamic behavior of the tiles in three directions, X-, Y-, and Z under a no-flow condition,

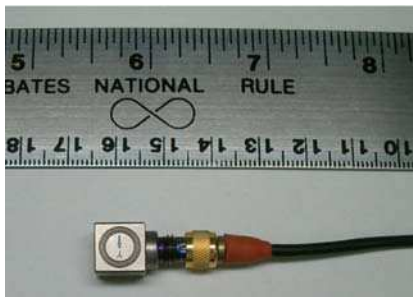
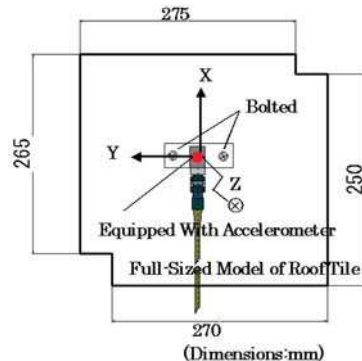
(a) Accelerometer

b) Roof tile equipped with accelerometer

Fig. 4. Accelerometer used in the experiments

and weighed approximately 5.0 g. The experimental measurement of the vibration frequencies for tiles was performed with the accelerometer. However, the vibration frequencies identified by the LDV were limited to small-amplitude modes. In this study, the accelerometer and LDV were used to determine the resonant frequencies of roof tiles that were and were not bolted to the roof bed.

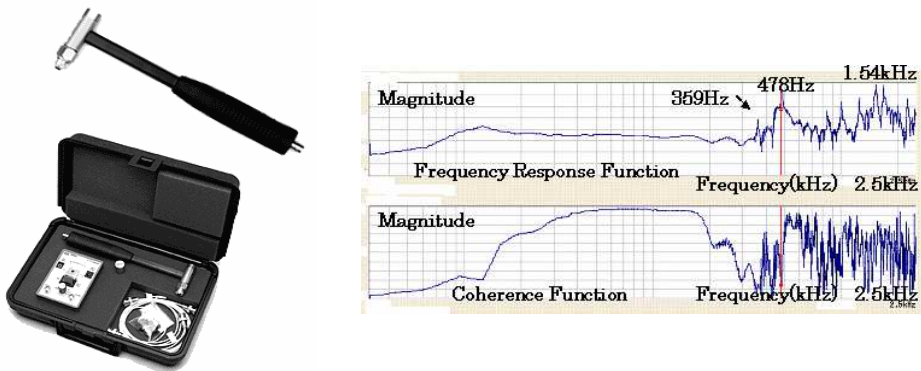
(a) Impulse force hammer b) Frequency response function and coherence function

Fig. 5. Frequency response function and coherence function of a roof tile generated by an impulse hammer test

An impact hammer with a force transducer was used to excite the tiles under no-flow conditions (Fig. 5 (a)). Two signal conditioners were used to provide power to the accelerometer and the force transducer, whose spectral analyses were performed using a fast Fourier transform (FFT) spectrum analyzer (ONO SOKKI DS-2100 4CH). The sampling frequency was 5,120 Hz over a frequency range of 0 - 2.5 kHz; 1,024 data points were sampled per spectrum. Unless otherwise stated, 64 spectra were averaged for each measurement. The frequency resolution of the spectra was 5 Hz. In order to analyze acceleration in a direction perpendicular to the surface of a roof tile, the time taken by the acceleration signal was recorded using the FFT analyzer. Two accelerometers were used simultaneously. Roof tiles that showed significant vibrations at any velocity, found from a series of experiments using accelerometers, were attached to two neighboring roof tiles on a model roof.

Fig. 5 (b) shows the frequency response function curve and coherence function curve of roof tiles measured using an impact hammer with a force transducer. One of the resonant frequencies obtained by the accelerometer was 478 Hz. As stated in the next section, the measured frequencies obtained using the wind tunnel test are nearly consistent with the resonant frequencies obtained by the excitation analysis of the impulse force hammer test.

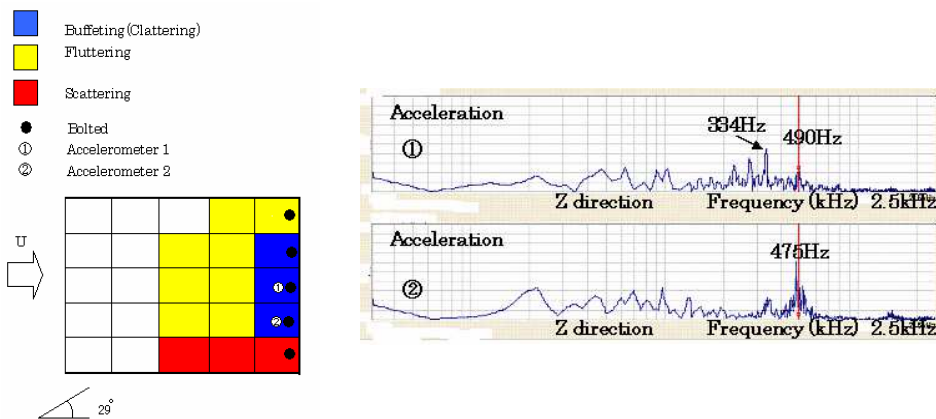
(a) Vibration of roof tiles (b) Vibrational acceleration power spectrum for roof tiles

Fig. 6. Effect of slope angle of roof on vibration of roof tiles at $\theta = 29$ degrees, $U = 39.0$ m/s

The slope angle of the roof was changed, and the effects of fluttering in the last stage of roof tile scattering were examined (Figs. 6-8). The small-amplitude vibration of the model roof tiles appeared in a low-velocity flow at the maximum pitch angle of 29 degrees, while the model roof tiles showed fluttering when the wind velocity reached approximately 38 m/s. They were more buffeted at the pitch angle of 24 degrees than at the pitch angle of 29 degrees, and then fluttered when the wind velocity reached approximately 40 m/s. The model roof tiles did not flutter at the minimum pitch angle of 19 degrees, and they were buffeted at a higher wind velocity than that at other pitch angles. They did not flutter at pitch angles of 24 and 29 degrees because of the weight of the neighboring roof tiles and bolts. The fluttering of the model roof tiles appeared with relatively large-amplitude vibrations, and it was regarded as fluttering when the roof tile was completely lifted from the roofing board and the board was exposed.

Figs. 6-8 show the results for several pitch angles. The largest number of roof tiles were buffeted and fluttered at the maximum pitch angle of 29 degrees (Fig. 6 (a)), resulting in three roof tiles being scattered. The roof tiles were not scattered at a pitch angle of 24 degrees (Fig. 7 (a)), whereas they were both buffeted and scattered at a pitch angle of 29 degrees. In this case, the roof tiles attached with the accelerometers and the eight neighboring roof tiles fluttered. At the minimum pitch angle of 19 degrees (Fig. 8 (a)), the roof tiles did not flutter even at the maximum velocity of 40 m/s, but a few roof tiles were buffeted.

Similarly, the signals from the accelerometers revealed fluttering at pitch angles of 24 and 29 degrees. The results obtained by the FFT analysis of the accelerometer signals at pitch angles of 24 and 29 degrees are shown in Figs. 7 (b) and 6 (b), respectively. The small-amplitude vibrations were recognized using accelerometers 1 and 2 at a low velocity at these pitch angles. However, a 50 m/s² vibration was recognized momentarily when the wind velocity was increased. The small-amplitude vibrations appeared at a low velocity, but gradually increased at a higher velocity (Peterka et al., 1997; Cermak, 1998). Moreover, acceleration and amplitude of the vibrations are related to the critical velocity at which fluttering occurs for a constant pitch angle of the roof. At a pitch angle of 24 degrees, the values of acceleration and amplitude increased when the wind velocity reached 40 m/s (Fig. 7 (b)). The acceleration and amplitude observed at a relatively high velocity for a pitch angle of 24 degrees also appeared at a low velocity for a pitch angle of 29 degrees (Fig. 6 (b)).

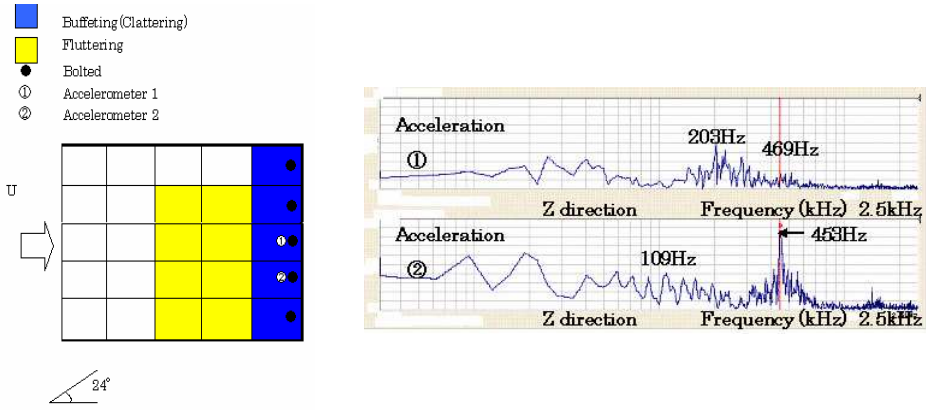
(a) Vibration of roof tiles b) Vibrational acceleration power spectrum for roof tiles

Fig. 7. Effect of slope angle of roof on vibration of roof tiles at $\theta = 24$ degrees, $U = 38.5$ m/s

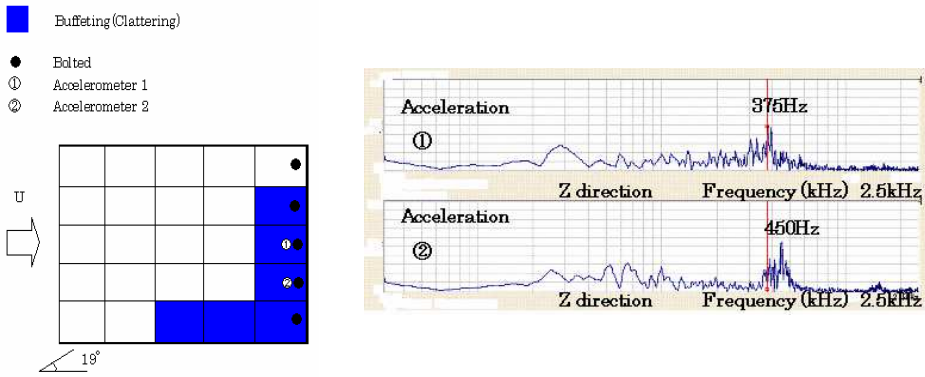
(a) Vibration of roof tiles b) Vibrational acceleration power spectrum for roof tiles

Fig. 8. Effect of slope angle of roof on vibration of roof tiles at $\theta = 19$ degrees, $U = 39.9$ m/s

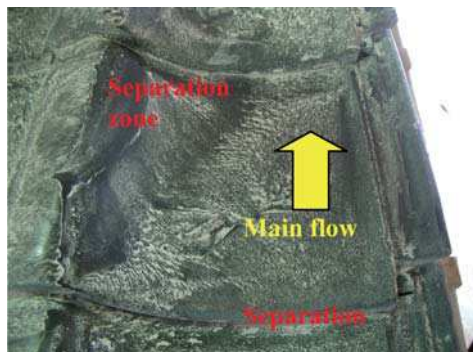
Fig. 9. Observation of the flow on the surface of the roof tile by the oil film method

If a roof tile is inclined with respect to the free stream, the flow will separate from one side as soon as the angle of incidence exceeds a critical value. Visualization using the surface oil flow method shows that the vortex cones caused by the yawing flow separation at the leading edges result in the highest negative pressure coefficients close to the windward gable and the windward eaves. If the roof pitch is increased, the vortex cones decrease in strength. In regions of separated flow, the external pressure distribution on a tiled surface

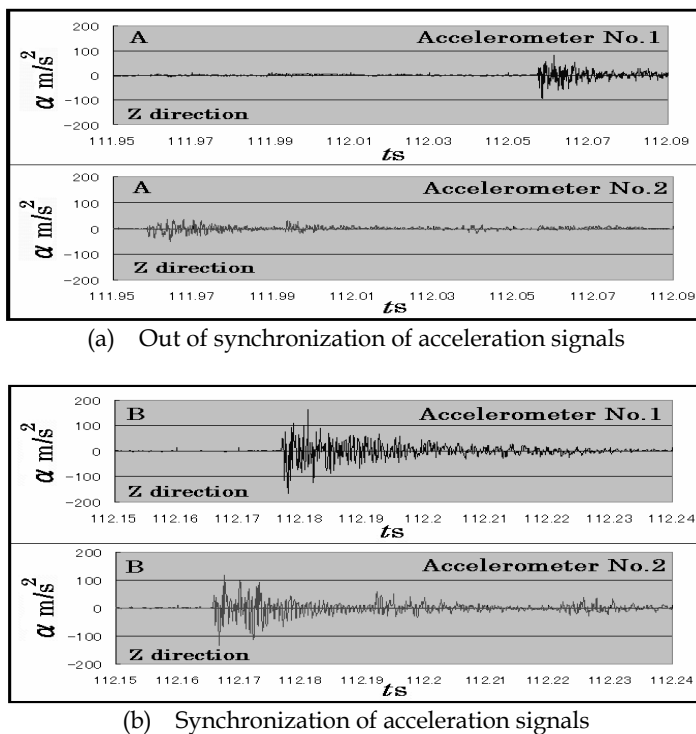
Fig. 10. Acceleration signals from accelerometers 1 and 2 at $\theta = 24$ degrees, $U = 40.0$ m/s

In a series of wind tunnel tests, the pitch angles of the roof were changed and two accelerometers were attached to neighboring roof tiles in order to detect and analyze acceleration signals. Fig. 10 shows an example of the acceleration signals that were frequently found whenever small-amplitude vibrations occurred. It shows the acceleration

signals and the behavior of the 25 model roof tiles at a pitch angle of 24 degrees and wind flow of 40 m/s. In this experiment, it was also recognized that the tiles locally arranged at the back and right side of the roof were often buffeted and scattered by strong winds. In a typical construction method, tiles are piled up and laid on the upper and lower side of a roof by their own weight. Therefore, the roof tiles locally arranged at the back and right side of the roof are held by the relatively lighter weight of the neighboring roof tiles. The wave-forms shown for case A in Fig. 10 (a) indicate that the signals are out of synchronization by a half cycle from both accelerometers. The wave-forms shown for case B in Fig. 10 (b) indicate the nearly synchronized signals from both accelerometers. Fig.10 shows the time history of the acceleration signals caused by the wind effect. These results show that it was found that the accelerations and time histories of the two roof tiles differ from each other. The forces affected both roof tiles simultaneously. On the other hand, even when a force did not act directly on a roof tile, it affected the other roof tile. In this case, the roof tile equipped with accelerometer ① was held by the roof tile equipped with accelerometer ② and the force of the roof tile equipped with accelerometer ② was added, although the force of the roof tile equipped with accelerometer ① did not act directly on it. The force of the tile equipped with accelerometer ① was added to the roof tile equipped with accelerometer ② although the force of the roof tile equipped with accelerometer ② did not act directly on it (case A). It was observed during a series of experiments that the roof tiles were buffeted almost simultaneously when vibration occurred (case B).

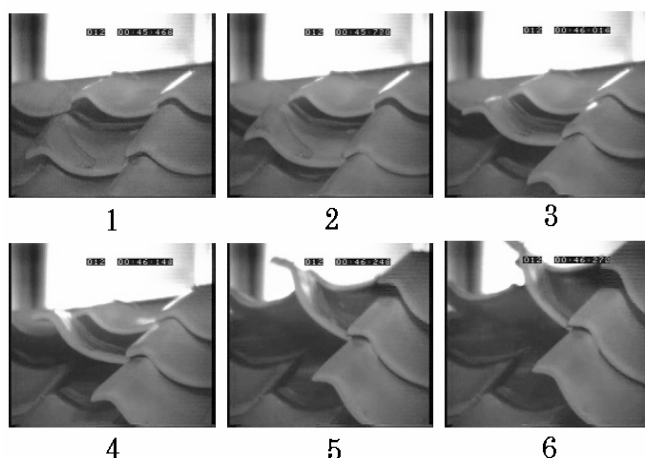
Fig. 11. Lifting up of roof tiles due to wind action as recorded by a high-speed video camera at $U = 40.0$ m/s

Hazelwood (1980b) described the lifting mechanism of a tile by a moment turning the tile upward around the pivoting point on the batten. The moment consists of a lifting force and two force couples caused by the external and internal pressure distributions, respectively. Fig. 11, which shows snapshots of a high-speed video camera picture, demonstrates this lifting mechanism for wind direction perpendicular to the eave. For a local flow direction perpendicular to the ridge, the internal pressure in the space between the tiles and underlay may become positive because of stagnation. As a result, the net wind load increases because of the sealing effect of the underlay. However, pressure equilibration in the gable roof is prevented, leading to a much lower net wind load for the leeward roof tiles. Aerodynamically favorable tiles should have a shape that prevents stagnation at the overlaps. The permeability at the overlapping gaps parallel to the ridge should be small and the permeability at the interlocking gaps perpendicular to the ridge, where suction occurs due to the element flow field, should be high (Hazelwood, 1980a).

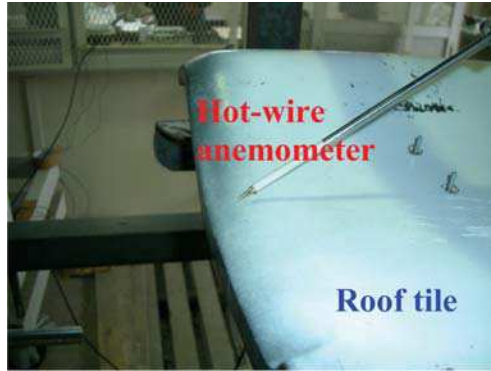
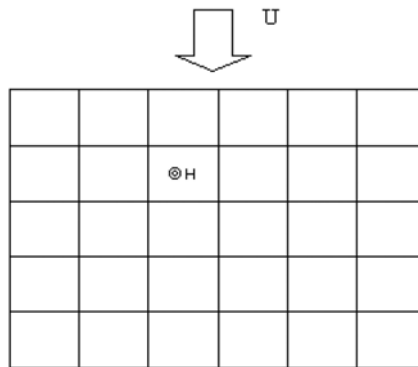
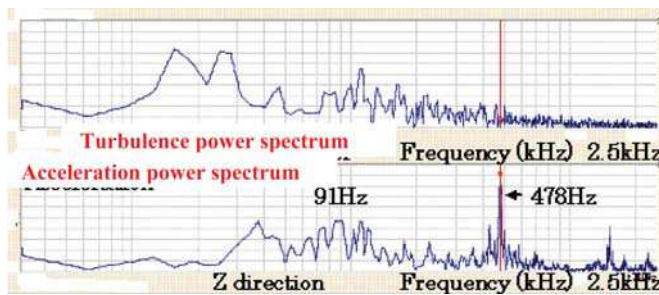
(a) Hot-wire anemometer and roof tile

⊙ Accelerometer
H Hot wire anemometer

(b) Positions of accelerometer and hot-wire anemometer

(c) Vibrational acceleration and turbulence power spectrum.

Fig. 12. Vibrational acceleration and turbulence power spectrum of roof tiles for $\theta = 0$ degrees, $\phi = 90$ degrees, and $U = 40.0$ m/s

Fig. 12 shows an example of the typical turbulence spectrum obtained by the hot-wire anemometer for $\theta = 0$ degrees, $\phi = 90$ degrees, and $U = 40$ m/s. With a turbulence level of surface flow close to the roof tiles, the tiles exhibited only the typical turbulence-buffeting response within the intermediate ranges of the angle of incidence. The Reynolds number during the experiment was so high that the edge separation was turbulent. The sources of vibration are the front and side edge vortices (Fig. 13). The vibration amplitudes increased progressively with increasing velocity, which indicates a typical buffeting response.

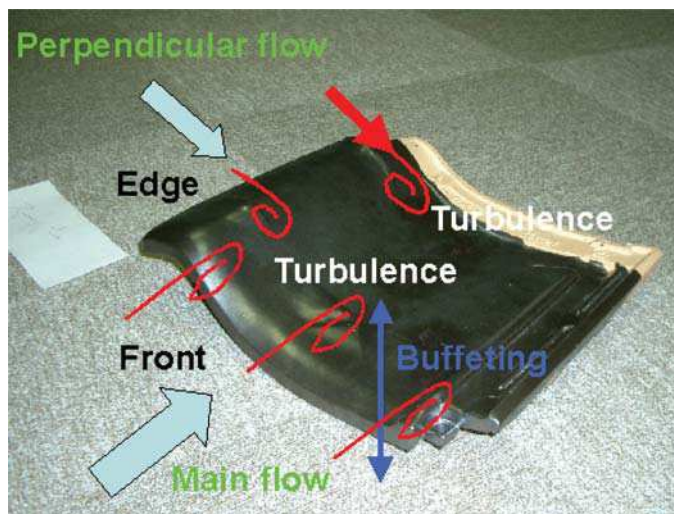
Fig. 13. Transverse vibration of roof tile

The small-amplitude vibrations of the roof tiles appeared first, the amplitude grew gradually larger as the wind velocity increased, and then fluttering with large-amplitude vibrations occurred, finally followed by scattering. The vibrational frequency was identified by image analysis of the high-speed video camera to measure relatively high-amplitude vibration in fluttering, which is considered to be the direct cause of tile scattering. The roof tiles do not always oscillate with a fixed vibrational frequency. Because vibrations with several frequencies affected the tiles and showed complex behaviors, some oscillation patterns were chosen at random from the data to be analyzed further. It was found that the amplitudes of tile vibration were larger than that of their natural frequency, and the vibration frequencies were low (in the range of 10 - 20 Hz).

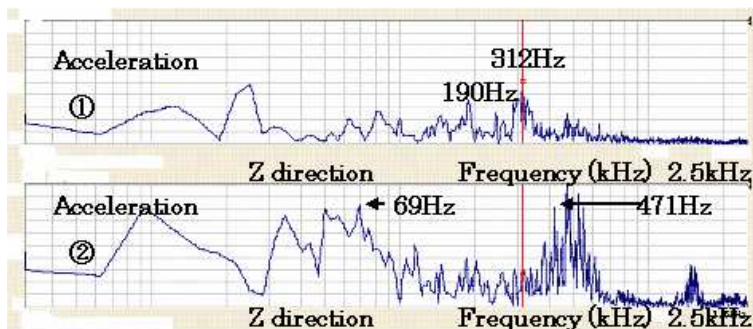
Fig. 14. Vibrational acceleration power spectrum of roof tiles at $\theta = 24$ degrees, $U = 40.0$ m/s

The results obtained by the FFT analysis of the acceleration signals in the experiment in which fluttering occurred are shown in Fig. 14. The results show the oscillation of fluttering at a pitch angle of 24 degrees and a wind velocity of 40 m/s. The wind velocity was gradually increased from the start of the wind tunnel test to its maximum velocity, and the acceleration measurement and the video camera recording were then started simultaneously. The sampling time of the FFT analyzer was set at 2,048 points, the frequency resolution was set at 800 lines, and the frequency range was 0 - 5 kHz. Moreover, the peak frequency of approximately 470 Hz, which appeared just before tile scattering, was the natural frequency and was also recognized by FFT analysis. To minimize the effects of sampling time on the results of the FFT frequency analysis, the FFT frequency was analyzed using a sufficient sampling time. As a result the relatively high frequency, i.e., the natural frequency, as well as the relatively low frequencies were recognized.
