Common Pacemaker Problems: Lead and Pocket Complications

Enes Elvin Gul and Mehmet Kayrak
*Selcuk University,
Meram School of Medicine,
Cardiology Department Konya,
Turkey*

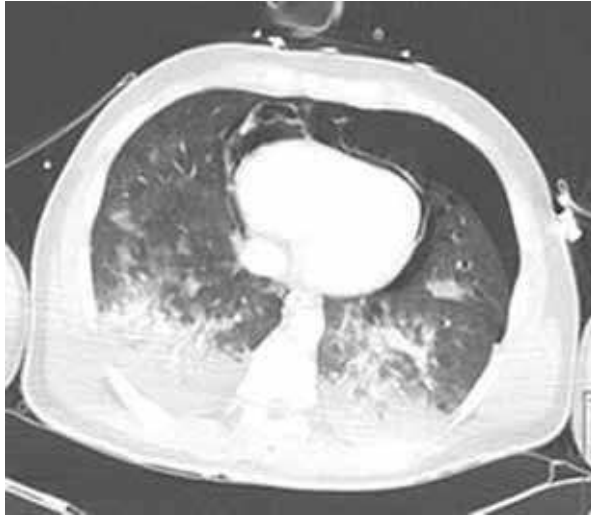
Fig. 3. CT scan of the chest showing massive hemothorax, pneumothorax, and pneumopericardium.

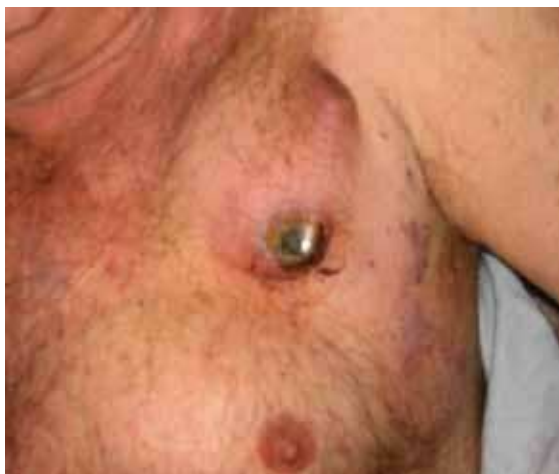
Fig. 9. Erosion of the automated implantable cardioverter-defibrillator (AICD).

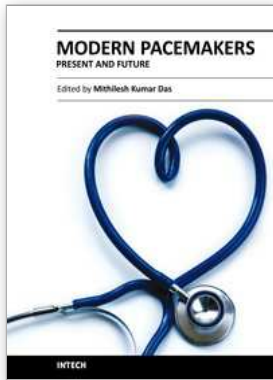
Modern Pacemakers - Present and Future
