Post-Tsunami Lifeline Restoration and Reconstruction

Yasuko Kuwata
*Kobe University,
Japan*

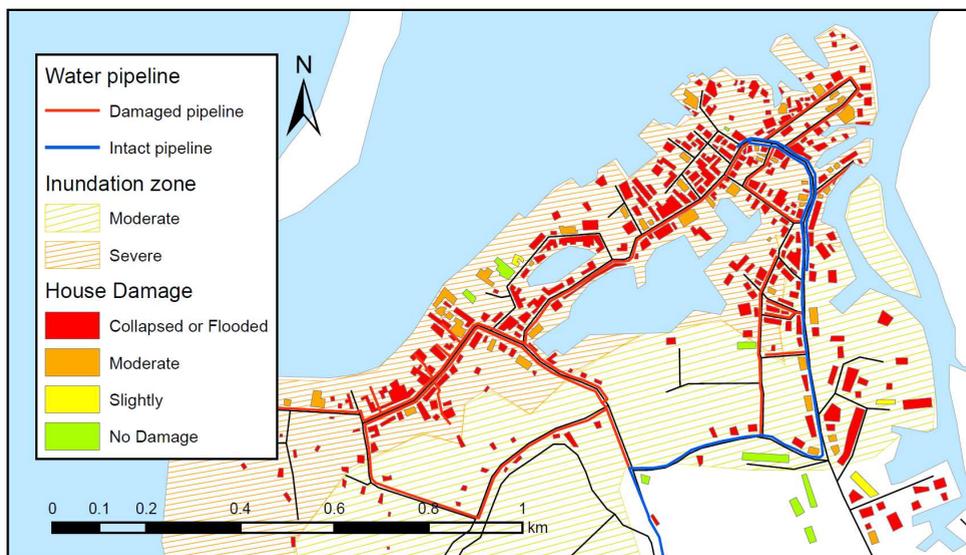
Fig. 1. Pipeline and house damage in Nam Kem village due to the 2004 tsunami. Inundation zones and house damage were taken from damage assessment reports of the local government. Water pipeline information is based on a PWWA report (PWWA, 2007)

Many parts of the water pipelines were destroyed in the western part of Nam Kem village, as shown in Fig. 1, which illustrates the damaged and intact pipelines in the inundation zones. Whereas the water-supply pipelines located 200 m from the coastline were completely destroyed by the tsunami, no pipeline damage is seen in regions 500 m from the coast. The level of damage to houses is also confined to the inundation zone. The people of Nam Kem village were the most severely affected, with 199 killed and 255 missing, after the report of Bang Muang TAO (small district of Phang Nga province).

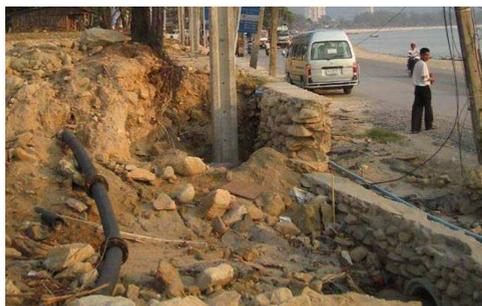
Photo 1. Exposed pipeline after scouring of embankment soil (Phuket, Thailand)

Pipeline damage was caused by collisions of driftwood and pebbles that were carried by the tsunami wave, as well as ground scouring caused by the tsunami. Coastal embankments and river bridge abutments were scoured, leaving the underground pipeline and surrounding facilities exposed (see Photo 1). There was extensive damage to the water meter because it was positioned above the ground and connected to fragile pipes (see Photo 2).

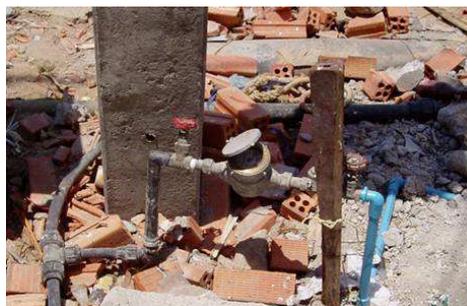
Photo 2. Water meter above ground. Black-colored polyethylene pipe is the service pipe of PWWA, and the blue-colored vinyl pipe is the residential pipe (Khao Lak, Thailand)

The residential pipe on the customer side of the meter was generally a fragile vinyl pipe (VP), whereas the service pipe on the PWWA side of the meter was a flexible polyethylene pipe (PE). Although the vulnerable water meter sustained severe damage, the repaired meter and piping maintained the previous standards. In addition to the physical damage to the facilities, it is believed that the water-supply facilities were broken by scrapers during the recovery work after the tsunami since the location of the pipeline beneath the ruins could not be identified. Fortunately, the water purification plant was located in the mountains as far as 18 km from the coast, and it was undamaged.

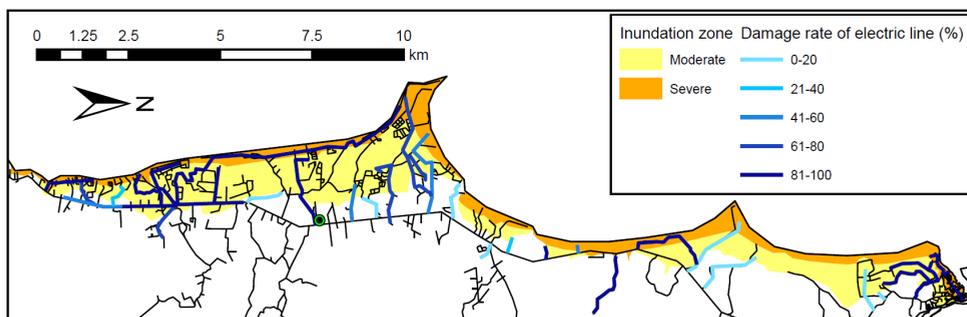
Fig. 2. Inundation zone and electric power line damage in Khao Lak, Thailand. Damage rate is after Provincial Electricity Authority of Phang Nga.

The electric power supply for the 40,000 customers of Phang Nga province is managed by Provincial Electricity Authority [PEA] of Phang Nga. Out of the eight administrative districts, Khura Buri, Ta Kua Pa, and Thai Mueang sustained severe damage to their electric power facilities. The main facilities, including the aerial electric power line, service transformer, and electric power meter, were damaged. For instance, damaged lengths reached 36 km for the high voltage line and 28 km for the low voltage line. As shown in Fig. 2, the high-voltage line ran along the main roadway, the Petch Kasem road, parallel to the coastline. The interruption in the inland low-voltage line was caused by the tsunami striking the high-voltage trunk lines along the coast. The damage rate (damaged aerial electric line length per total line length) was 80 to 100% in the inundation zone, where the inundation height was estimated to be 6 to 7 m.

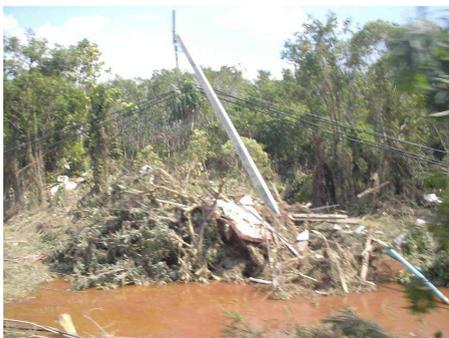
Photo 3. Electric pole tilted by collision with tsunami driftwood (Khao Lak, Thailand)

The electric power service interruption was caused by the collapse of electric poles because of the tsunami (Thailand witnessed a weak earthquake, so most of the damage was caused by the tsunami). Some poles had cracks at the bottom and others had cracks at the center. The locations of the cracks varied because of the random nature of the colliding driftwood (see Photo 3). The other cause of damage was the scouring of the pole foundations (see Photo 4), which caused the poles to tilt or fall, resulting in the snapping of the power lines.

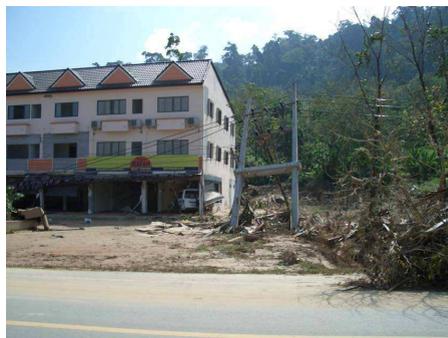
Photo 4. Electric pole tilted as a result of the scouring of the ground by the tsunami (Khao Lak, Thailand)

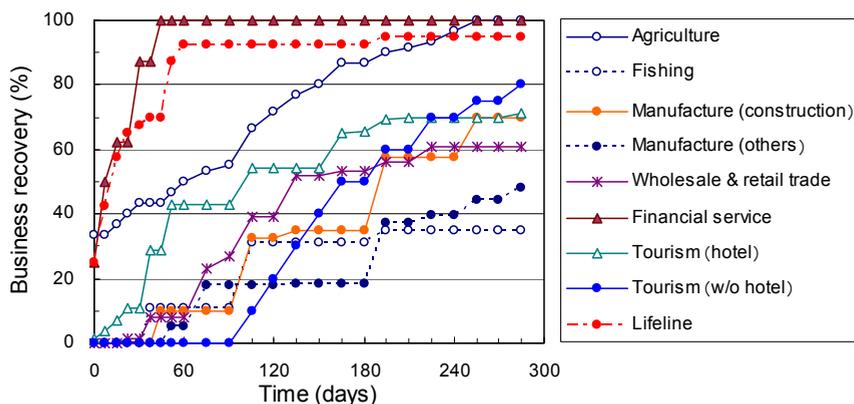
Fig. 3. Business recovery process of industry from tsunami in Sri Lanka

Fig. 3 shows the business recovery process of the local industries, which is the average of responses in each industry, as shown weekly for the first three months and every couple of weeks after that. Here the rate of business recovery is defined as the sales of their products compared to that before the tsunami based on the interview of owners. As is readily seen, lifeline and financial (banking) businesses were recovered remarkably quickly. The reason for the rapid recoveries that office buildings did not have extensive damage and their officers could respond to those damages promptly. They could also receive emergency relief and repair workers from the unaffected offices thanks to mutual cooperation. The reason the banks recovered rapidly is that their main offices are in Colombo, and they served as a back-up system for customer information. Communications and relationships in non-crisis times are thus important and effective in cases of emergency.

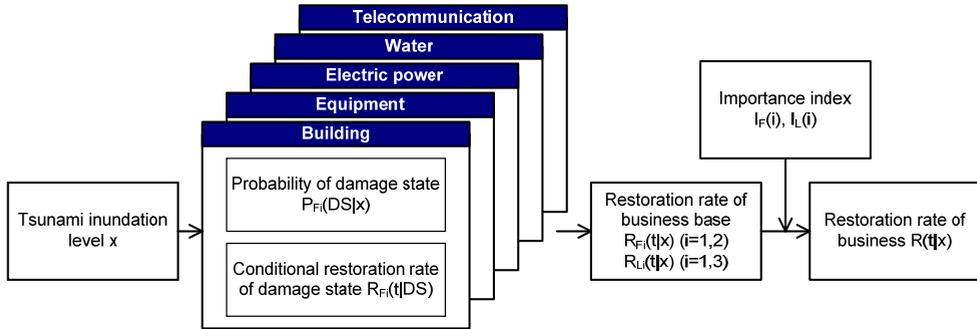
Fig. 4. Business restoration evaluation model after tsunami disaster considering facility and lifeline services

An evaluation method for tsunami damage and the restoration curve of the business base is proposed herein. The business base used in this study involves building, equipment, and lifeline service. Fig. 4 shows the schematic evaluation model, including damage estimation of the business base caused by the tsunami, rate-to-time model for restoration of the business bases, and the business recovery rate resulting from facility restoration and its influence on the business.

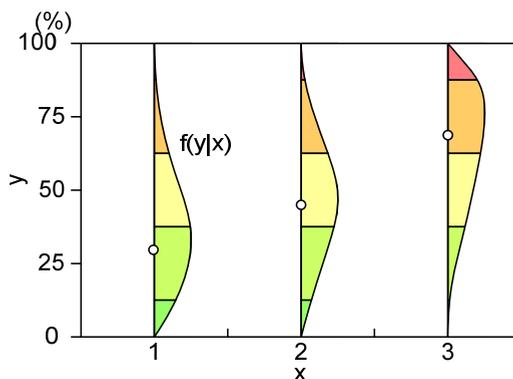
Fig. 5. Schematic model of tsunami intensity level x and damage rate, y

The DS of a facility is classified into five discrete categories. Each of these categories corresponds to a damage rate of the facility, y , which is treated as a random variable with a corresponding probability distribution, $f(y|x)$, at every tsunami intensity level, x , as shown in Fig. 5. Each DS has a representative value of damage rate as listed in Table 1, and the probability of the damage state is expressed by section integral calculus of the distribution's lowest damage rate y_1 to the highest damage rate y_2 when given the damage rate distribution $f(y|x)$ as follows.

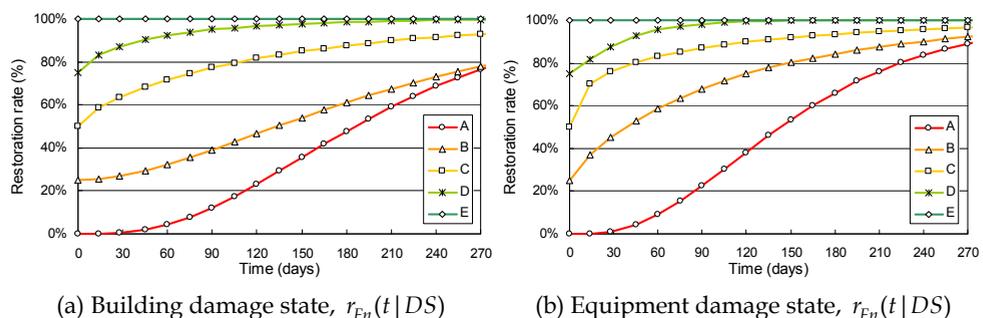
Fig. 6. Restoration rate of damage state

Furthermore, the conditional restoration rate of each damage state is shown in Figs. 6 and 7. If the building is in damage state “A” or “B”, it has a dramatically slow restoration; in contrast, the restoration curve is convex if it is in another damage state. In other words, if the industrial building and equipments were completely destroyed or washed away by the tsunami wave, more time was needed for restoration because of the cost of new construction. Moreover, with regard to the equipment, the damage state A shows a concave restoration process, but other damage states show fast restoration.

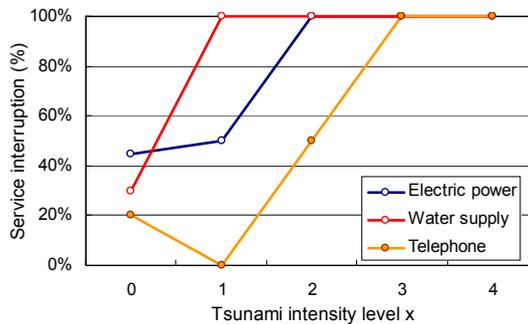
Fig. 7. Lifeline service interruption by tsunami intensity level

Here, we estimate the restoration process of lifeline systems such as electricity, water supply, and telecommunication. In this regard, the actual probability of the lifeline damage state and the restoration days indicated by the responders are employed because there is not enough information on the lifeline network system and the inundation area to be analyzed. Furthermore, the number of restoration days for the users is much higher than that of the main network reported by lifeline companies. Fig. 7 shows the supply interruption rate of the lifeline companies due to tsunami intensity level. It shows a 20 to 50% interruption of lifeline even though the area had not been hit by the tsunami wave. In addition, the electricity and water-supply services stopped completely when the inundation level was more than 2 m. Thus, it can be concluded that the above-ground lifeline facilities such as electric power and water meters are easily destroyed by tsunami waves. The interruption in telecommunication was less than that for other lifelines because of the functioning of mobile phones during and after the tsunami.

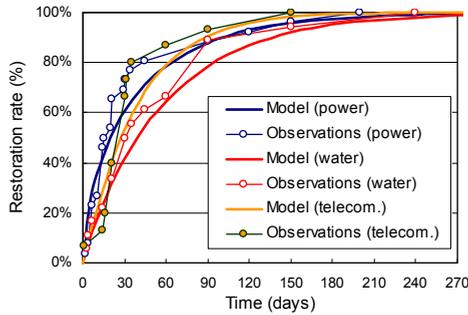
Fig. 8. Restoration curves of lifeline service

Similar to the facilities, the probability density distribution of the restoration rate was estimated using the gamma function by the method of moment as shown in Table 8. We had some responders whose lifeline services had not been recovered at that time. Because the outside buildings were still under construction, it was not possible to install inside facilities. In this study, we have removed those answers from the analyses. The mean number of days for water-supply restoration was 58 days, and that for electric power supply and telecommunication was 39 days. Fig. 8 shows the comparison of the values observed and the proposed model of lifeline services. The proposed model could express the characteristics of observation values appropriately.

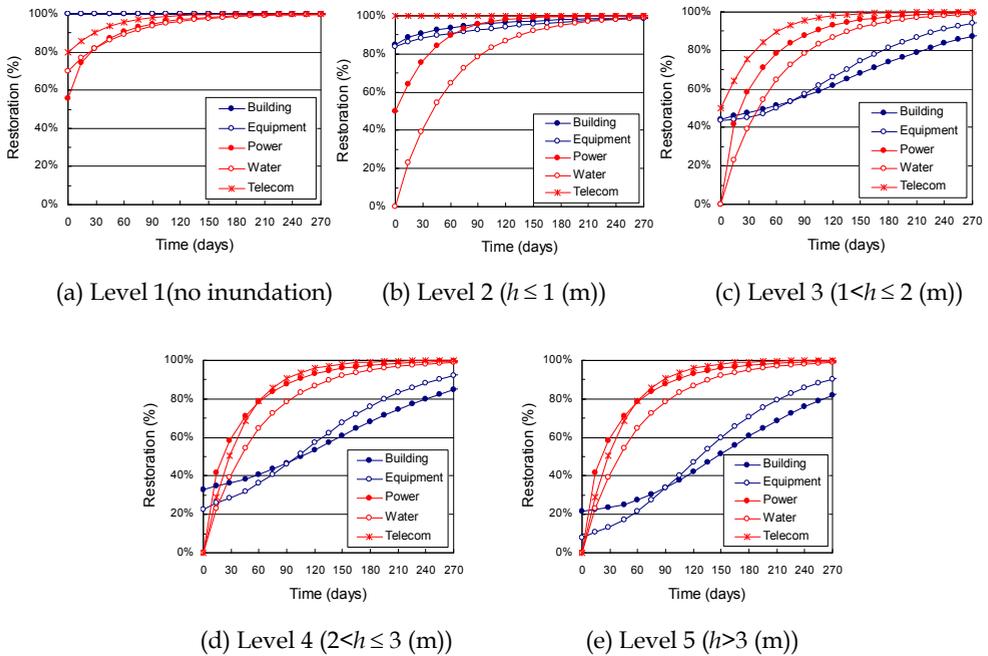
Fig. 9. Restoration curves of business bases by tsunami intensity level

The restoration curves of business facilities and lifelines under the same tsunami intensity level are compared, as shown in Fig. 9. As can be seen in this figure, business facilities such as building and equipment are restored sooner than the lifelines if the tsunami intensity level is either 1 or 2. However, business facilities are restored slower than lifelines if the tsunami intensity level is 3 or higher. When the tsunami inundation height is higher than 1 m, the business recovery depends more strongly on the business facilities rather than the lifeline.

It should be noted that lifelines are damaged even in places where the tsunami does not reach, as is shown in Fig. 9(a). This is because the lifeline is a system that works in a wide area. Moreover, since the lifeline is managed as a public service, its restoration is relatively rapid. The restoration of buildings and equipment, which are mostly private property, is very slow, especially in the first three months after a disaster, relative to the lifeline.

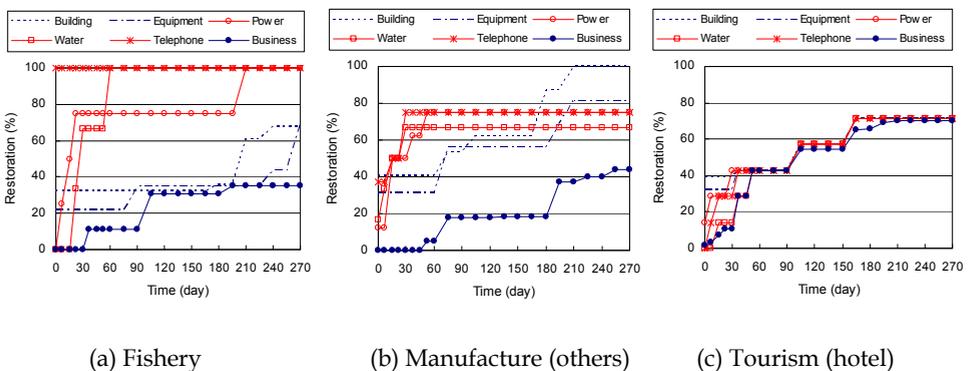
Fig. 10. Restoration processes of business bases and entire business

Fig. 10 shows the temporal change of business base restoration rate for the three selected types of industry (fishing, manufacturing, and tourism). The observed temporal changes of entire business recoveries for each industry are also shown (same as Fig. 3). The entire business recovery is the same as or smaller than the restoration of the business base. For the fishing industry, sales depend strongly on equipment (fishing boat) restoration. While the lifeline is recovered soon in the manufacturing industry, business restoration is connected to facility restoration. For tourism (hotels), both the restorations of the entire business and the business base are almost the same. It is indicated that in the first few months, lifeline services were restarted at a slightly damaged hotel, and an extensively damaged hotel was restored with lifeline repair a few months later. In other words, the hotel industry cannot run without a lifeline service. The results of a comparison of restoration processes show that the influences of the business base on the entire business functionality are different among the industries.

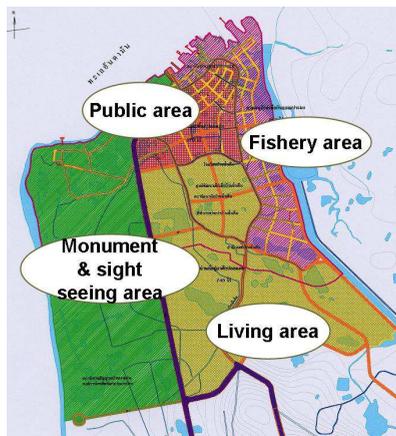
Fig. 11. Nam Kem village reconstruction planning (Source: DPT, Thailand)

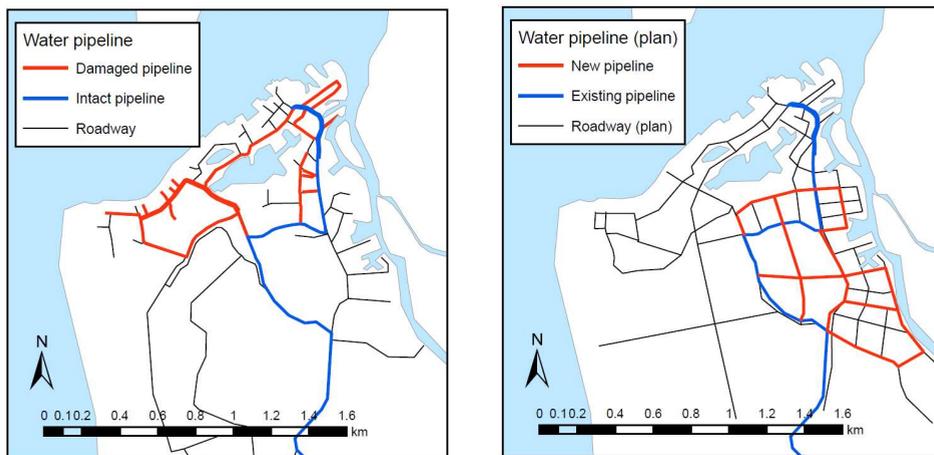
(1) Current pipeline after tsunami (2) Planned pipeline based on DPT planning

Fig. 12. Nam Kem village reconstruction planning (DPT, Thailand)

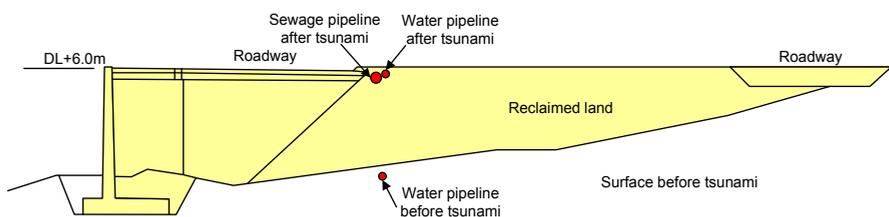
Fig. 13. High-raised tidal wall and reclaimed land development at Aonae district

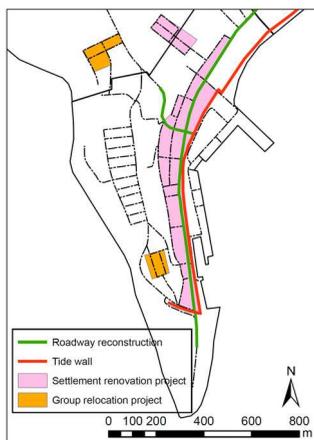
Fig. 14. Disaster reconstruction projects of Aonae district

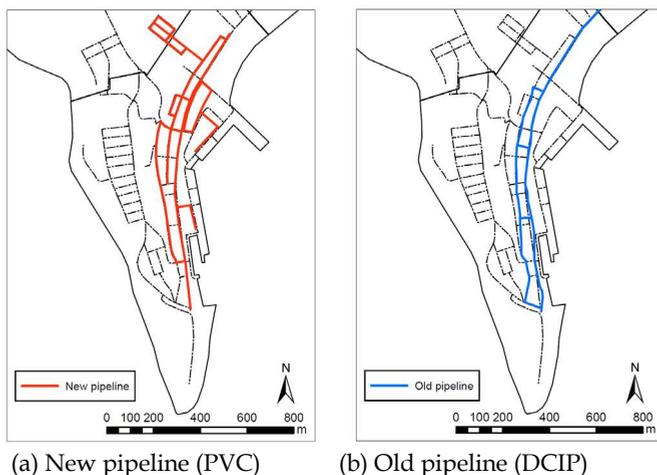
Fig. 15. Water supply pipeline networks of Aonae district before and after tsunami, underlying on the new roadway

Based on the reclaimed land development and new roadway construction, the water-supply pipeline used before was left under the surface before the tsunami, and the new pipeline was constructed over it, as shown in Fig. 15. A polyvinyl chloride pipe (PVC) was adopted in the reconstruction work in spite of the ductile iron pipe (DIP), which was used before the tsunami. As shown in the plan of pipeline networks in Fig. 12, the pipeline in Aonae district was completely reconstructed. In contrast to the previous pipeline, the new pipeline draws streamline.

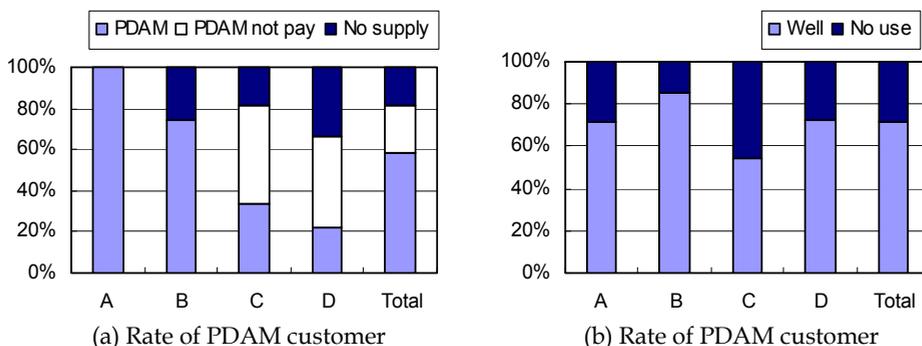
Fig. 18. Water use in Banda Aceh

The number of answers are not enough statistically, but the rate of PDAM customers in each district as shown in Fig. 18(a) is confirmed to be similar to the statistics of customer number by the PDAM. In resettlement district, A, residents uses 100% PDAM water-supply, and 70 to 80 % of residents do in the other districts. The PDAM customers without charge in Districts C and D are those live in the area under pipeline construction. Those who do not use the PDAM water use domestic water from shallow well. As a whole, 20 % does not use the PDAM water, 50 % uses both the PDAM water and domestic water as shown in Fig.18(b) Well user increases in inland Districts A and B.

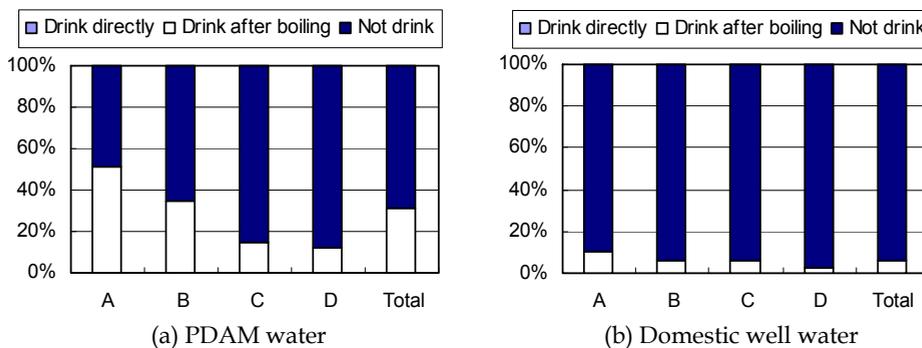
Fig. 19. Water use for drinking

Among the PDAM users, 10 to 50 % drinks the water after boiling as shown in Fig.19(a). The severely suffered districts, C and D, indicates low rate of drinking customer. Less 10 % drinks domestic water after boiling as shown in Fig.19(b). Water use in Indonesia is

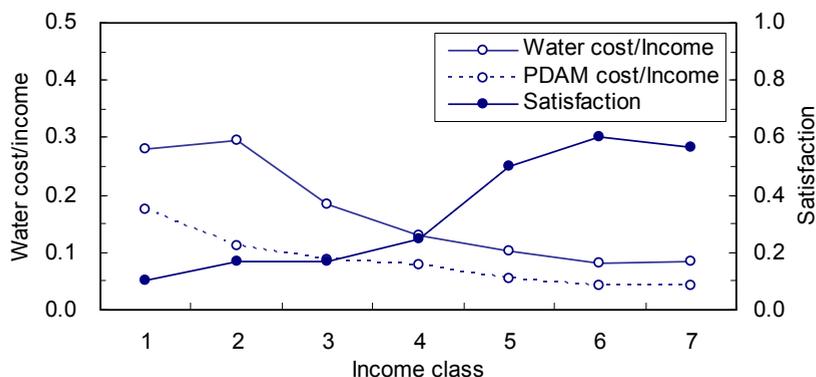
Fig. 20. Water cost rate to income versus water satisfaction regards to monthly income class. Income class 1: < 350,000 IDR, 2: 350,000 – 500,000 IDR, 3: 500,000 – 750,000 IDR, 4: 750,000 – 1,000,000, 5: 1,000,000 – 1,250,000, 5: 1,250,000 – 1,500,000 IDR, 6: >1,500,000 IDR. IDR=Indonesian Rupiah (1,000 IDR = 0.12 USD =9.4 JPY, 2011)

It should be noted that the water charge from the PDAM water is almost same as the bottle purchasing cost. The responders buy a monthly average of 11.7 gallon-sized water bottle. One bottle (about 3.785 liter) costs about 5,000 Rupiah and the bottle water costs 1,321 Rupiah per liter. Meanwhile the PDAM water costs about 3 Rupiah per liter. If the PDAM can obtain residents satisfaction on the water quality and residents can drink it even after boiling, the whole residential water charge decreases less than 10 % and the residents also satisfy the water charge. It should be discussed that how much the pipeline network completion for better water quality at the customer side can be invested considering the water charge. These assessments of water pipeline install would be necessary for future work.
