Seismic Potential Improvement of Road Embankment

Ken-ichi Tokida
Osaka University
Japan

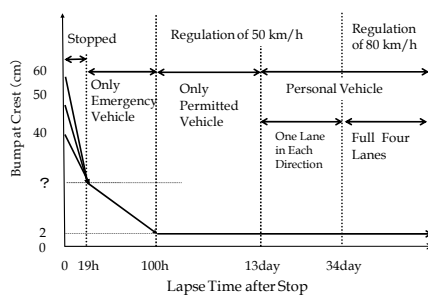
Fig. 1 shows the time history just after the main shock occurrence for opening Kanetsu Highway and Hokuriku Highway which were stopped mainly by the damages relating to not the bridges but the embankments to the emergency vehicles such as ambulances etc. and the public cars. It can be seen it took about 13 days to open the highways for the personal vehicles under the speed regulation. As mentioned above, we can realize the importance of seismic design and reinforcement for road embankments in the future.

Fig. 1. Recovery of traffic performance after stopping caused by earthquake

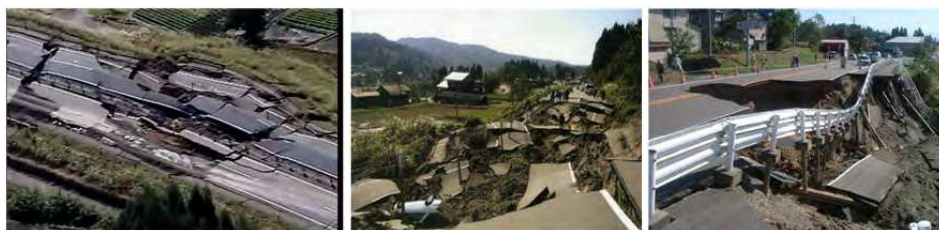
The typical examples of severe or large-scaled damages and slight or small-scaled damages of road embankments can be shown as Photo. 1 and Photo. 2, respectively. The former indicates three examples, i.e. (a) very severely damaged site reported by Higashi Nippon Highway Co. Ltd. where all 4 lanes were slid perfectly, (b) severely damaged site reported by Hokuriku Regional Bureau of Ministry of Land and Transportation where all 2 lanes were slid perfectly and (c) a little severely damaged site also reported by Hokuriku Regional Bureau where almost 2 lanes were slid partially and each traffic performance was lost perfectly. While, the latter indicates two examples, i.e. (a) partially slid site also reported by Hokuriku Regional Bureau where the sliding occurred only at the shoulder of the embankment and was retrieved easily with large-scaled sand bags as shown in Photo. 2, and (b) cracked site reported by Higashi Nippon Highway Co. Ltd. where only the shoulder was cracked a little and dump trucks can run without urgent retrieval, then their loss of traffic

(a) 4 lanes slid perfectly

(b) 2 lanes slid perfectly

(c) Almost 2 lanes slid

Photo 1. Large-scaled damage of road embankment without traffic performance

Comparing the severe damage of road embankment shown in Photo. 1(b) with the slight damage shown in Photo. 2(a), it can be hinted to control the position of the sliding plane occurred not to reach to the traffic lane, then to keep the traffic performance at a certain level just after an earthquake. This fundamental design concept was proposed by Tokida et al. (2007) and named “Sliding Failure Control Method”. The control of the sliding failure aims to change the position of sliding plane and/or to decrease the sliding displacement occurred during earthquakes not to disturb the traffic performance perfectly. Furthermore, as shown in Fig. 5, four specific design concepts such as “Crest Reinforcement Structure”, “Barrier Reinforcement Structure”, “Artificial Reinforcement Structure” and “Toe Reinforcement Structure” can be proposed to achieve the fundamental design concept. The performance of each reinforcement structure is as follows.

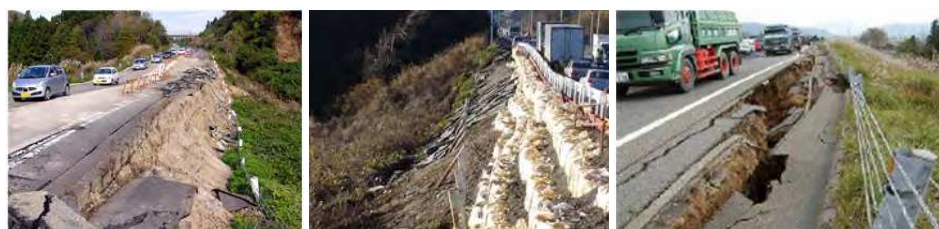
performance were small and the road could be used just after the earthquake by small-scale and short-time restoration or not.

(a) Partial sliding and urgent retrieval with sand bags

(b) Slight crack at shoulder

Photo 2. Small-scaled damage of road embankment with a certain traffic performance

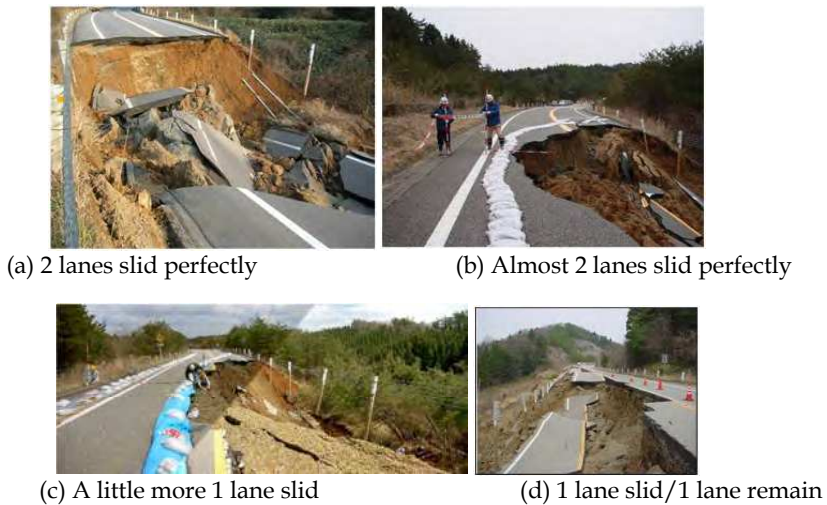
Photo.3 reported by Ishikawa Prefecture shows four examples of the slid road embankments which locate at Noto Toll Road at the mountainous area of Noto Peninsula. These photos indicate (a) severe damaged site where 2 lanes were slid perfectly, (b) severe damaged site where almost 2 lanes were slid, (c) severe damaged site where slight 2 lanes were slid and (d) severe damaged site where one side of 2 lanes slid and each traffic performance was lost perfectly.

The severe sliding damages such as Photo. 3 which resulted in the perfect stopping of traffic performance occurred at 13 sites located along the road of about 48.2 km. The site shown in Photo. 3(c) is selected to apply the analytical method named Newmark Method to simulate the sliding plane and its displacement in Chapter 5.

Photo 3. Large-scaled damage of road embankment without traffic performance

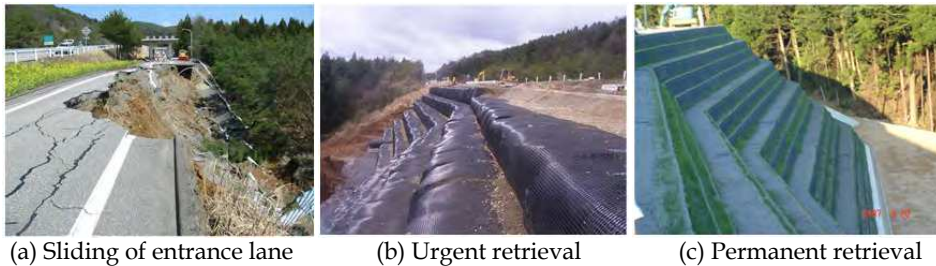
In Photo. 4 reported by Ishikawa Prefecture, Photo. 4(a) shows the severe damaged on ramp close to the toll gate. Most damaged embankments were retrieved urgently and permanently with use of the geotextile which can be shown in Photos. 4(b) and 4(c), respectively. Noto Toll Road was opened to the public urgently in about one month later

Photo 4. Damage and seismic retrieval with geotextile

It can be indicated that the seismic design with the seismic coefficient of 0.2 was applied to reinforce the retrieved embankments strongly more than that before the earthquake for the future earthquakes. Such seismic retrieval for the road embankments at Noto Toll Road may be the first case in Japan and can be referred for other embankments in the future.

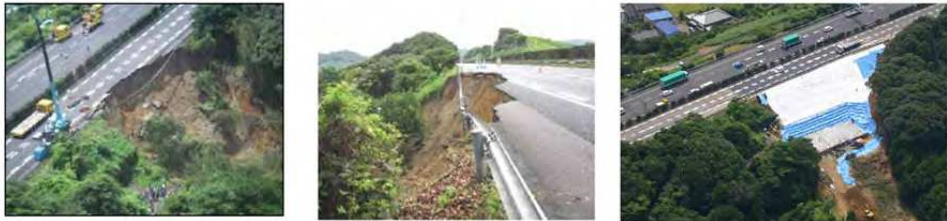
economical influences and so on were very large for Japan. However the urgent and extended retrieval was executed, it took 5 days to recover the limited traffic performance for the personal vehicles as shown in Photo. 5(c). The permanent retrieval ended on June 10, 2010, i.e. in about ten months and the traffic performance was recovered perfectly.

(a) Overview of sliding (b) Shoulder and slope slid (c) Urgent retrieval

Photo 5. Partially damaged site without traffic performance and urgent retrieval

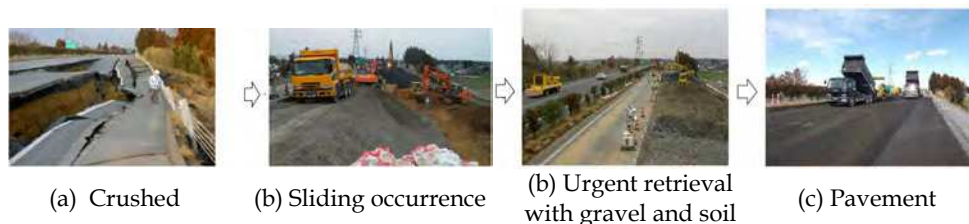
However the damages by tsunami occurred widely and severely, other damages of civil engineering structures such as road bridges, road embankments, river dykes and so on were not so remarkable because the epicenter of the main-shock is rather far and the damages occurred along the coasts may be washed away by tsunami attacks. The most severely damaged embankment of all ones at Tohoku Highway and Joban Highway which are the main trunk routes to connect Tokyo with Tohoku Region, where the earthquake occurred can be introduced as shown in Photo. 6 reported by Kanto Branch Office of Higashi Nippon Highway Co. Ltd. As shown in Photo. 6(a), the one side of 2 lanes in one direction slid. However the thickness of the soft ground beneath the embankment body is about 3.6m, the type of the failure is a toe sliding failure and a little small failure. The work flow of the urgent retrieval for this embankment can be shown as Photo. 6(b), 6(c) and 6(d), respectively. As shown in Photo. 7 under urgent retrieval work, the height and the damaged length of the embankment are about 8m and 150m, respectively. The traffic performance for the personal vehicles was recovered urgently on March 21, 2011. Then it takes about 10 days to complete the urgent retrieval and open the highway to the public.

Photo 6. One side of two lanes damaged and urgent retrieval

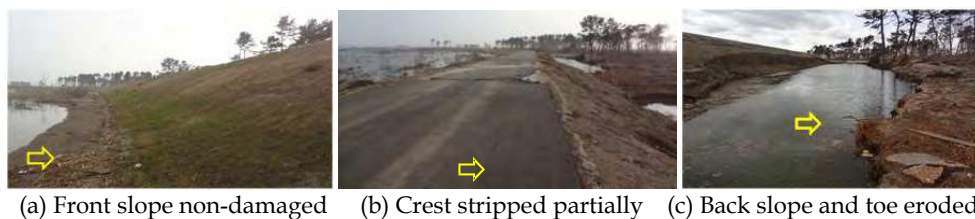
Some lessons concerning to road embankments against tsunami attacks can be obtained as follows. Photo. 8 is a newly constructed river dyke along the channel which locates in Miyagi Prefecture facing the Pacific Ocean where the earthquake occurred. As shown in the Photo. 8, the river dyke which height and width at the crest are about 4m and 6m, respectively is paved and can be used as a road. Then the lessons obtained from the damages of this dyke can be applied for the future design against tsunami disasters. Photo. 8(a) shows the condition of the front side of dyke slope against tsunami attacks which came from the left side of the Photo. 8(a). It can be seen that almost all of the front sides were not damaged, i.e. the front side may be strong against tsunami attacks which height is assumed to be about 10m around this site and then the overflowed water depth at the dyke crest can be estimated to be about 4m. Photo. 8(b) shows the condition at the dyke crest where the asphalt pavements are stripped partially, but the road function was not lost so much. Then it can be indicated that the asphalt pavement at the crest is very effective against the overflowed water by tsunami. Photo. 8(c) shows the conditions of the back side of dyke slope washed away by tsunami. It can be known that the back side slope is eroded near the surface and the toe ground is eroded severely and trenched deeply. However the back side slope is fallen down partially, the minimum stability of the dyke can be maintained to keep the performance of the dyke and/or road. However the above lessons may be limited to this dyke, they become very important hints for the design against tsunami attacks.

Photo 8. Dyke overflowed by tsunami

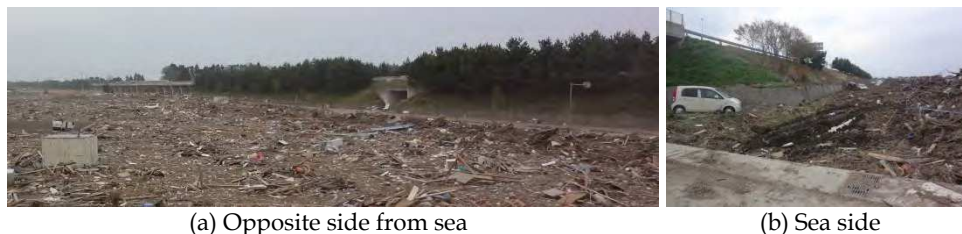
Photo 9. Comparison of damages at both sides of highway embankment

Photo. 9 shows another example from which we can get some lessons on the performance of the road embankments against tsunami attacks. Photos. 9(a) and 9(b) show the landscapes after tsunami attacks at the opposite side and the front side of the road embankment against tsunami attacks, respectively. However the road embankment was expected to perform the barrier function against tsunami attacks, the performance may be small as shown in Photo. 9(a) because the box culvert and the elevated bridge permit tsunami flow to go through.

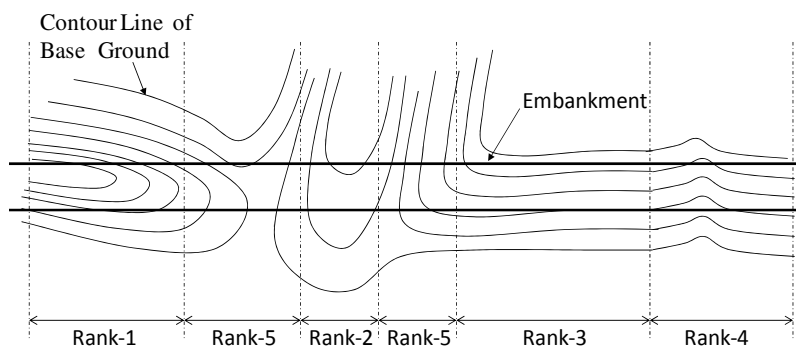
Item 1 on the topographical conditions below embankments can be selected because the damage risk relates to the original terrain condition under the embankment such as ridge slope or stream. For example, the assessment rank and each relating score are assumed as shown in Fig. 2.

Fig. 2. Identification of topographical ranks for Item 1

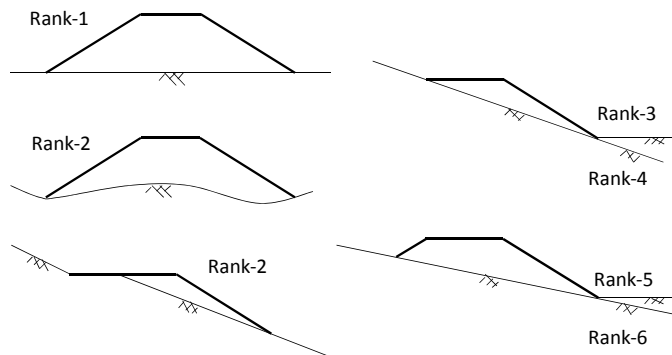
Item 4 on the traverse structure of embankment can be selected because the damage risk relates to the traverse structure of the embankment, including the incline of the foundation ground, the configuration of the embankment, as shown in Fig. 3.

Fig. 3. Identification of traverse structures for Item 4

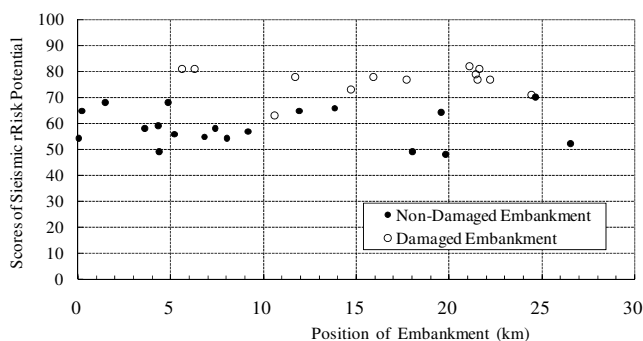
The example of application of the macroscopic assessment method with the value of SRP can be obtained as shown in Fig. 4 where 13 damaged and 19 non-damaged embankments in the 2007 Noto Peninsula Earthquake are selected and compared each other.

The average score μ and standard deviation σ are 60.7 and 8.2, respectively on the 19 non-damaged embankments. Then the score range of $\mu \pm \sigma$ is from 52.5 to 68.9. The average score and standard deviation are 75.2 and 4.8, respectively on the 13 damaged embankments and then the score range of $\mu \pm \sigma$ is from 70.4 to 80.0.

Fig. 4. Scores of seismic risk potential between non-damaged and damaged embankments in the 2007 Noto Peninsula Earthquake

Based on the results as shown in Fig. 4, the following lessons can be drawn to use the evaluation value of seismic risk potential practically.

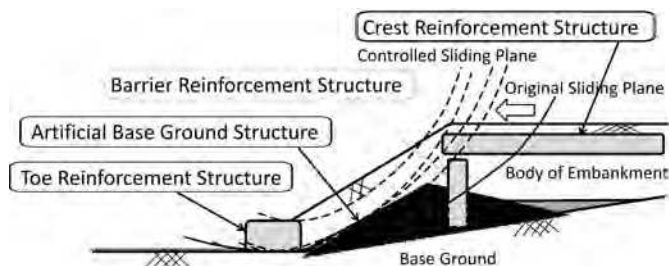
Crest Reinforcement Structure aims to reinforce the crest of embankment partially with use of geotextile etc. and not to occur the sliding plane and decrease the sliding displacement on the top of the embankment, then maintain the traffic performance enough just after an earthquake. Toe Reinforcement Structure aims to reinforce the toe of embankment to control the sliding plane and decrease the sliding displacement. Artificial Reinforcement Structure aims to control the sliding plane by improving the embankment body stiffly as shown in Fig. 5 to control the sliding plane not to reach the traffic lane. Barrier Reinforcement Structure aims to control the position of the sliding plane with use of sheet piles etc. and not to occur at the traffic lane, then maintain the traffic performance enough just after an earthquake.

Fig. 5. Typical concepts proposed for performance-based design of road embankment

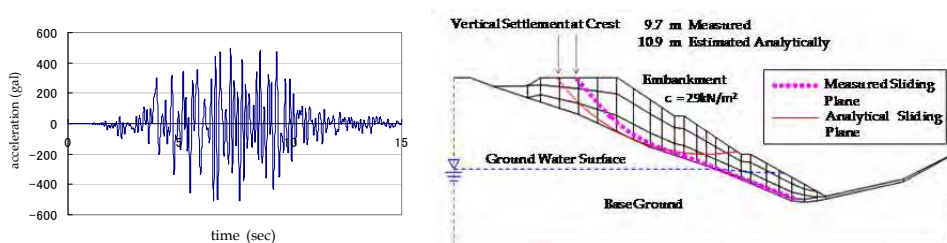
Fig. 7 is the example applying the Newmark Method to the embankment damaged during the Noto Peninsula Earthquake in 2007. The ground motion inputted at the bottom of the embankment model shown in Fig. 7(b) is revised the maximum acceleration from the ground acceleration of 580gal in the East-West direction shown in Fig. 7(a) which was observed at Togi City set by National Research Institute for Earth Science and Disaster Prevention (NIED) to the one of 500gal. As known in Fig. 7(b), the position of the sliding plane measured after the earthquake is almost similar to the analytical one. Furthermore, the measured sliding displacement at the crest of the embankment is 10.9m and similar to the 9.7m measured.

(a) Observed E-W ground motion at Togi (b) Measured and analytical sliding failure
Fig. 7. Example of application of Newmark Method

In this case study, the sliding failure such as the position of the sliding plane and the sliding displacement estimated with use of the Newmark Method is well estimated analytically.

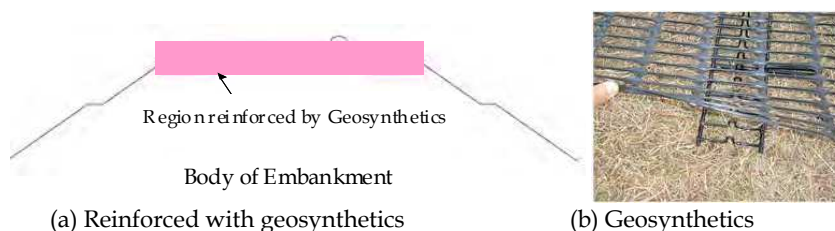
Fig. 8 shows the example of the Crest Reinforcement Structure with use of the geosynthetics. This structure can be applied to both existing and newly constructed embankments. In the case of the existing embankment, the sheets of geosynthetics are installed at the overall crest of the embankment as shown in Fig. 8 based on the excavation and the re-pavement, or around the shoulder of the embankment partially. The reinforcing work is necessary to be paid attention to reduce the effects on the traffic performance as little as possible. On the other hand, in the case of newly construction, the sheets of geosynthetics can be easily set inside of the embankment. The practical applications of the crest reinforcement structure with use of geosynthetics have been discussed and clarified as follows.

Fig. 8. Example of crest reinforcement structure

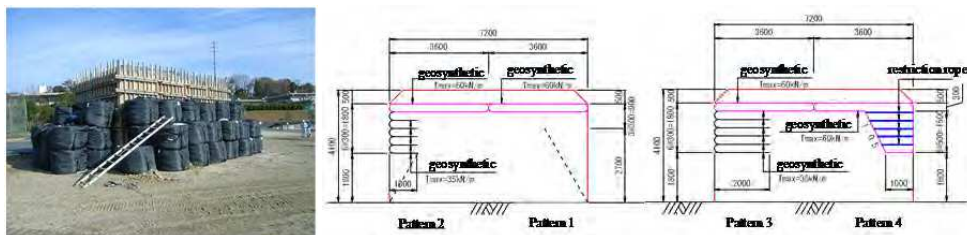
ropes. The soil properties are shown in Table 3 and the fine aggregate without fine-grained fraction of the wet density of $\gamma_t = 18\text{kN/m}^3$ which tends to occur a collapse easily. The static failure of the reinforced embankment model is planned to be occurred by removing the panels and sandbags.

(a) View of embankment model

(b) 4 patterns of reinforced embankment models (unit:mm)

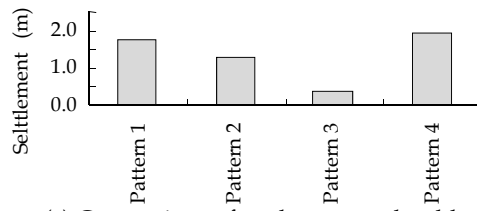
The collapse mode of each reinforced embankment model is illustrated in Fig. 10(a). In case of Pattern 1, the large sliding failure occurred at the whole area of the embankment body beneath the surface layers. In case of Patterns 2 and 3, each deformation of the embankment body is smaller than Pattern 1. Moreover, the deformation of the embankment model in case of Pattern 3 with a longer reinforcement than that of Pattern 2 became smaller than that of Pattern 2. The difference of each damage level can be known in Fig. 10(b) which shows the side plane conditions and the surface condition of the crest of the embankment models. In case of Pattern 4, the whole reinforced part slid down severely because of the weight of the reinforced body.

(a) Deformation of models (unit: mm)

(b) Difference of Settlement Level

(c) Comparison of settlement at shoulder

Fig. 10. Comparison of damage level between different reinforcement patterns

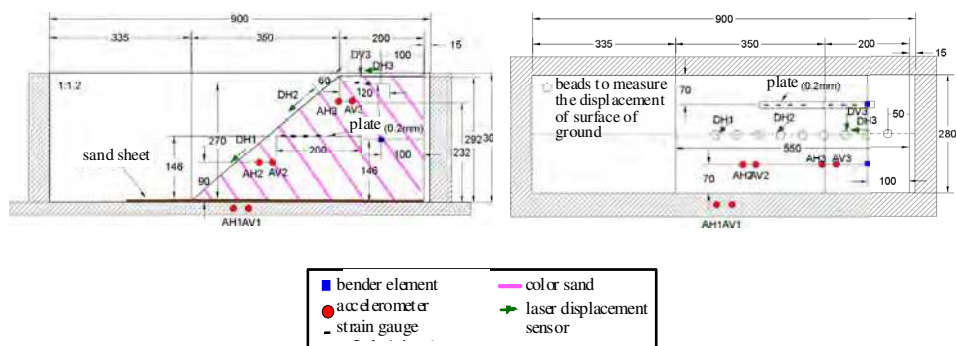
which the strain gauges are pasted on both sides are placed in the upper and central parts of embankment to investigate the failure mechanism.

(a) Cross section (unit: mm)

(b) Plane section (unit: mm)

Fig. 11. Embankment model and measurement for dynamic centrifuge test

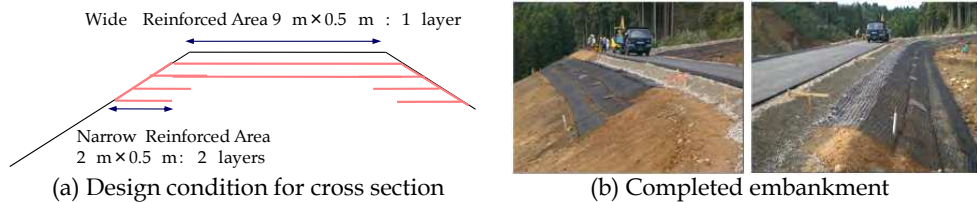
As shown in Fig. 16(a), one reinforced layer with two long sheets of 9m and two reinforced layers with two short sheets of 2m which are similar to the Case 2 in the centrifuge test in Fig. 13. The thickness of each layer is 0.5m. However the seismic design hasn't been applied in this case, it's very important that this case is the first trial to apply the Crest Reinforcement Structure in Japan as shown in Fig. 16(b) and can be obtained important lessons to construct the structures in the field.

Fig. 16. Application of crest reinforcement structure to actual road

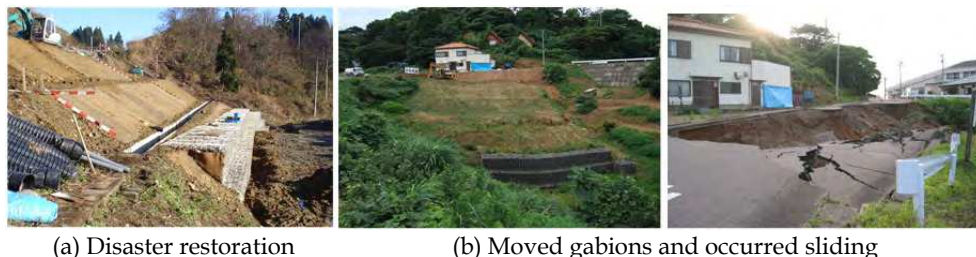
reported in recent years. A large-scale gabion is given as a typical structure of the Toe Reinforcement Structure in this Chapter. As for the large-scale gabion, the merits to apply it are low-cost, good construction workability, and there are a lot of actual results in the field as the disaster restoration method for the purpose of drainage as shown in Photo.11 (a).

Photo 11. Application of large-scaled gabion at present

However the gabions were set only for drainage in advance, they could not work against the seismic motion as shown in Fig. 11(b). Then it is necessary and effective to apply the large-scale gabions for not only drainage but also reinforcement of the embankment.

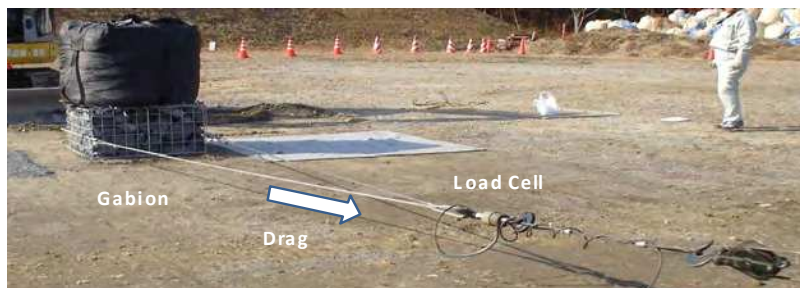
Photo 13. Typical method to drag gabion and measure drag-Load

Furthermore, three types of the weight and/or load condition are considered. The weight at Stage 1: 7.487kN are the same with that of the practical gabion and each weight at Stage 2: 15.249kN and at Stage 3: 21.619kN is about twice and three times the weight of the practical one, respectively. Photo.13 shows the typical method to drag a gabion and to measure the drag-load where the steel wire connected to the gabion is pulled by the winch which is set on the right side in Photo. 13.

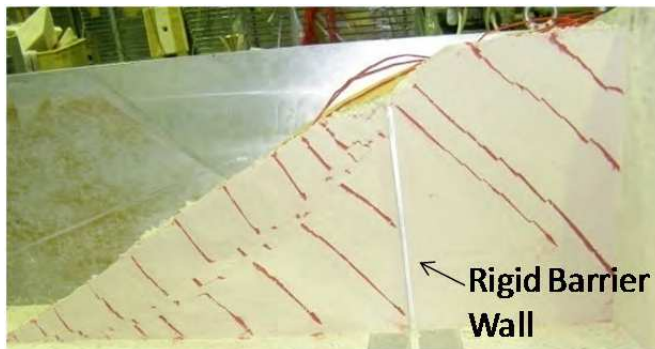
The centrifuge test is conducted on the effects by Barrier Reinforcement Structure with a rigid plate shown in Photo. 14. The test conditions and measurement system are same with the former tests in Fig. 11. The under edge of the barrier structure is set to be rotated and not to be moved horizontally, i.e. assumed to be a hinge. The upper edge of the one is free and not to be connected with the side wall of the container.

Photo 14. Centrifuge test on the Barrier Reinforcement Structure

It can be known that however the rigid plate is inclined a little toward the slope, the sliding plane can be controlled toward the shoulder of the crest where the traffic performance isn't affected severely. If the upper edge is fixed, the effectiveness of the barrier may become larger. The Barrier Reinforcement Structure can be assumed to be effective to decrease the residual displacement at the crest of road embankments. As the rigid plate, the sheet piles and the reinforced concrete wall etc. can be considered as the practical barrier reinforcement structures.
