Fracture Analysis of Generator Fan Blades

Mahmood Sameezadeh and Hassan Farhangi

This chapter reports the failure investigation of a rotating axial flow fan of the Iran Montazer-Ghaem-VI 123 MW capacity generator unit. The unit was equipped with two rotating fans, one at each end namely at the turbine side and the exciter side of the generator. The failed fan consisting of 11 blades was mounted on the generator-rotor at the

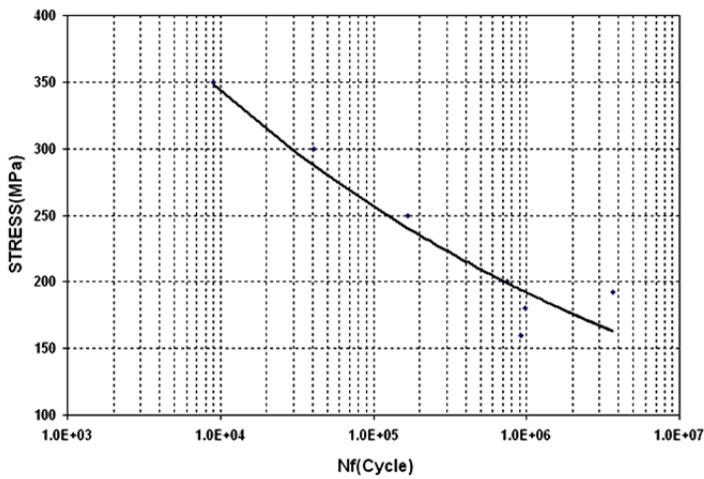
The measured lifetime versus applied stress from the rotaty bending fatigue test is presented in Fig. 3. A SEM micrograph taken from the fracture surface of a tested specimen

Figure 3. Fatigue test S-N curve

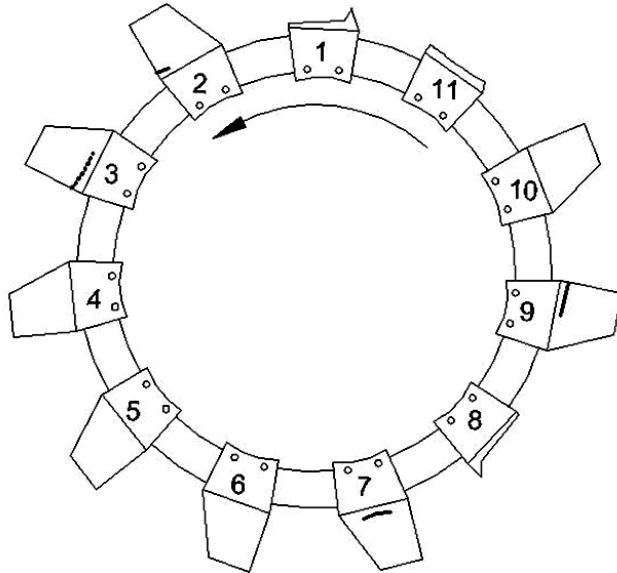
Faint beach marks indicative of the progressive nature of crack growth in the semi-elliptical region can be seen in Fig. 8. Parallel microscopic fracture surface markings can also be observed in this region at higher magnifications in SEM micrograph as shown in Fig. 9. A schematic drawing of the fan with the location of damaged blades is presented in Fig. 10. Visual inspections and fractographic assessments revealed that the sequence of fracture for the broken blades has been blade No. 1, blade No. 8 and blade No. 11 respectively (Sameezadeh, 2005).

Figure 10. Schematic drawing of the fan with location of damaged blades
