Pacing System Malfunction: Evaluation and Troubleshooting

Majid Haghjoo, MD, FACC, FESC
*Rajaie Cardiovascular Medical and Research Center,
Iran University of Medical Sciences,
Iran*

This chapter will discuss the differential diagnosis, evaluation, and management of the common malfunctions encountered in the single-chamber, dual-chamber, and biventricular pacing system.

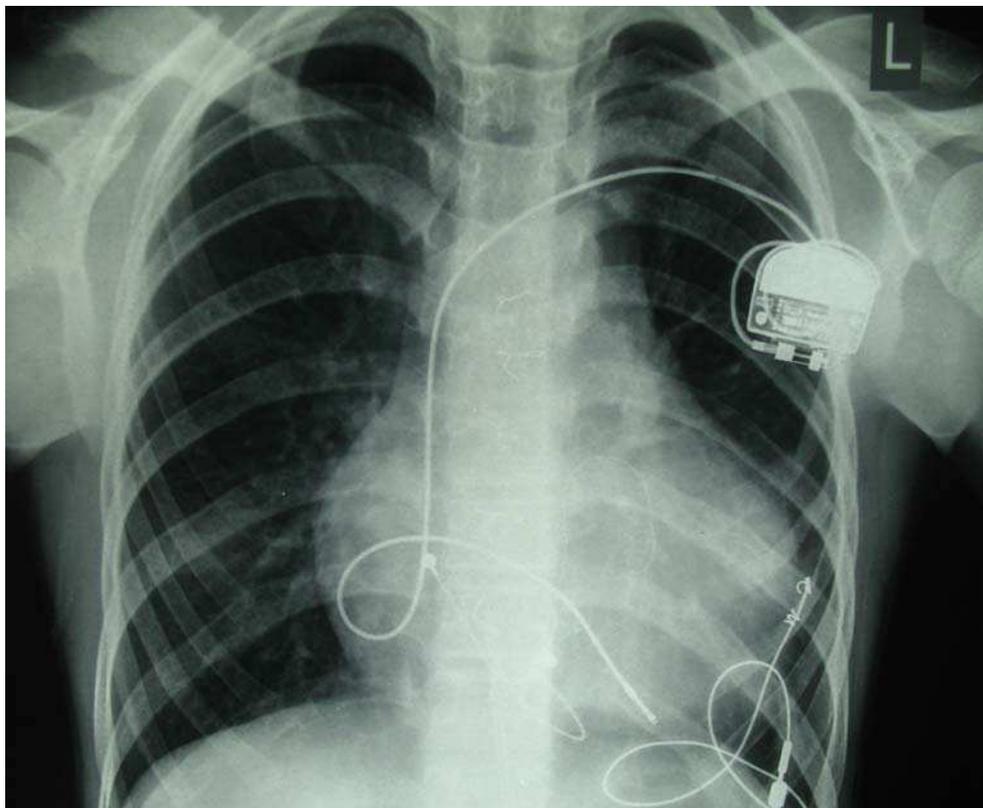
Fig. 1. This chest x-ray illustrates a typical example of conductor fracture with intact insulation. Conductor fracture occurred near to the fixation sleeve.

Lead conductor fracture is the most common cause of an open circuit. Although the clinician might expect that fracture of a lead would result in the absence of any visible pacing artifact, this is frequently not the case. This occurs because the current passes across the gap in the conductor coil though the fluid in the lead with high resistance. In such circumstances,

energy reaching the heart is subthreshold with no capture, but a stimulus will be present. The ECG with an intermittent conductor fracture may show a varying amplitude artifact if recorded with an analog machine. Lead fracture is associated with infinitely high lead impedance if the insulation remains intact. However, total lead transection (concomitant conductor fracture and insulation defect) may show normal or minimally elevated impedance. Chest x-ray may show conductor fracture (figure 1). In contrast to the unipolar lead, diagnosis of the conductor fracture is very difficult in a coaxial bipolar lead unless there is total disruption of both conductors at the same place. Reprogramming to unipolar mode is a temporary measure in partial fracture of bipolar lead. In pacemaker-dependent patients with complete lead transection, temporary pacemaker implantation is necessary before definitive management. Definitive treatment of conductor fracture is lead replacement.

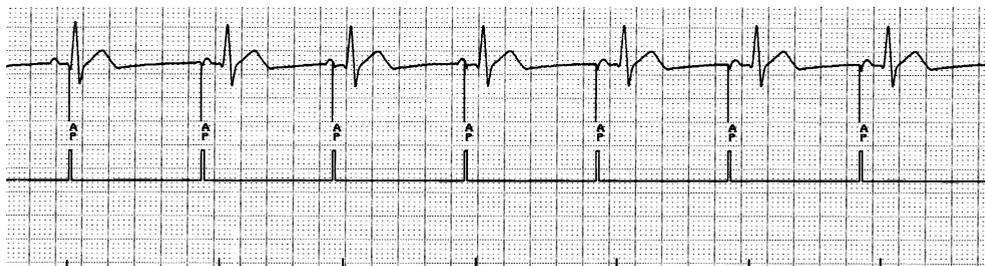
Fig. 2. This tracing shows inappropriate atrial pacing because intrinsic depolarization is not seen by the pacemaker.

A proper sensing require good quality signal with adequate amplitude and slew rate. Apparently high amplitude signal may not be appropriately sensed because of the slow slew rate (Furman et al, 1977). Undersensing is characterized by the inappropriate pacing because of underdetection of the intrinsic signals (figure 2). The etiologies of the undersensing are listed in Table 3. As in failure to capture, onset of the undersensing in relation to implantation time may direct the clinician to the correct diagnosis. Early-onset undersensing is most probably due to *lead dislodgment or lead perforation*. Late-onset

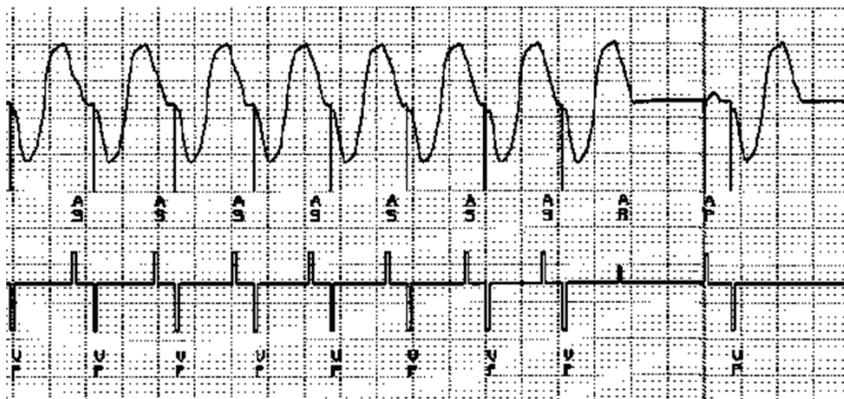
Fig. 3. This tracing was recorded from a patient with dual-chamber pacemakers who presented with frequent palpitations. Pacemaker interrogation showed frequent episodes of pacemaker-mediated tachycardia initiated by a PVC and terminated by a P-wave falling within the PVARP.

Pacemaker-mediated tachycardia (PMT) is characterized by the active participation of the pacemaker in the tachycardia (figure 3). There are several forms of PMT. Typical form of PMT is endless-loop tachycardia (ELT). ELT only occur in patients with P-synchronous dual-chamber pacing (DDD, VDD) and intact retrograde ventriculoatrial conduction. ELT is classically initiated by a PVC. If the PVARP has expired and retrograde P-wave is sensed, the sensed atrial event triggers the ventricular output. This setups a repetitive sequence of the sensed retrograde P-wave, triggering a ventricular output at the end of maximum tracking rate interval (Den Dulk et al, 1982). In addition to PVC, atrial undersensing, atrial oversensing, and atrial noncapture may initiate ELT. PVARP extension after a sensed ventricular event is the main defense against the ELT. If ELT is initiated, PVARP extension and withholding the ventricular output for one cycle are the major modalities to terminate ELT. Second form of PMT is secondary to tracking of atrial signals (atrial tachycardia/flutter/fibrillation) (figure 4) or oversensing on the atrial channel (Greenspan et al, 1984). This is not a pacemaker malfunction and terminated by applying magnet. Third form of PMT is called repetitive nonreentrant ventriculoatrial synchronous rhythm (Love, 2007). Several factors predispose the patient to this kind of PMT. First, intact ventriculoatrial conduction is needed. Second, a sufficiently long PVARP should be programmed to avoid ELT induction. Third, a relatively rapid baseline rate is also required to render the atrial tissue refractory. In this condition, retrograde P-wave is not sensed (functional undersensing) allowing atrial escape interval to be completed and atrial pulse is delivered with no capture (functional noncapture). Then, the ventricular output is delivered at the end of the programmed AV interval. Therefore, this rhythm is characterized by ventricular pacing, atrial undersensing, and atrial noncapture in the presence of normally functioning dual-chamber DDDR or DDIR pacemakers (figure 5). To prevent this rhythm, a new algorithm called noncompetitive atrial pacing (NCAP) has been introduced. Other preventive strategies are providing short AV intervals at high rates or AAI pacing.

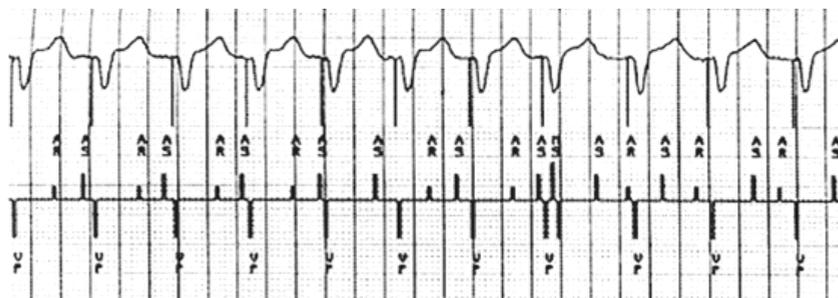
Fig. 4. This figure is recorded from a patient with dual-chamber pacemaker and paroxysmal palpitations. Device interrogation showed tracking of the atrial signals during paroxysmal atrial tachycardias.

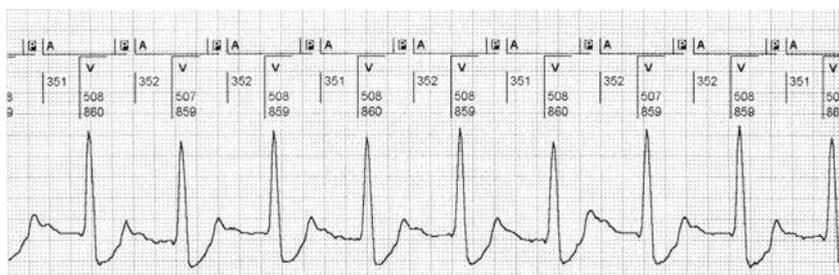
Fig. 5. This figure shows a classical example of repetitive nonreentrant ventriculoatrial synchronous rhythm. This rhythm is characterized by ventricular pacing, atrial undersensing, and atrial noncapture in the presence of normally functioning dual-chamber pacemakers.
