Lessons Learned from Recent Earthquakes – Geoscience and Geotechnical Perspectives

Robert C. Lo¹ and Yumei Wang²

1. Introduction

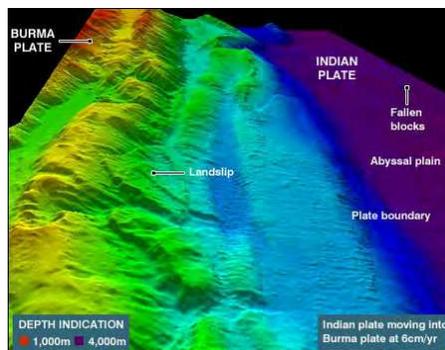
Fig. 2. Three-Dimensional Sonar Imagery of Seabed off the coast of Sumatra Island. (BBC 2005)

The December 26, 2004 Sumatra earthquake was triggered by the rupture of a locked segment of the fault plane at least 500 km long by 150 km wide between the subducting Indo-Australian Plate and the upper Eurasian (Burma) Plate (see Fig. 2). Figure 3 shows the computed vertical and horizontal components of surface displacements of the upper plate based on a finite-fault model (EERI 2005, 2006, ASCE 2007, BSSA 2007).

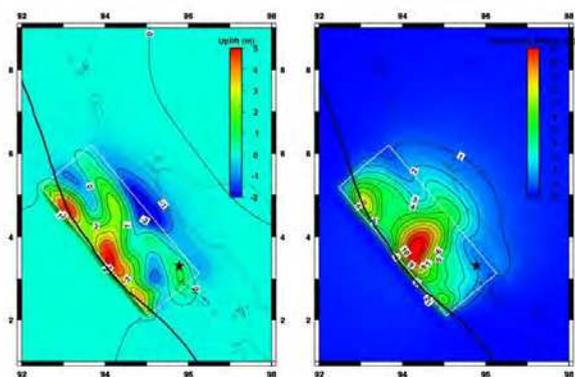
Fig. 3. Modelled Surface Displacements of the Upper Plate in Metres, for Vertical (Left) and Horizontal (Right) Components, 2004. http://neic.usgs.gov/neis/eq_depot/2004/eq_041226/neic_slav_ff.html

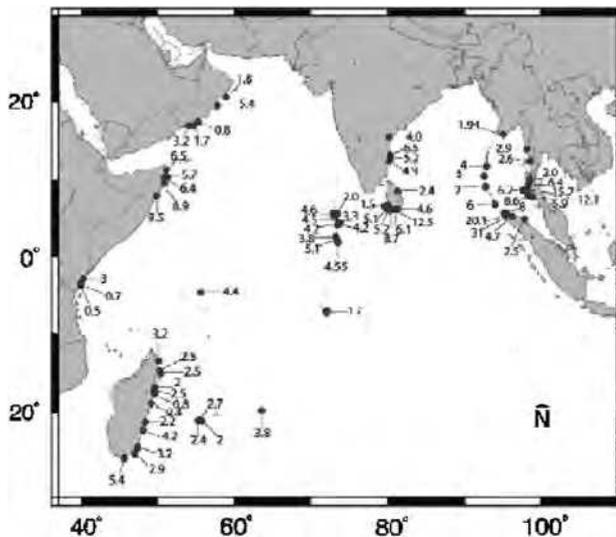
Fig. 5. Representative Tsunami Runup Heights along Shores of Indian Ocean, 2004.
(EERI 2006)

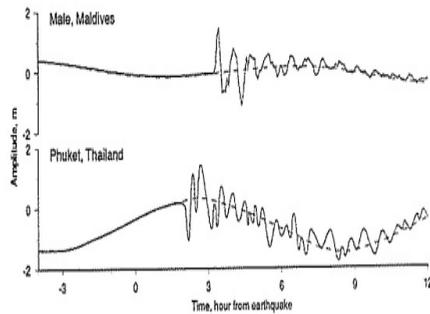
Fig. 6. Tide Gauge Records from Male, Maldives and Phuket, Thailand, 2004. (EERI 2006)

- Two types of leading waves of tsunami were modelled back in 1994: a leading depression N-wave (LDN) and a leading elevation N-wave (LEN). Tide-gauge records on Fig. 6 confirmed the validity of the earlier hydrodynamic modelling: LDN wave was shown on Phuket, Thailand record, while LEN wave on Male, Maldives record. Historically, the leading depression N-wave, i.e., that causing the initial receding of the shoreline as the tsunami approaching, has been a death trap for many unwary fishermen and beachcombers.

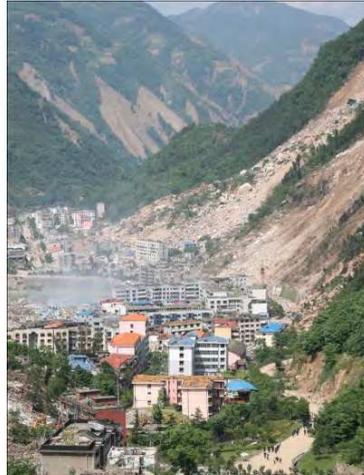
Fig. 9. Landslides in Proximity of Old Beichuan Town. <http://www.agu.org/news>

Due to the steep and rugged topography in the affected mountainous region, wide spread landslides (see Figs. 9 and 10) have been major destructing factors, besides strong earthquake shaking (EEEV 2008, EERI 2008). About 20,000 fatalities, near one-fourth of the total, were caused by 15,000 geohazards in the form of landslides, debris flows and rockfalls, with the largest landslide involving a volume of 1.1 billion m³. In the high, steep slopes (see Fig. 10) along the 270 km long Longmenshan tectonic belt, the large vertical acceleration and topographic amplification of ground motion have resulted in more than 10,000 potential geohazard sites after the event (Yin et al. 2011).

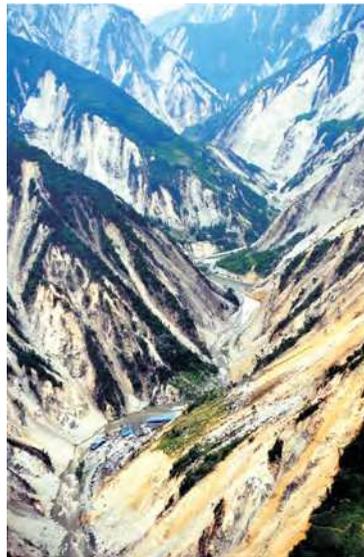
Fig. 10. Landslides along Minjiang River near Wenchuan County. (EEEV 2008)

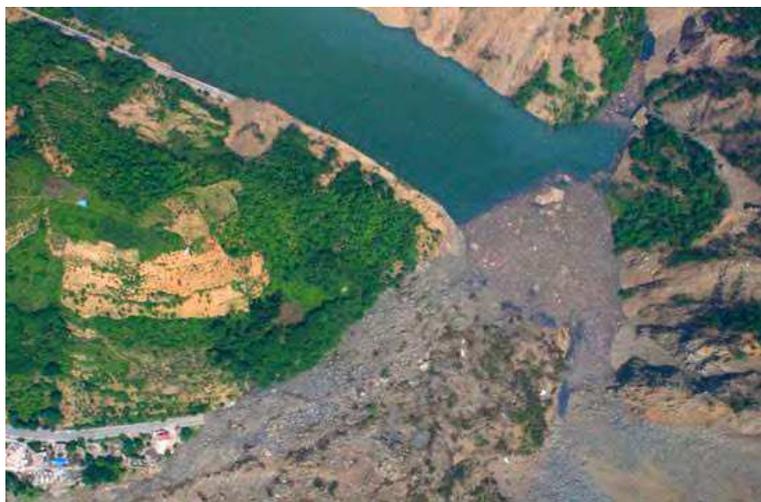
Fig. 11. Landslide Lake at Tangjiashan Landslide. Engineering Resilient Cities - Mahin - Oct 2008

Up to 34 landslide lakes were formed in Sichuan and one in Gansu provinces, threatening about 700,000 people living downstream. The largest one was located in Tangjiashan, Beichuan County (see Fig. 11), with a 71-m high debris dam blocking the Shitingjian river forming a lake about 800 m long and 600 m wide. The downstream flood-threatened area had to be evacuated, and the debris dam breached by excavation and blasting to remove the secondary flood hazard.

moving sliding debris (see Fig. 43). The presence of water in the soil mass, as reflected in its degree of saturation, increases the probability of triggering a slide during an earthquake. Thus, whether the occurrence of earthquake is in dry or wet season could have significant difference in its impact. Heavy precipitation in earthquake stricken area could trigger post-earthquake landslides, debris flows and/or lahars (mudflows of volcanic debris). Moreover, the amount of water within the sliding mass and/or being entrained along its moving path increases its run-out distance and, hence, downstream impact. The local topographical detail along the debris travel path dictates the area being buried by the slide debris. The formation of a landslide lake, caused by temporary blockage of river by unstable slide debris, poses a special flood hazard. Timely construction of a spillway to drain the lake is required to ameliorate the downstream flood hazard such as the case with the Tangjiashan Landslide-Lake after Wenchuan 2008 earthquake (see Fig. 11).

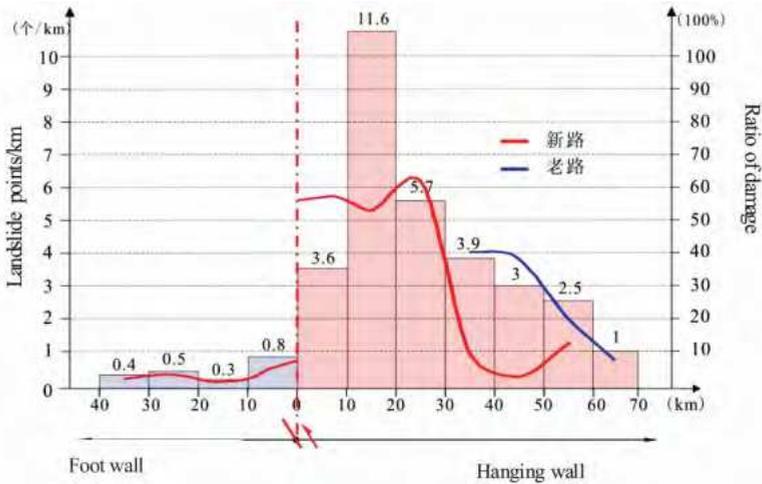
Fig. 12. Landslide Activities above Hanging Wall versus Foot Wall. (EEEEV 2008).

Figure 12 shows the number and severity of landslides per km of National Highway Route #213 over the hanging wall versus foot wall. As expected in a thrust-fault earthquake (Sommerville 2000), there is substantially more damage over the hanging wall as compared to that over the foot wall. Similarly, there is more damage in the area along the earthquake propagation direction than in the opposite direction.

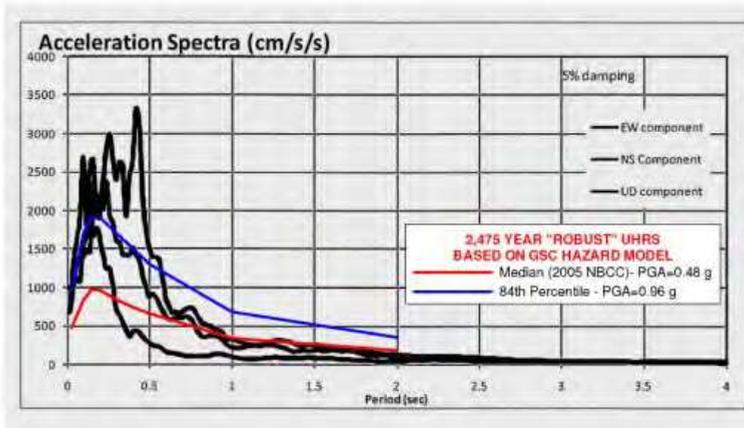
Fig. 13. Acceleration Response Spectra for Qingping Station in Epicentral Region. (Ventura et al. 2008)

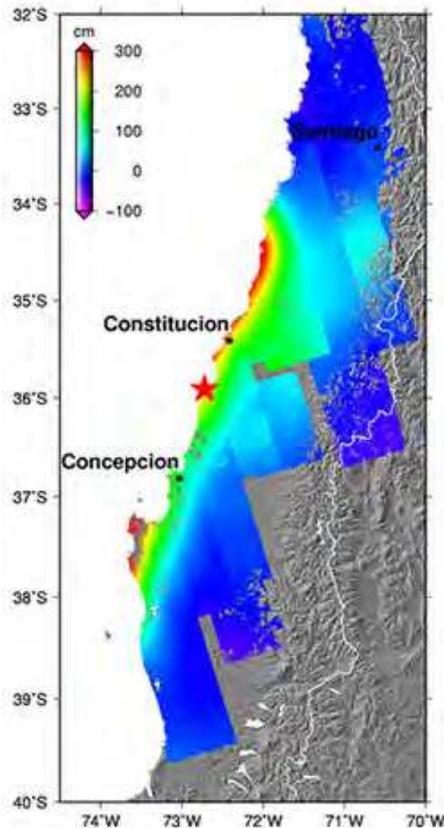
Fig. 21. Fault Plan Slip Distribution over land area - Maule, Chile.
http://tectonics.caltech.edu/sliphistory/2010_chile/index.html

Figure 21 shows the modelled slip distribution over the fault plane in the land area. The maximum fault slip along the coast line is about 300 cm. The earthquake occurred in the

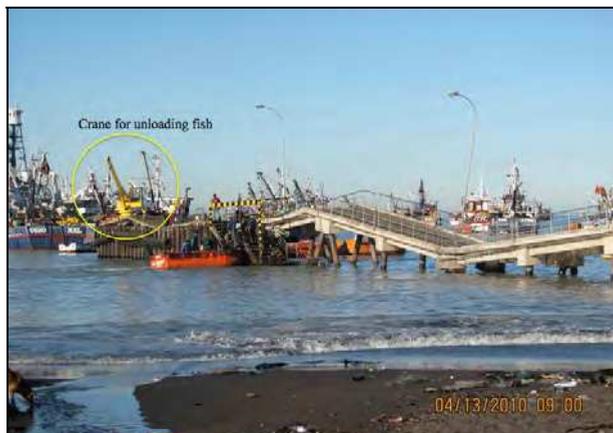
Fig. 22. Distorted Fish-Unloading Concrete Pier at Coronel Port, Chile. (TCLEE 2010)

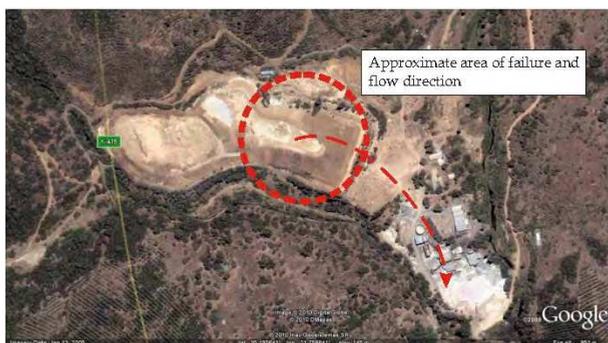
Fig. 23. Bird's-eye View of Las Palmas Tailings Impoundment Prior to Failure. (GEER 2010)

The flow failure of a tailings dam triggered by the earthquake is shown in Figs. 23 and 24 (GEER 2010). Compared with a large number of tailings dam failures in the 1965 La Ligua earthquake and two failures in the 1985 Santiago earthquake, tailings dam performance in this event seems to show some improvement. Compacted engineering fills and structures supported by improved ground using stone columns and micro-piles were reported to perform well.

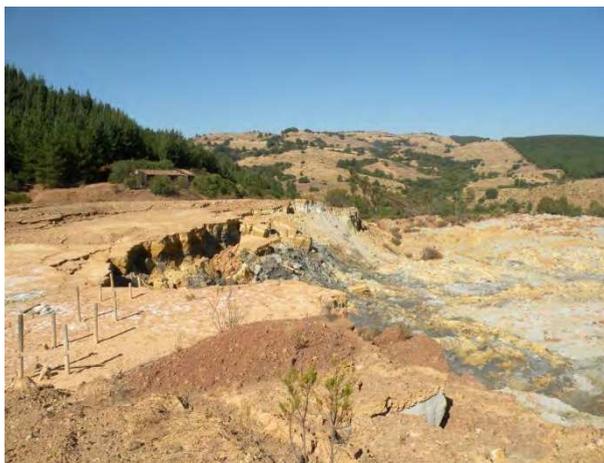
Fig. 24. Upper Scarp of Failed Tailings Impoundment. (GEER 2010)

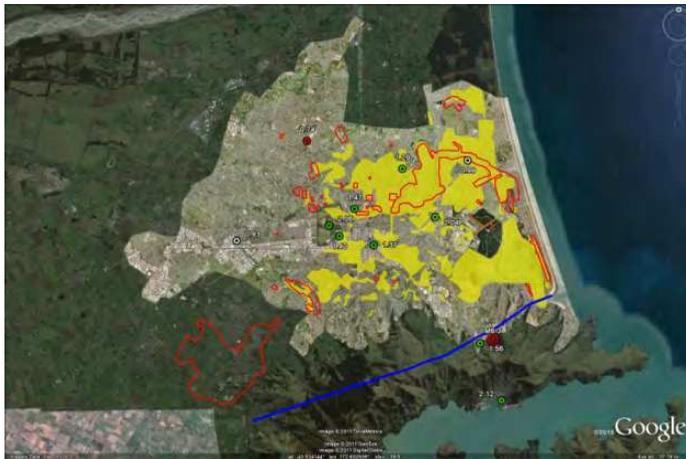
Fig. 25. Liquefaction Maps: Sept. 2010 (Red) and Feb. 2011 (Yellow). (GEER 2011)

Both the September 2010 Mw 7.0 Darfield and February 2011 Mw 6.1 events were shallow crustal earthquakes, which triggered wide-spread liquefaction in the fluvial and diluvial deposits in the epicentral region (see Figs. 25 and 26). Peak ground accelerations spiking above 1 g, often with higher vertical than horizontal acceleration, were reported in the epicentral areas of both events. In the central business district of Christchurch, the largest city on the South Island, peak acceleration reached about 0.7 g on February 22, 2011 as compared to about 0.3 g on September 4, 2010. Figure 27 shows the horizontal acceleration response spectra for Christchurch Hospital with 5% damping. It illustrates that the aftershock is reflected by the current New Zealand 2,500-year design spectrum, while the main shock is corresponding to the 500-year design spectrum. Proposal to increase the design spectrum for periods less than 1.5 sec is being considered (EERI 2010/2011).

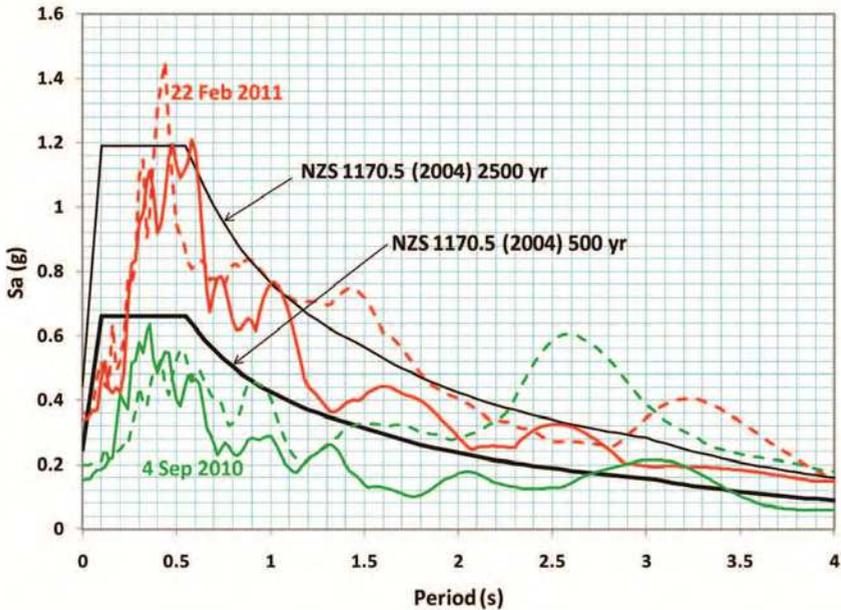
Fig. 27. Horizontal Acceleration Response Spectra for Christchurch Hospital. (EERI 2011)

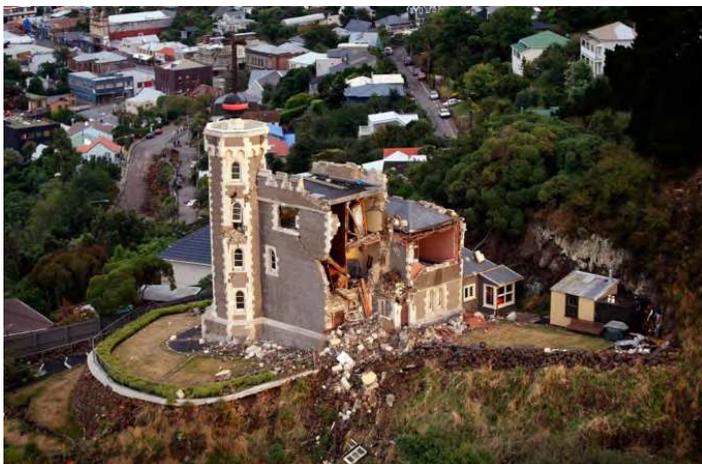
Fig. 30. Topographic Amplification May Play a Role in Damaging an Unreinforced Masonry Building, 2011. <http://otilya.com/view/NewsAsia-Pacific/New-Zealand>

The smaller aftershock caused significant casualties and heavier structure damages in Christchurch (see Figs. 28, 29 and 30) than the main event, because it occurred much closer to the central business district, where many buildings had already suffered varying degrees of damage due to the prior event.

- Site amplification – Site amplification of ground motion through soft soil deposits has been well recognized and incorporated in the modern seismic design codes. However, severe building damages suffered at soft sites at Adaparazi and Avcilar during 1999 Kocaeli earthquake reiterate the importance of this phenomenon. Avcilar is near Istanbul and about 80 km west of the epicenter. The distance attenuation of ground motion was more than compensated by local site amplification. Similarly, topographic amplification of ground motion was also evident during Christchurch (see Fig. 30), and all other recent earthquakes.

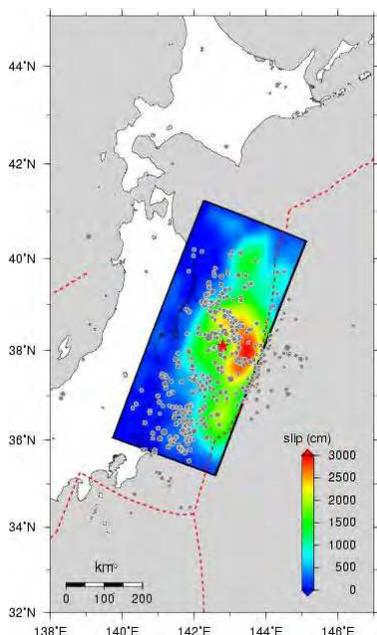
Fig. 31. Fault Plane Slip Distribution Tohoku-Oki, Japan. http://tectonics.caltech.edu/slip_history/2011_taiheiyo-oki/index.html

Figure 31 shows the modelled slip distribution over the fault plane which triggered the Tohoku-Oki earthquake. The slip on the offshore rupture plane was about 30 m, but the slip

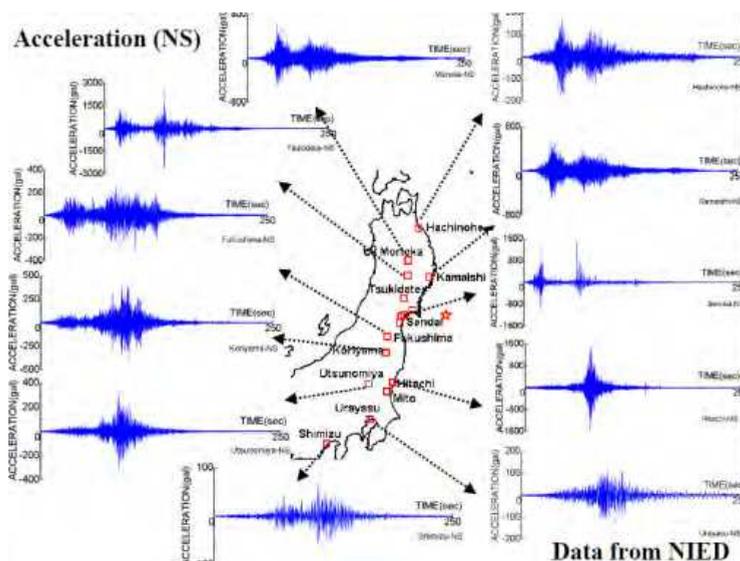
Fig. 32. Ground Acceleration Time histories Recorded in Earthquake Region. (NIED 2011)

along the east coastline reduced to below 5 m. Figure 32 shows acceleration time histories recorded in the earthquake region (NIED 2011). These records have been used to analyze structures such as the study of the response of high-rise buildings to long-period ground motions (Takewaki et al. 2011). It is worth to note that some of the records in Fig. 32 show multi-sequences of earthquake excitations. Moustafa and Takewaki (2010) indicated that such earthquake sequences would result in more severe structural damages due to the accumulation of inelastic deformations. Substantial damages were suffered by the buildings and infrastructures in such a major subduction event of long duration due to the combined effect of earthquake shaking and tsunami onslaught. Earthquake subsidence caused some coastal areas submerged in tidal water (see Fig. 33). JSCE (2011) provided an overview of the characteristics of the earthquake and tsunami; and damage reconnaissance including: geotechnical and structural damage, liquefaction, damage to dykes and levees, and bridges.

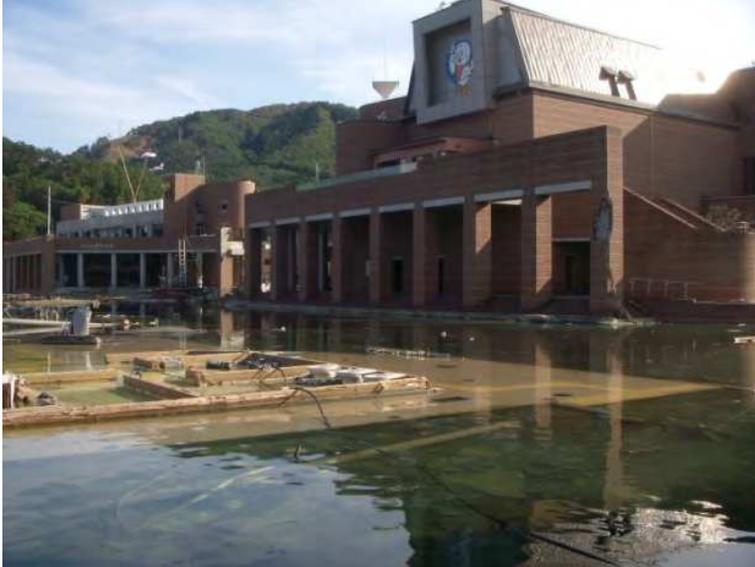
Fig. 33. Waterfront Buildings in Onagawa, Japan Inundated by Tidal Water Due to Earthquake Subsidence. http://tectonics.caltech.edu/slip_history/2011_taiheiyooki/index.html

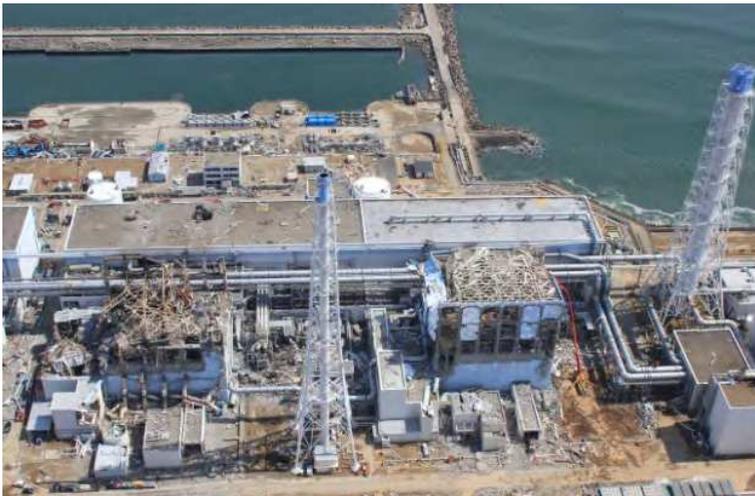
Fig. 34. Blast-Damaged Fukushima Dai-Ichi Nuclear Power Plant Unit 3 (left) and Unit 4 (right).<http://pinktentacle.com/>

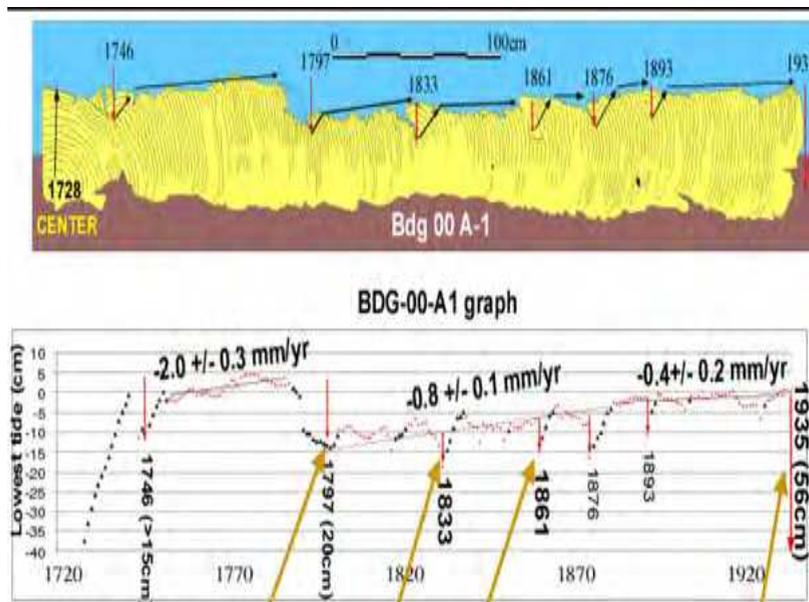
Fig. 35. Sea Level Changes Inferred from Truncated Coral Growth Rings. (Caltech 2011)
http://www.tectonics.caltech.edu/images/sumatra/coral_record_web.jpg

- Coral as natural record of relative sea-land movement (see Fig. 35) – Coral has been successfully used by researchers to study co-seismic and inter-seismic ground movements caused by inter-plate subduction earthquakes (Caltech 2011).

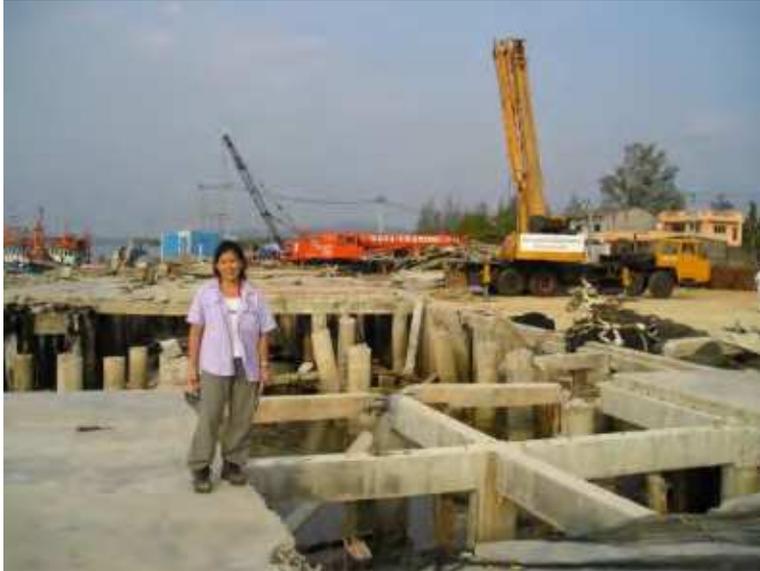
Fig. 36. Wharf Damaged by Wave Impact and Uplift, Bam Nam Kem, Phang Nga Province, Thailand, 2004.

- Forces associated with tsunami – In addition to the inundation effect of rapidly moving waves, tsunami also exerts additional physical forces to structures such as hydrodynamic pressure including uplift (see Figs. 36, 37 and 38), debris impact and wave scour (see Figs. 39 and 40). The overturning of seawalls could be caused by the combined effect of tsunami hydrodynamic pressure, uplift and scour. Both passive and active measures are used to mitigate tsunami damage. Passive measures are use of buffer zone and/or natural barriers such as mangroves and sand dunes to avoid building structures in near shore areas. Where structures are required in tsunami-vulnerable zone, both inundation effect and tsunami-related forces have to be considered in the overall design and operation of these structures. Well designed concrete buildings, which have crawl space on the first floor to allow tsunami flowing through, performed well (see Figs. 41 and 42). However, the “soft-story” effect under seismic loading condition should be carefully evaluated.

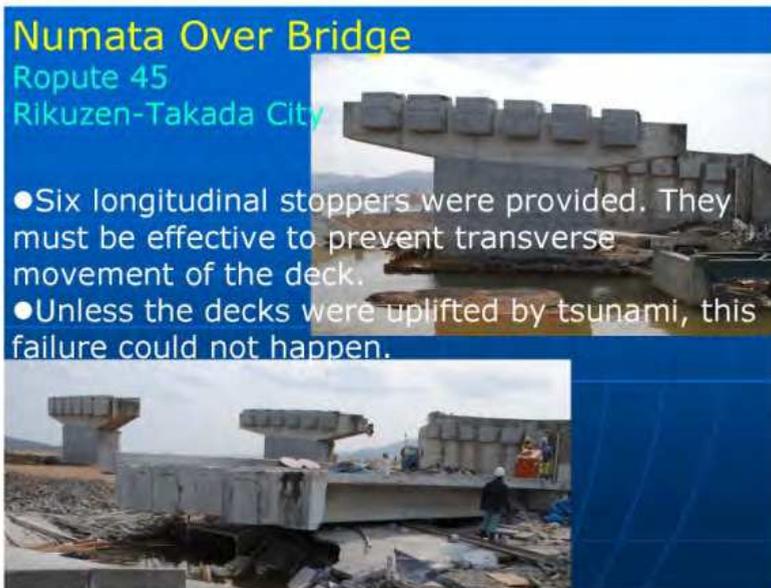
Fig. 37. Uplift of Bridge Deck In Spite of Longitudinal Stoppers – Tohoku Earthquake. (Kawashima 2011)

- The important impact of tsunami hydrodynamic pressure on the performance of port facilities and bridges have been recognized for some time, vertical restrainers to counteract the tsunami uplift force against bridge decks such as experienced in the Maule and Tohoku earthquakes are proposed by Kawashima (2011). Policy to require vessels leaving the ports and sailing to the sea upon receiving tsunami warning would prevent damage to the vessels as well as port infrastructures from vessel impact.

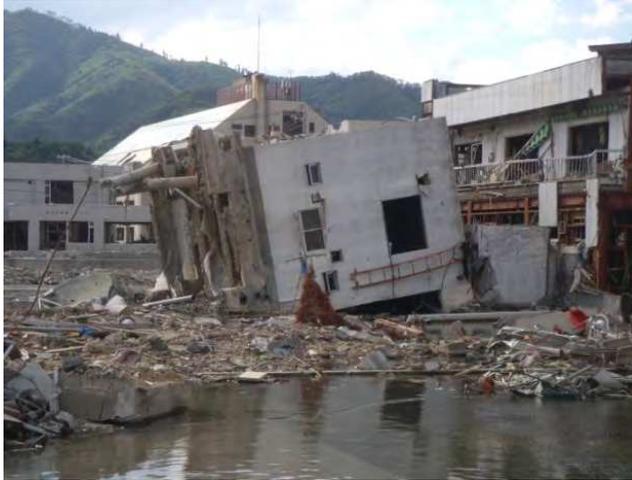
Fig. 38. Overturned Police Station, Onagawa, Japan, 2011.

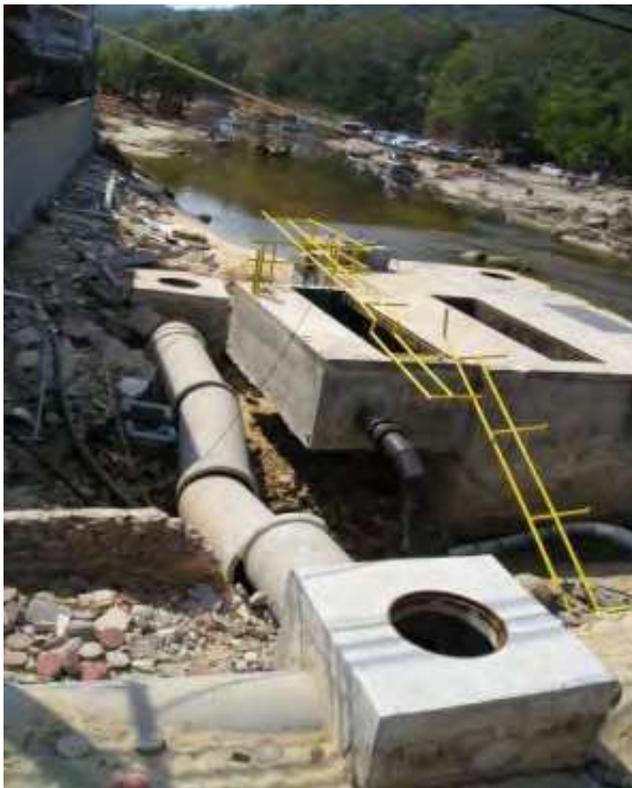
Fig. 39. Pump Station Damaged by Wave Scour, Patong Beach, Phuket Province, Thailand, 2004.

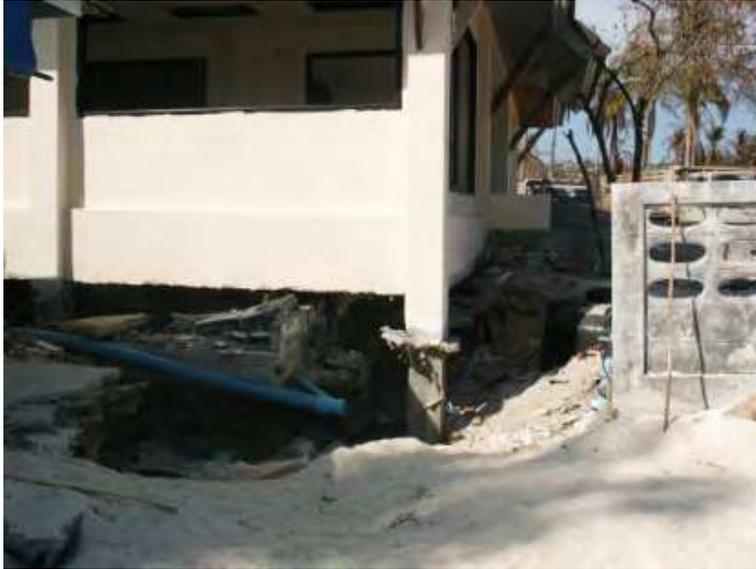
Fig. 40. Scouring of Foundation Soils and Severing of Building's Utility Lines, Phi Phi Island Hospital, Thailand, 2004.

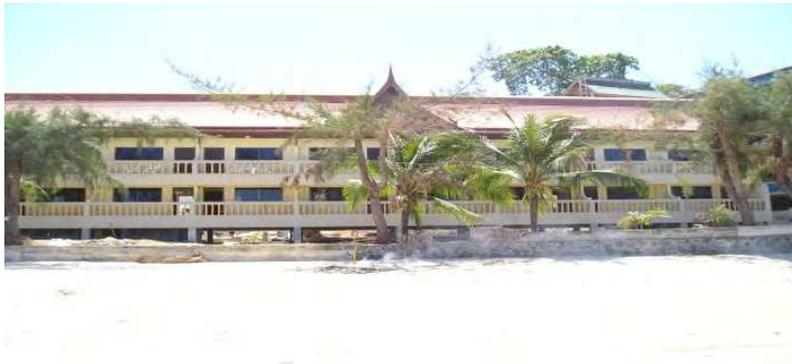
Fig. 41. Building with Crawl Space on the First Floor, Kamala Beach, Phuket Province, Thailand, 2004.

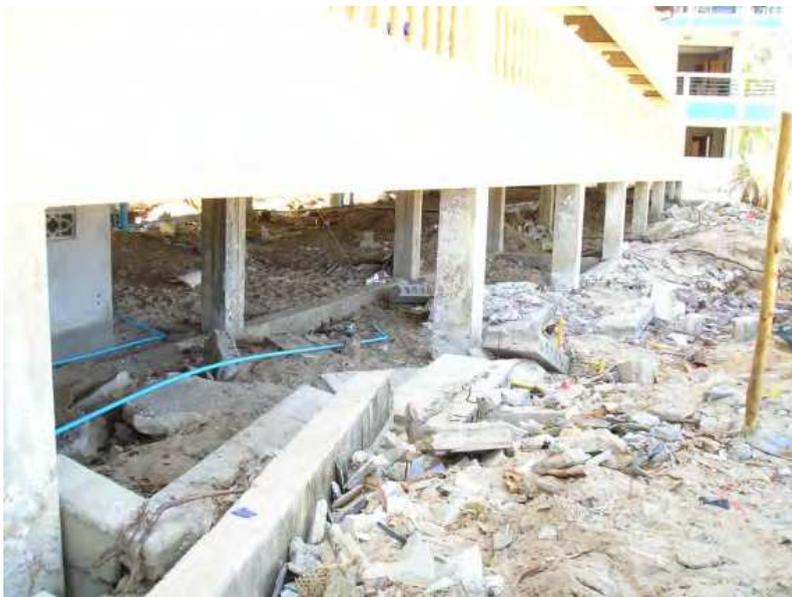
Fig. 42. Close-up of Fig. 41, Showing Inter-connected Grade Beams and Columns.

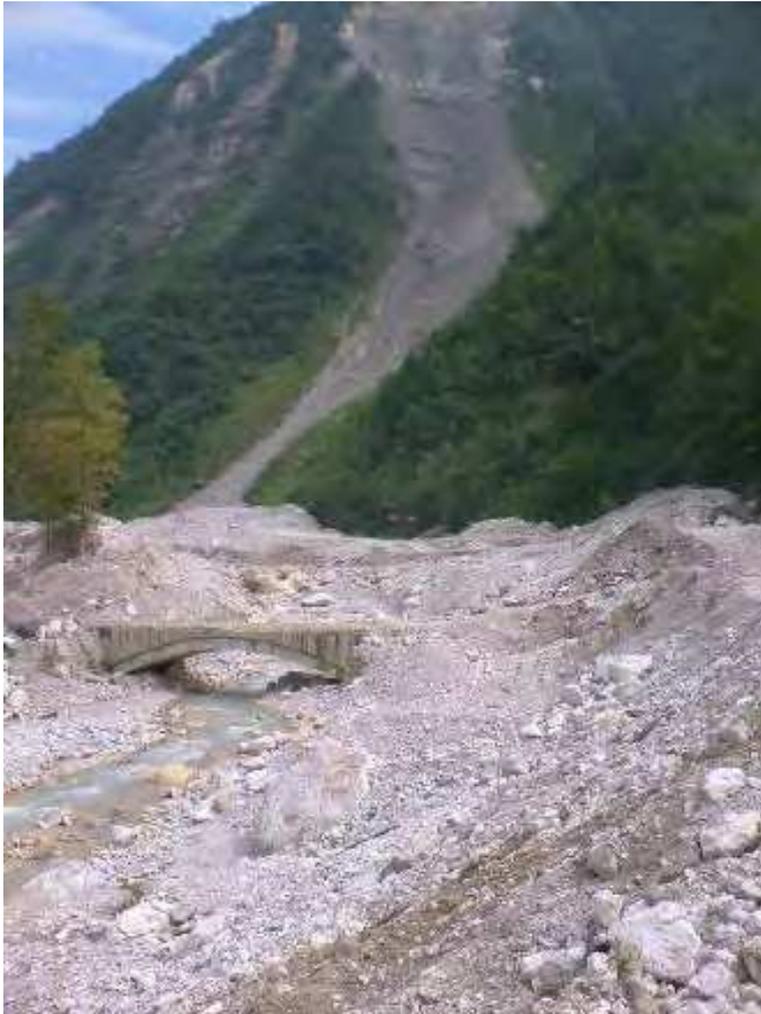
Fig. 43. Debris Flow at Huosigou, Chongzhou, China, 2008.

- Landslide – Correlations between the number of landslides and earthquake magnitude have been established around the world. In regions with pyroclastic deposits, the number of landslides for a given magnitude far exceeds those in other regions due to the relative large void ratio and weak strength of these deposits. The areas threatened by a landslide include the sliding land mass as well as the area traversed by the fast-

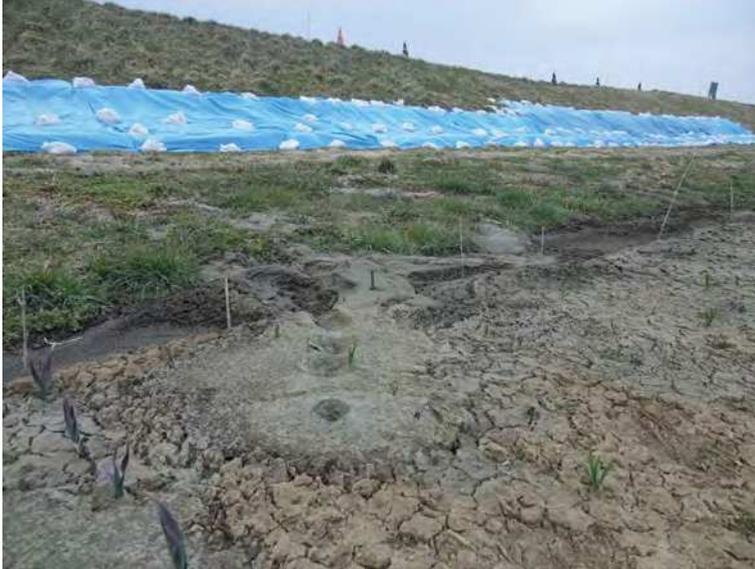
Fig. 44. Levee Slope Repair and Sand Boils at Toe, Japan. (JSCE 2011)

areas with high groundwater table, such as low-lying areas, river banks and ports, and lead to slope failure, lateral spreading, foundation horizontal displacement and settlement or uplift, bearing-capacity failure, and rupture of lifelines. Emergency repair of flood-control dykes or levees damaged by liquefaction of subsoils was often needed such as after Tohoku-Oki earthquake (see Fig. 44). The Tohoku-Oki earthquake caused levee damage at over 2,000 locations.

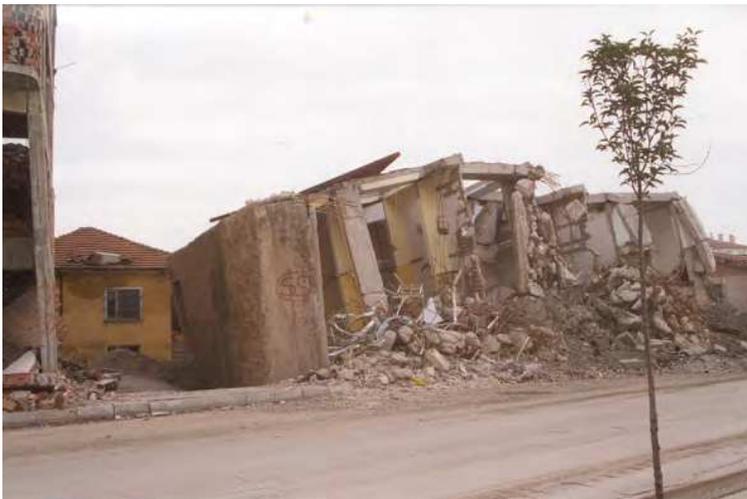
Fig. 45. Overturned Building of High Aspect Ratio in Adapazari City, Turkey, 1999.

- Bearing-capacity failure – Foundation bearing-capacity failure also occurs in cohesive soil due to the softening effect of earthquake shaking. The punch shear failure of footings is associated with soil heave in the adjacent area. For tall and narrow buildings with an aspect ratio (height/width) greater than 2, it could lead to severe tilting or

overturning of the building (see Fig. 45). This type of foundation behavior was observed in Mexico City due to the presence of sensitive Mexico City clay during the 1985 Michoacan earthquake, and again in Adapazari City due to the presence of Holocene alluvium during the 1999 Kocaeli earthquake.

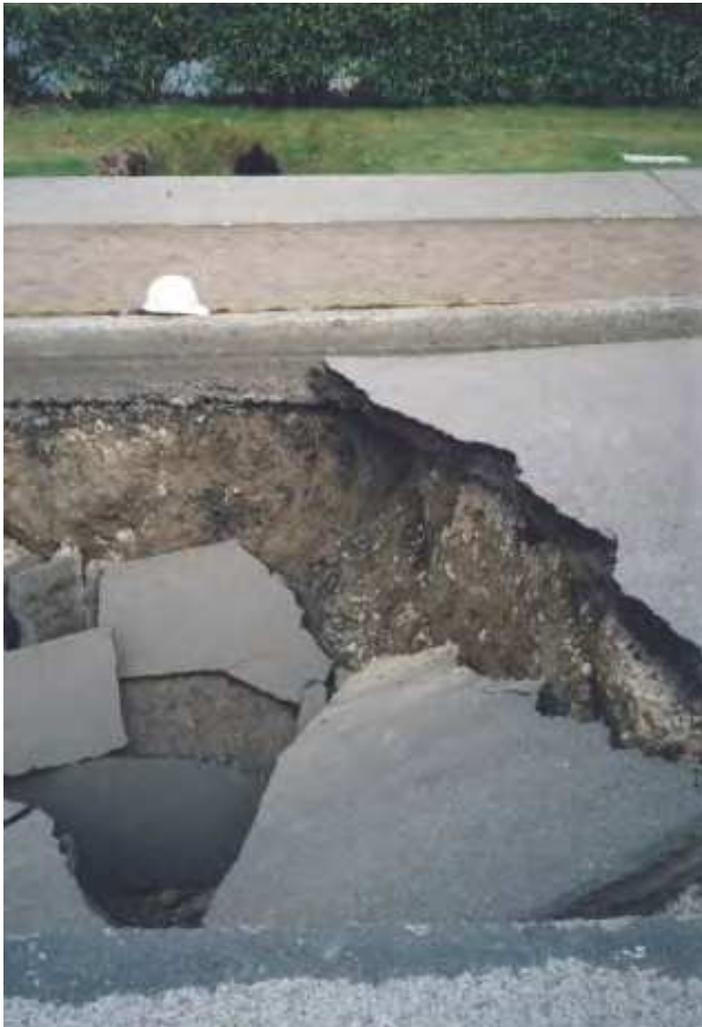
Fig. 46. Sinkhole Formed by Collapse of Roadway During Earthquake, Washington, 2001.

- Surface expression of underground failure – Sinkhole may occur during an earthquake. The phenomenon appears to be puzzling until the cause is identified. Usually, sinkhole

occurs where pre-existing underground voids already formed prior to the earthquake. These voids may be formed by solution of limestone, abandonment of mine workings or “piping” erosion of fine soils by groundwater flow. In other situation, earthquake-triggered failure of underground structure could also result in the formation of sinkholes. The former examples are sinkholes occurred along highway culverts in El Salvador and Nisqually earthquakes where “piping” erosion of backfill around the culverts was present (see Fig. 46), and sinkholes occurred at the abutment of Matahina Dam in New Zealand (Gillon and Newton 1991). The latter example is the sinkholes formed due to the collapse of Bolu Tunnels after the 1999 Düzce earthquake. At Christchurch, concern of voids formed underground due to massive loss of sand to the surface because of liquefaction was raised (see Fig. 26).

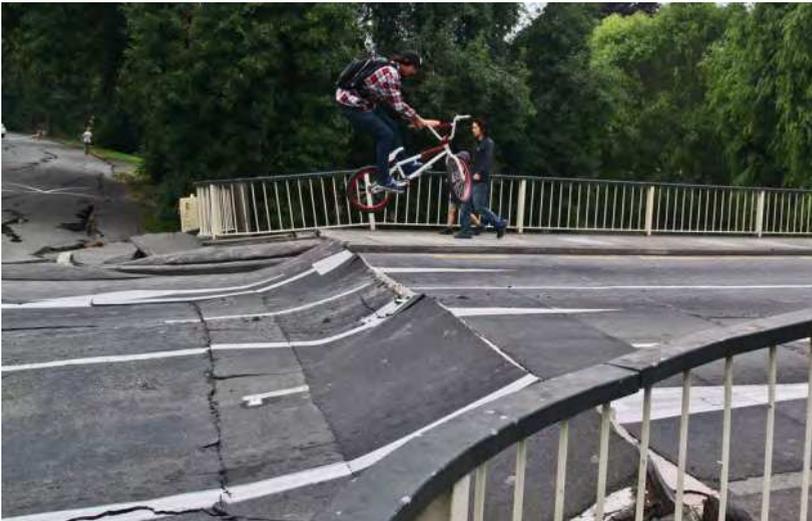
Fig. 47. Settlement of Approach Fill at Bridge Abutment Formed a Bike-Jump for a Youngster. <http://otilya.com/view/News/Asia-Pacific/New-Zealand>

- Ground displacement – Ground displacement includes tectonic movement or non-tectonic surface processes. When it occurs within the footprint of structures, it affects the structural stability and integrity. Where lifelines intersect fault traces, the impact of potential ground displacement related to fault rupture is a major design challenge as the experiences in Wenchuan, Kocaeli and Düzce earthquakes show. On the other hand, differential settlement of approach fill and pile supported bridge deck at bridge abutments is a frequently recurring scene, e.g., at Christchurch (see Fig. 47). Subsoil volume decrease would lead to foundation settlement with no adjacent soil heave.

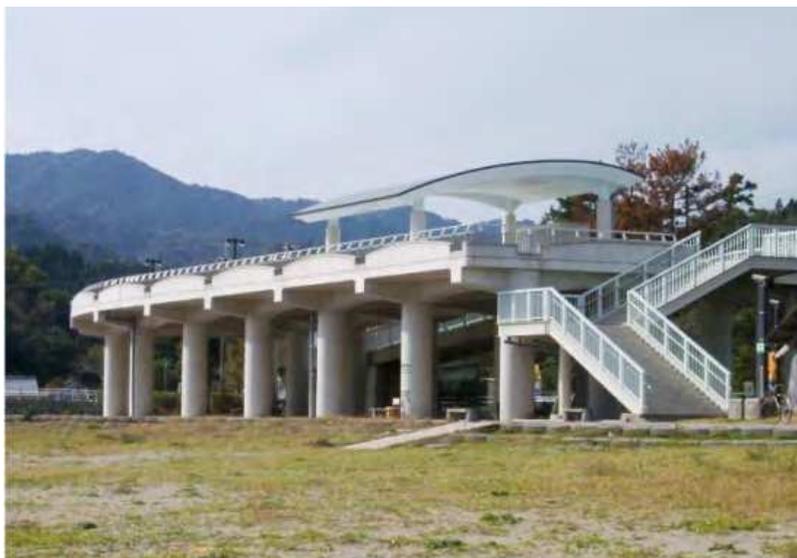
Fig. 48. Vertical Evacuation Structure at Shirahama Beach Resort in Japan. (FEMA 2009)

- Tsunami vertical evacuation refuges - are an engineering option for enhancing public safety against near-field earthquakes (FEMA 2008/2009). These structures should be clearly identified as tsunami-proof refuges. They need to be designed for both earthquake and tsunami loads, as well as to a safe height above the tsunami run-up, allowing for rapid public ingress and upward movement (see Fig. 48). As a cost-effective measure, any elevated structure in a tsunami-vulnerable zone such as water tower, lighthouse or fire-lookout tower could be designed with additional capacity and features to accommodate tsunami-escapees looking for an escape path.
