# Degradations of Incoloy 800 Steam Generator Tubing

## 1. Introduction

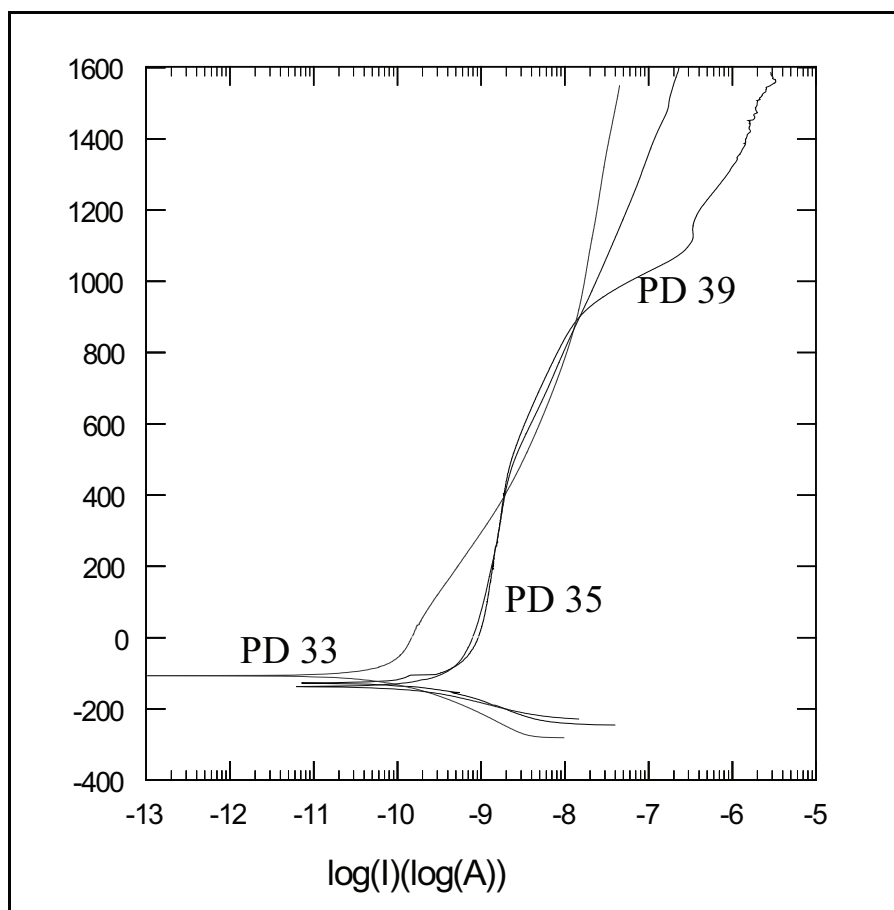
Fig. 12. Potentiodynamic curves Incoloy-800 tested pH=7.5: PD 33- as received; PD 35 - tested 10 days; PD 39 - tested 19 days

Fig.12 and Fig.13 show the results of electrochemical measurements performed by the potentiodynamic method. The electrochemical potential values measured in demineralised water at a pH=9.5 for samples tested by autoclaving at a pH=7.5: PD 35 - tested 10 days, PD 39 - tested 19 days and PD 33- initial status; and pH=8.5 for samples tested by autoclaving at a pH=8.5: PD 36 - tested 10 days, PD 37 - tested 47 days, PD 38 - tested 96 days and PD 34- initial status, show that the oxide films formed on the samples surface at higher exposure times provides them a relatively high corrosion resistance.

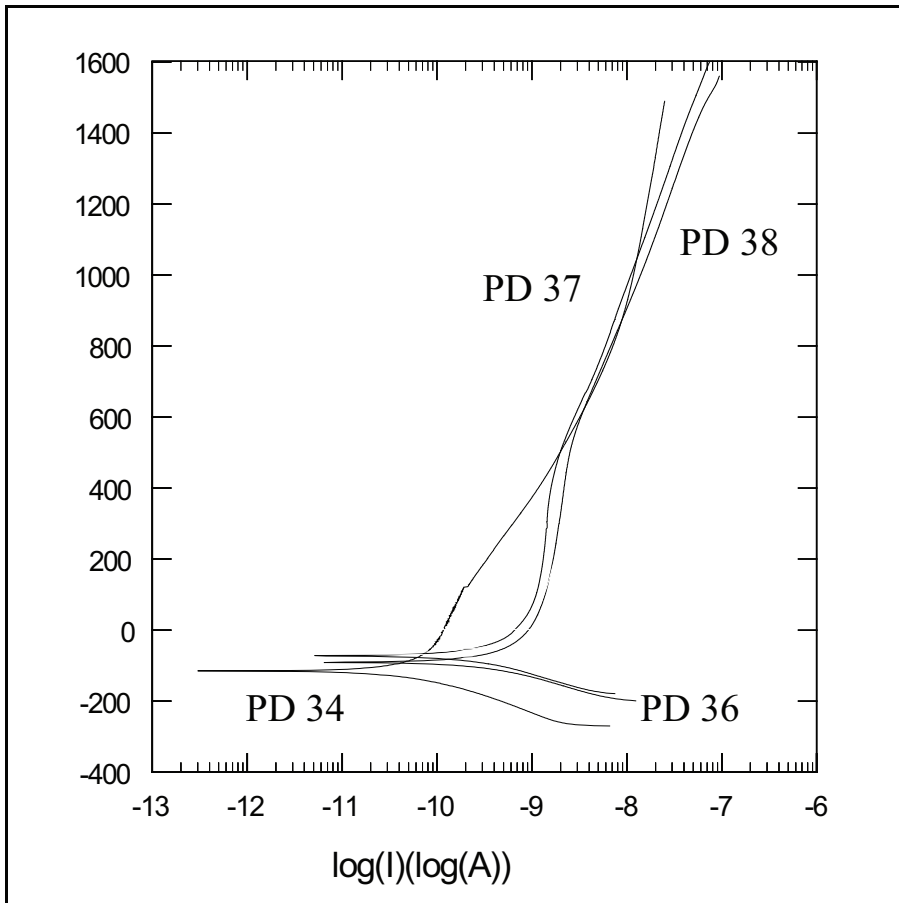
Fig. 13. Potentiodynamic curves Incoloy-800 tested pH=8.5: PD 34- as received; PD 36 - tested 10 days; PD 37 -tested 47days; PD 38 - tested 76 days
