Recent Landslide Damming Events and Their Hazard Mitigation Strategies

Ahsan Sattar and Kazuo Konagai
Institute of Industrial Science, University of Tokyo
Japan

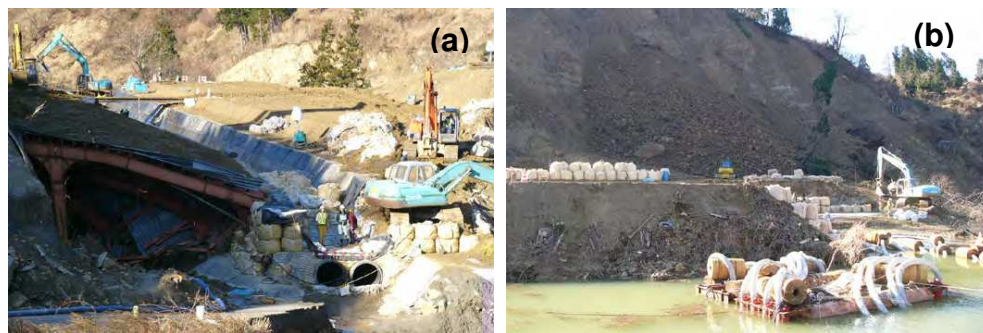
Fig. 4. Emergency works at Higashi Takezawa landslide dam. Photo taken on 20.12.2004 by Takeji & Tadashi, 2005

The following steps have been taken for stabilizing the landslide mass: twelve pumps were installed first to lower and keep the lake water level 11.5 m below the overflow point. In addition, the outflow level was raised by 3 m with sand bags at the outlet. Keeping in view the pumping power for this temporary system, diversion pipes were installed in case water overtopped the landslide mass (Fig. 4). Finally, a 280m long concrete-faced spillway was constructed with its cross-section large enough for snow melts.

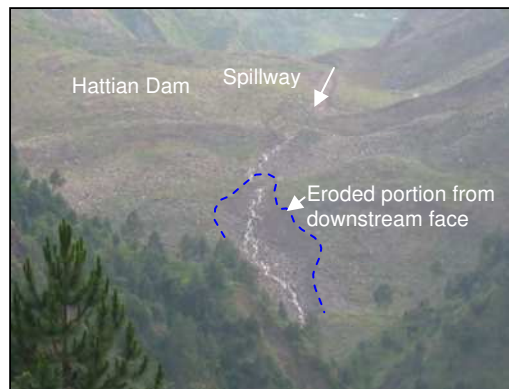
Fig. 7. Front view of the Hattian landslide mass, showing the downstream face erosion.

Gradual toe erosion was initially observed, which was then followed by a rapid head cutting erosion of the downstream face of the dam (Fig. 7). On 9th February 2010, the water of Karli Lake breached the debris dam after five days of incessant rain, and the breaching drained about 36 million m^3 of water from the lake. According to the back analysis conducted by Konagai, et al., (2011) the peak outflow was about 5500 m^3/s . A moderate 32 mm/day rainfall was estimated on the day prior to the day of breaching. About 7.78 million m^3 of soil was estimated to have been eroded during the breaching event. The flushed debris mass was deposited along the Karli River. Fig. 9 shows the satellite image and profile of the Karli River before and after the breaching. A major portion of the eroded material is deposited over the approximately 2km downstream stretch from the dam along Karli River and less significantly beyond the stretch. The flow along the Karli River reached the depth up to 20 m. The debris deposit was about 40 m thick near the toe of the dam.

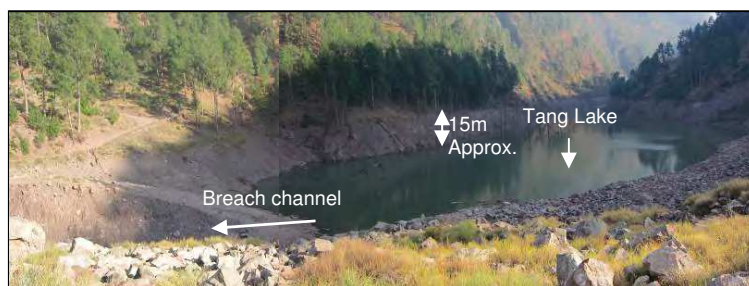
Fig. 12. Tang Lake after breaching (Photo taken on 6th Dec-2010). From Konagai et al., 2011

The Tang Lake breached during the monsoon rains (July-August) of 2010. In the breaching process, the water from Tang Lake eroded the north-eastern end of the landslide lobe, which had been covered with boulders segregated up at the time of deposit, and approximately 15 m depth of the lake water was drained leaving 1.9 million m^3 water in the lake (Fig. 12).
