Chapter from the book *Modern Pacemakers - Present and Future*

Common Pacemaker Problems: Lead and Pocket Complications

Enes Elvin Gul and Mehmet Kayrak
*Selcuk University,
Meram School of Medicine,
Cardiology Department Konya,
Turkey*

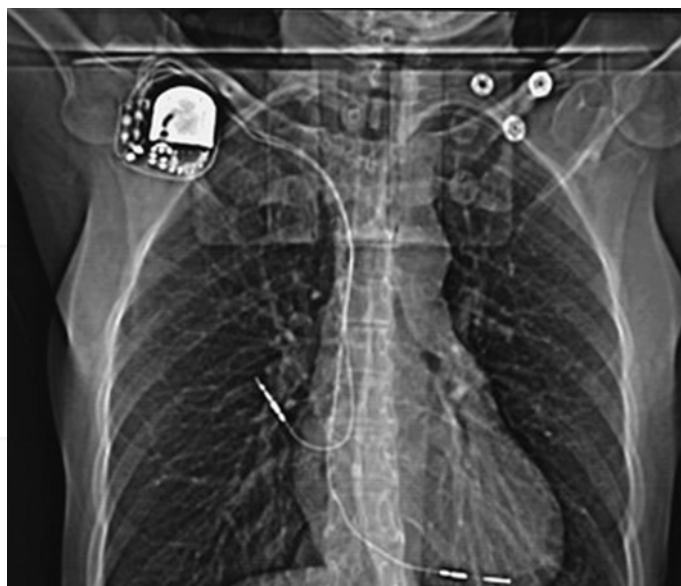
Fig. 5. Chest X-ray demonstrating severe lead perforation due to implantable cardioverter-defibrillator implantation.

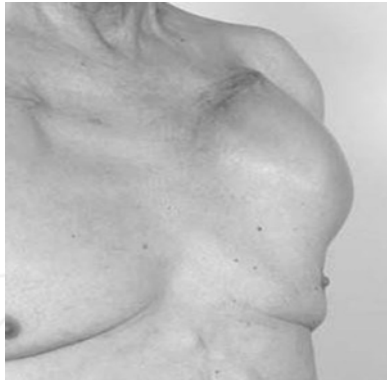
Fig. 8. Pocket hematoma

Hematomas occurring at the pacemaker pocket site can vary from a small ecchymosis to large and tense swelling (Figure 8). The risk of haematoma is increased in patients taking antithrombotic or anticoagulant drugs (Goldstein et al., 1998). Most small hematomas can be managed conservatively with cold compress and withdrawal of antiplatelet or antithrombotic agents. In patients requiring oral anticoagulants (warfarin), to take INR of about 2.0 at the time of implantation is safe (Belott & Reynolds, 2000). Unfractionated heparin or low-molecular-weight heparin are always discontinued prior to device implant and ideally avoided for a minimum of 24 hours post implantation. Administration of anticoagulants can be resumed within 48-72 h after implantation if there is no evidence of substantial hematoma formation. Occasionally, large hematomas that compromise the suture line or skin integrity may have to be surgically evacuated. Evacuation of the hematoma is very rarely needed (<0.5% of cases). Needle aspiration increases risk of infection and should not be done. Aspiration should be considered only if there is continued bleeding, potential compromise of the suture line or skin integrity, or pain refractory analgesics (Pavia & Wilkoff, 2001).

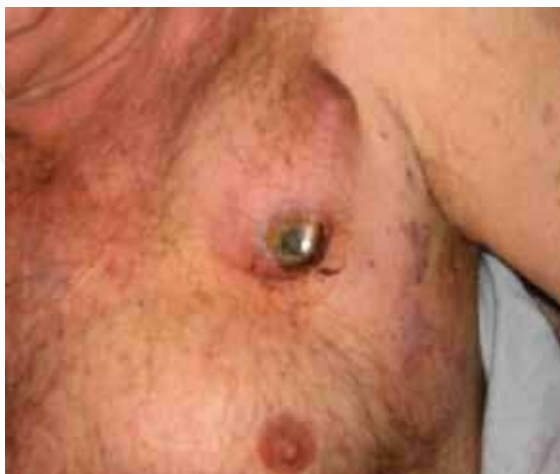
Fig. 9. Erosion of the automated implantable cardioverter-defibrillator (AICD).

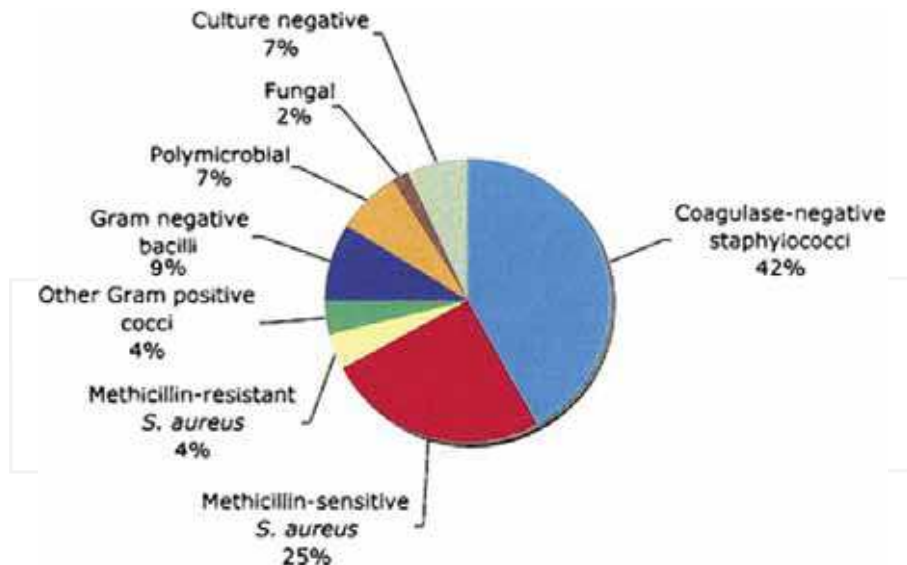
Fig. 10. Microbiology of permanent pacemaker/ICD infections (With permission of: Sohail MR, Uslan DZ, Khan AH et al. Management and Outcome of Permanent Pacemaker and Implantable Cardioverter-Defibrillator Infections. J Am Coll Cardiol 2007; 49:1851-9).

Early infections are most commonly caused by *Staphylococcus aureus* and late infections most commonly by *Staphylococcus epidermidis*, although infections by *Staphylococcus lugdunensis* (Anguera et al., 2005), *Streptococcus bovis*, *mitis*, and *sanguis*, *Pseudomonas* (Laguno et al., 1998), enterococci and fungi and even *Mycobacterium fortuitum* (Sharma et al., 2005) have been described (Figure 10).
