Fouling in Plate Heat Exchangers: Some Practical Experience

Ali Bani Kananeh and Julian Peschel
GEA PHE Systems
Germany

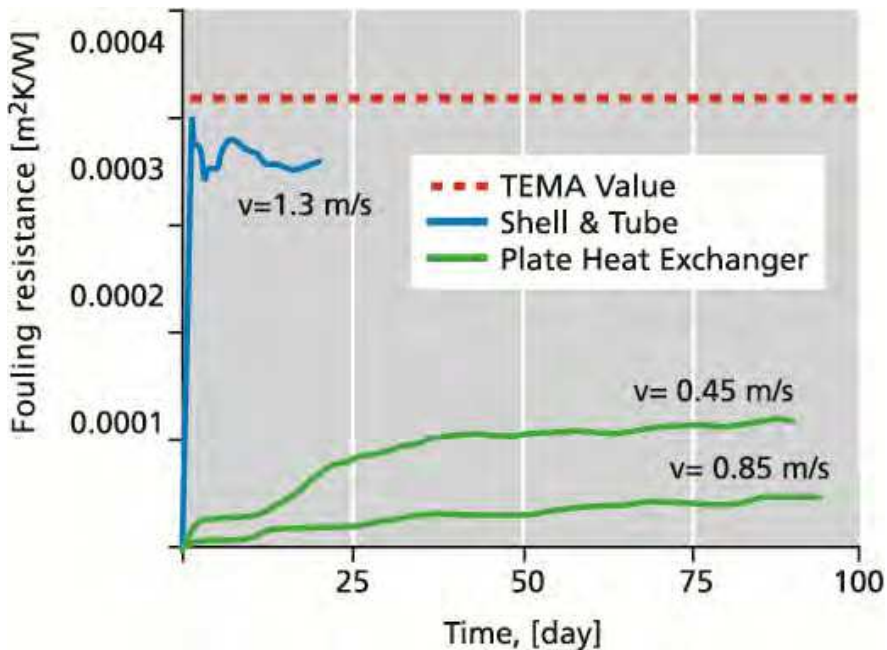
Fig. 2. Comparison of fouling resistance in PHE to tube-side fouling resistance (Müller-Steinhagen, 2006).

The manner in which fouling and fouling factors apply to plate exchangers is different from tubular heat exchangers. There is a high degree of turbulence in plate heat exchanger, which increases the rate of deposit removal and, in effect, makes the plate heat exchanger less prone to fouling. In addition, there is a more uniform velocity profile in a plate heat exchanger than in most shell and tube heat exchanger designs, eliminating zones of low velocity which are particularly prone to fouling. Figure 2 shows the fouling resistances for cooling water inside a plate heat exchanger in comparison with fouling resistances on the tube-side inside a shell and tube heat exchanger for the same velocity. A dramatic difference in the fouling resistances can be seen. The fouling resistances inside the PHE are much lower than that inside the shell and tube heat exchanger.

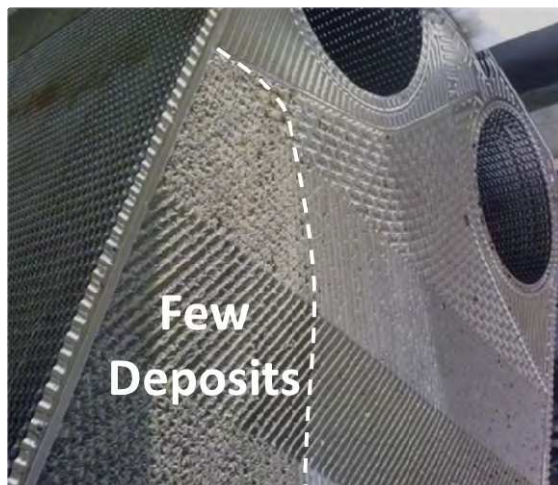
Fig. 8. Deposits formed on the surface of NT-plate.

Fewer deposits were accumulated on the NT-plates due to the asymmetric flow distribution over the channels as can be seen in Figure 8. These deposits were formed because the unit was taken into operation in parallel with the old two VT-plates units and hence most of the cooling water was flowing inside them. The NT-plates unit was designed in principle to replace one of the VT-plates units so that the gap velocity could be increased.

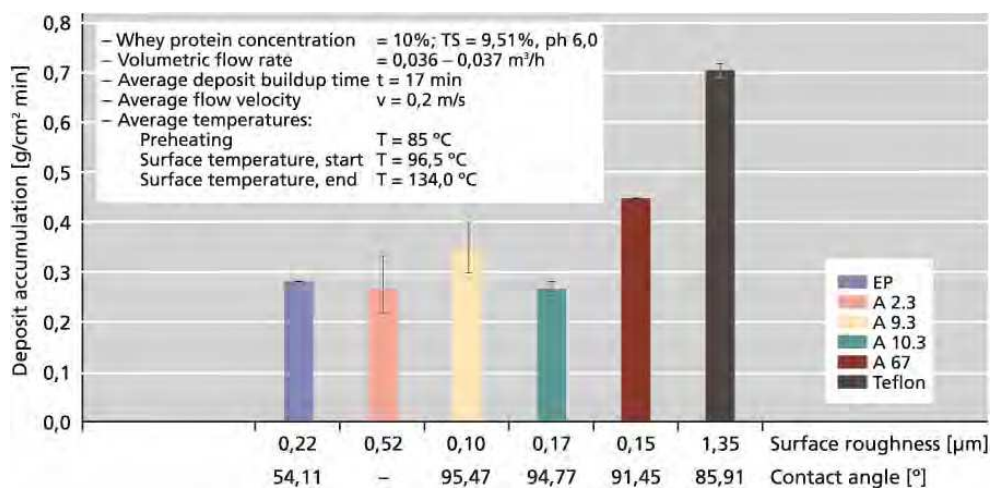
Fig. 12. Deposit accumulation rates for laboratory tests with whey protein on small coated cylindrical ducts. Plate characteristics are given in Table 6.

Laboratory investigations were carried out by IUUV on the deposit of whey protein on the tube surface. Different stainless steel tubes were tested by IUUV using the laboratory heat exchanger apparatus described in section 3.2. Figure 12 shows the deposit accumulation rates of whey protein solution for the different tube surfaces.

The Polyurethane-coated tubes gave the thinnest deposit layer, closely followed by the electropolished tubes. The laboratory cleaning tests showed that under the same hydrodynamic conditions, the cleaning time for test tube A9 is only 20% of that needed for the standard stainless steel tube.

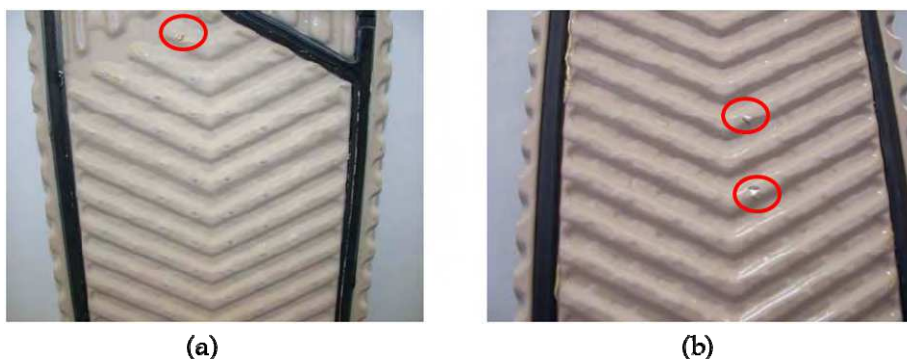
Fig. 14. Coated heat exchanger plates from heating section: (a) A2 coating, (b) A10 coating.

Figure 14 shows photographs for two different coated plates from the heating section in the heat exchanger after different experimental runs (A2 on left and A10 on right).

It is evident that the coatings have been locally destroyed at the contact points, as pointed by the red circles in the figure. The flow in the plate gap causes relatively high vibrations with particularly strong stresses to the contact points, which is added to the high thermal stresses. The coatings at the present stage of development could not withstand these stresses and need further development.
