# Application of Thermography in Materials Science and Engineering

Alin Constantin Murariu, Aurel - Valentin Bîrdeanu, Radu Cojocaru,  
Voicu Ionel Safta, Dorin Dehelean, Lia Boțilă and Cristian Ciucă  
*National R&D Institute of Welding and Materials Testing – ISIM Timișoara  
Romania*

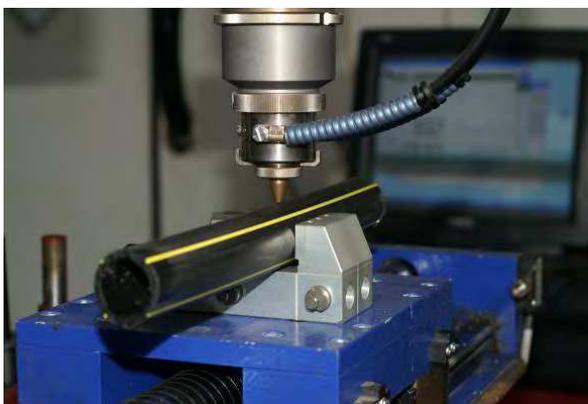
Fig. 1. LSI experimental setup

Using the active thermography, a method for quality assessment of HDPE pipes was developed and, in order to reveal the new method’s sensitivity, an experimental program was designed using pipe specimens with longitudinal simulated imperfections. The imperfections were performed using Laser Simulated Imperfection - LSI method (Murariu & Birdeanu, 2007), and activation was done with water at 80°C. For simulating the imperfections in the base material a Nd:YAG laser Trumpf HL 124P LCU (Trumpf GmbH, Ditzingen, Germany) with a fibreglass connected cutting head was used (figure 1).

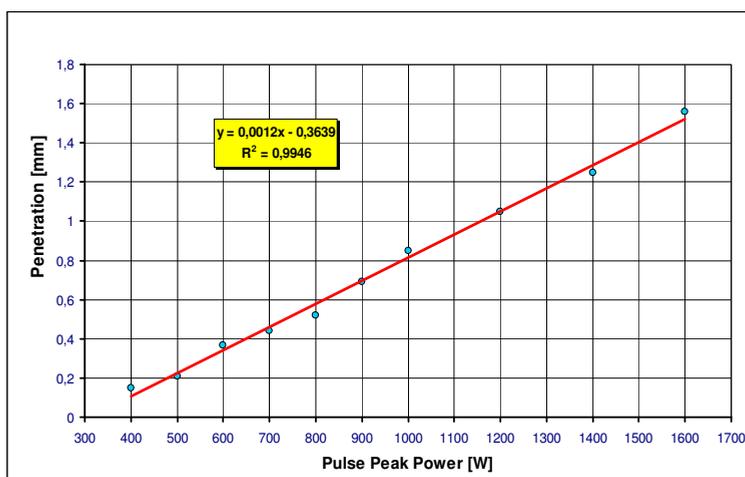
Fig. 2. LSI calibration - fitted experimental data

The data was graphically fitted (figure 2) and the corresponding equation describing the penetration depth variation as a function to the pulse peak power for the targeted domain was established. Using the mathematical equation it was possible to calculate the pulse power peak necessary to simulate the required imperfections in the material. Furthermore, the calculated parameters were verified by doing a set of experiments and measuring the penetration depths and it was determined that the measured data corresponded to the calculated one in respect to the experimental errors.

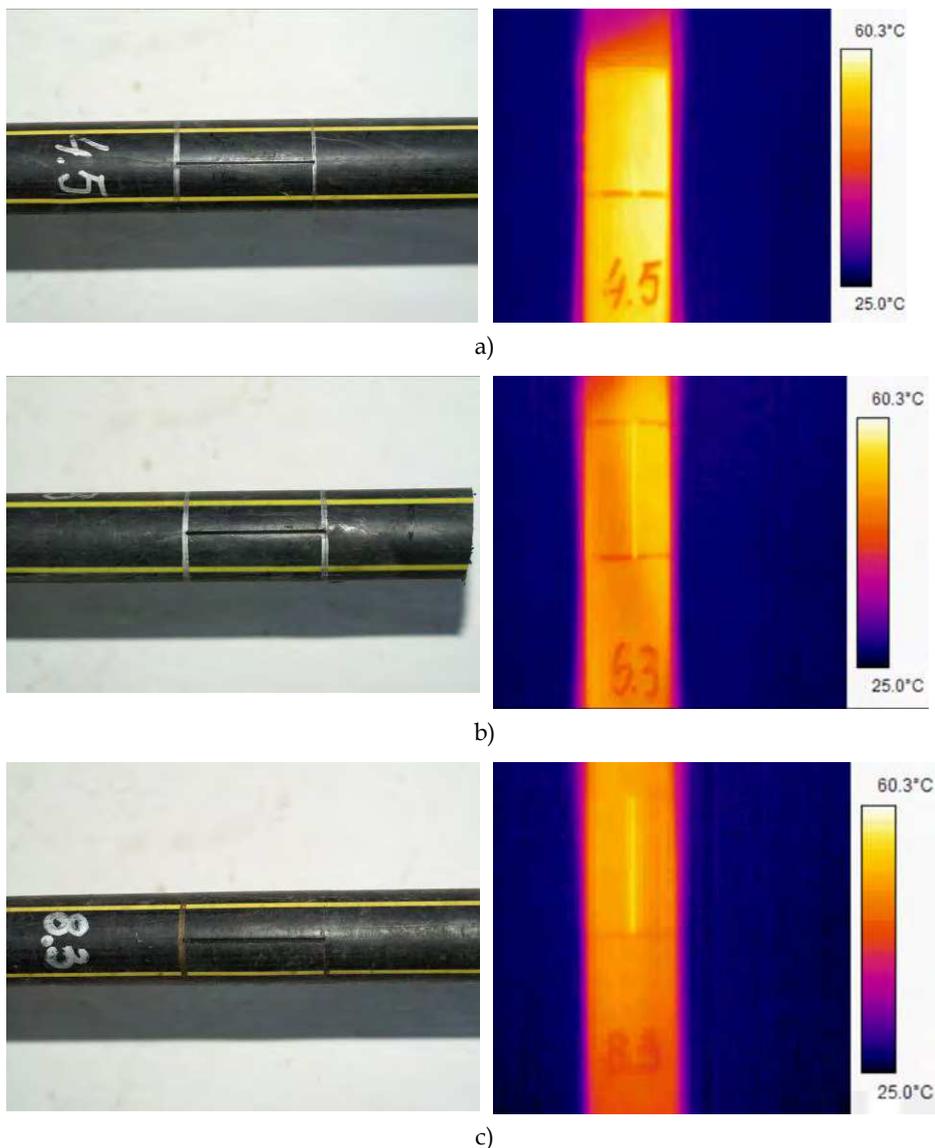
a) relative notch depth  $A=5\%$  of the pipe wall thickness b) relative notch depth  $A=10\%$  of the pipe wall thickness c) relative notch depth  $A=40\%$  of the pipe wall thickness

Fig. 3. PE 80 pipes with LSI simulated imperfections examined by thermography

In order to estimate the sensitivity of the method, an experimental program was performed using PE80, DN 32, SDR11, GAS pipes and the longitudinal notch with depths between 0.15 mm and 1.5 mm have been created using LSI method. Thermographic examination results are shown in Figure 3. The thermographic images were analyzed and the imperfections were revealed. The minimum notch depth which could be detected was  $h=0.15\text{mm}$  for a pipe with wall thickness  $e=3.0\text{mm}$  (imperfection has a relative size of  $A=5\%$  of the component wall thickness) but one could consider that the use of an automated computer analysis of the thermographic images, can improve the limit of the detection.

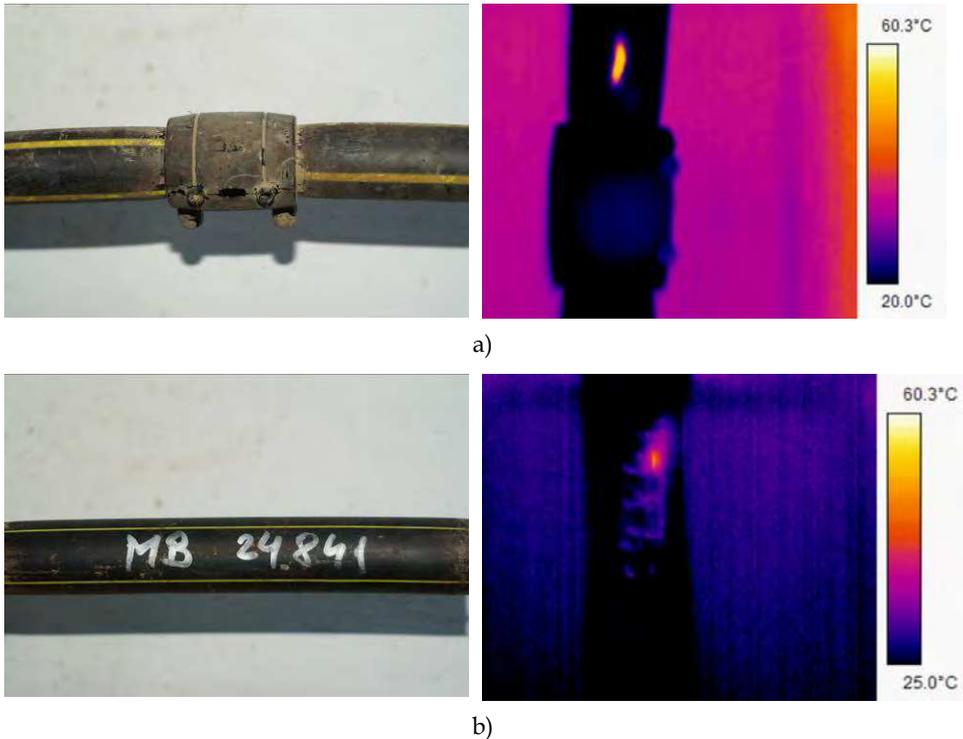
Fig. 4. PE 80 pipes with flaws obtained on hydrostatic inner pressure test at a constant temperature (80°C and 10 bar); a) sleeve welded joints with flaws in the MB, b) PE 80 pipe cracked after 24841 hours of testing

After the calibration and the evaluation of the method's sensitivity, experimental measurements were performed on pipes with real flaws obtain by hydrostatic inner pressure at constant temperature after different testing durations. The results are shown in Figure 4.

The experiment did show that by using thermography method and transient temperature regime obtained by thermal activation with warm water, filiform defects of thermoplastic pipes can be detected. This rather fast and accurate method can also detect defects which are sometimes more difficult to identify using other NDT methods, e.g. ultrasound, X-Ray.

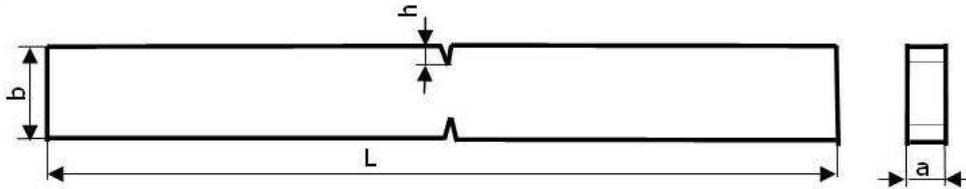
Fig. 5. Blueprint of the samples with bilateral V notch

thermoplastics or advanced materials for stress raiser sensibility evaluation of materials or products in the elaboration/fabrication phase and also after an in-exploitation duration. The experimental program used samples extracted from PE 80 SRD 11 GAS  $\phi 160 \times 15.5$  mm polyethylene pipes. Strip samples with width  $b=20.0$  mm and thickness  $a=15.5$  mm were cut from sample pipes with length  $L=200$  mm. Simulated imperfections were realized by mechanical processes (milling) and consisted in transversal cuttings with angle of the flanks of  $45^\circ$  and with top radius of  $0.25$  mm (figure 5). Five sets of ten samples with notch depth  $h=1.0, 1.5, 2.0, 2.5$  and  $3.0$  mm were prepared.

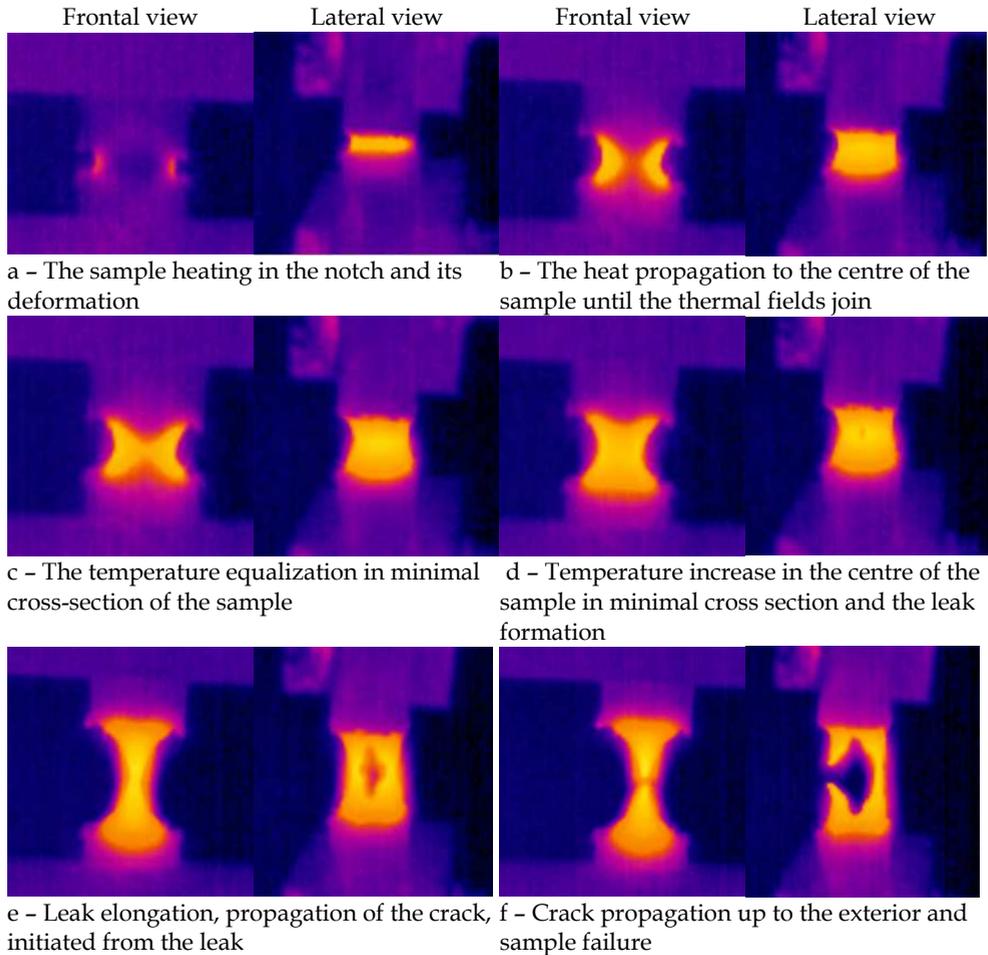
Fig. 6. The fracture dynamic of a sample with V notch

The experimental setup included a universal mechanical testing machine, an air conditioning room and an infrared thermography camera. The clamping dies speeds of the tensile loading machine were,  $v=1, 5, 10, 25, 50, 75, 100, 125, 150$  and  $650$  mm/min. The test was performed at room temperature ( $23 \pm 2^\circ\text{C}$ ). The thermographic camera did record the caloric energy emission during the tensile loading process of the sample and temperatures of the interest zones (stress raisers zone created by the presence of the plane imperfections) were monitored. The method did allow the analyses of the thermal image of the tested samples, which distribution is modified during the testing. The surface temperature values in the imperfection simulated zone were recorded and correlated with the applied stress levels. Thus the method allows studying of the defects' severity and their evolution together with the reaction of the adjacent material due to loading process. The tests proved the tensile strength, the identification of the fracture type and the fracture position, under controlled tests condition: temperature, loading rate. It was determined that the recorded temperatures during the tensile tests are correlated with the local stress condition induced by the loading of the specimen which has geometrical discontinuities. Also it was highlighted that the sample failure is determined by the appearance of "hot" spots in the breaking cross-section. This spots are specific to each type of imperfection and do determine the sample's failure dynamic. Figure 6 shows the possibility of using infrared thermography to failure dynamics analysis of samples with simulated defects.

Next, to prove the way in which the temperature modifications during the testing do influence the failure's character, the aspect of the tested samples' surface failure was analyzed in cases of samples for which the notched area represents 10 and 30% of the transversal cross section of the sample. Figure 7 presents the surface aspect of a sample fracture by axial loading with clamping dies speed of  $650$  mm/min. The sample presents bilateral V notches with  $h=1$  mm depth, occupying 10% from the transversal cross section area. Figure 8a, presents the fracture surface of a sample with bilateral V notches with  $h=3$  mm depth, affecting 30% of the transversal cross-section area. The tests were similar to the previous ones. One can observe that, depending on the fracture's character, the sample

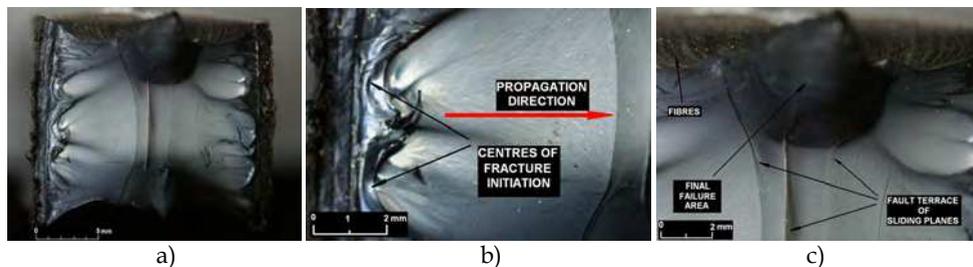
Fig. 7. The breaking surface of a sample with bilateral V notches with  $h=1\text{mm}$  depth and  $v=650\text{ mm/min.}$ ; a - failure surface, b - aspect of the fracture initiation zone, c - aspect of the final fracture zone.

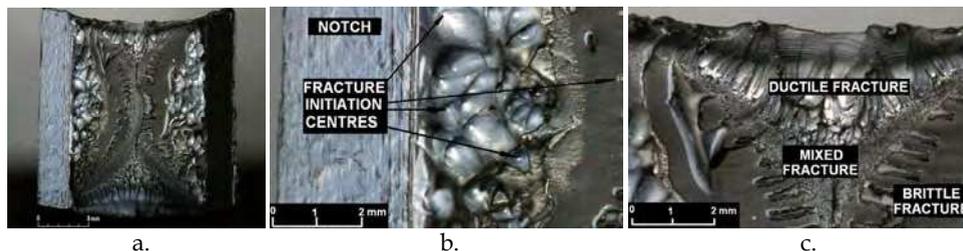
Fig. 8. The breaking surface of a sample with bilateral V notch with  $h=3$  mm depth and  $v=650$ mm/min.; a - The breaking surface, b - The breaking initiation centres, c -The areas with ductile, fragile or mixed breaking

presents bi-axial symmetry. In the transversal fracture surface of the sample multiple fracture initiation centres (figure 8b) are observed with a spherical shape when they are single, or elongated if they are grouped. In the fracture surface both ductile fracture areas, with significant deformations and slipping areas near the breaking initiation centre, and fragile fracture areas without significant deformations (figure 8c) are present.

The modification of the fracture's character is explained by the difference in the sample temperatures in the transversal cross section, during the tensile test. Thus, the sample's temperature is higher in the V notch which is a stress raiser and in the centre of the lateral surfaces, a fact that was confirmed by thermography. The apparition of the fragile failure is explained by the fact that the test was made at high rate ( $v=650$ mm/min.) in the conditions of a 30% decrease of the fracture's section. Because the time was insufficient to achieve a uniform temperature in the transversal cross section, the sample fracture took place by different failure mechanisms; the fracture's character was influenced by the local stress distribution and temperature.

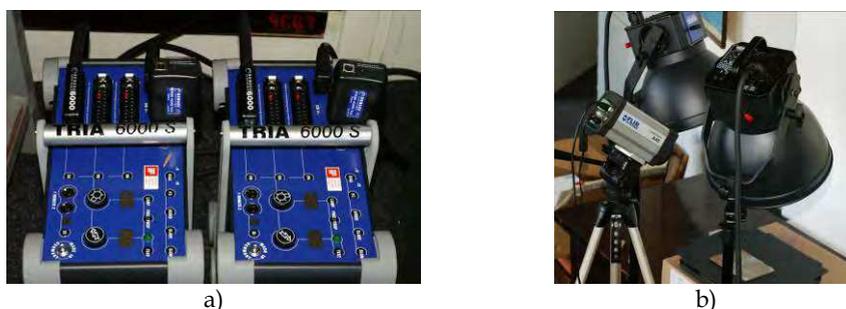
a) Generators; b) Flash lamps and thermographic camera

Fig. 9. Activation system – experimental setup

The following is an example of active thermography used for quality assessment of thermal spray coated surfaces. The proposed activation system (figure 9) is composed of 2 generators and two flashbulb based lamps with the necessary accessories, which ensure the activation energy and its uniform distribution on the tested object. To evaluate the quality of the layers deposited by thermal spraying, using the active thermography method, artificial defects were machined on testing specimens according to an experimental program using

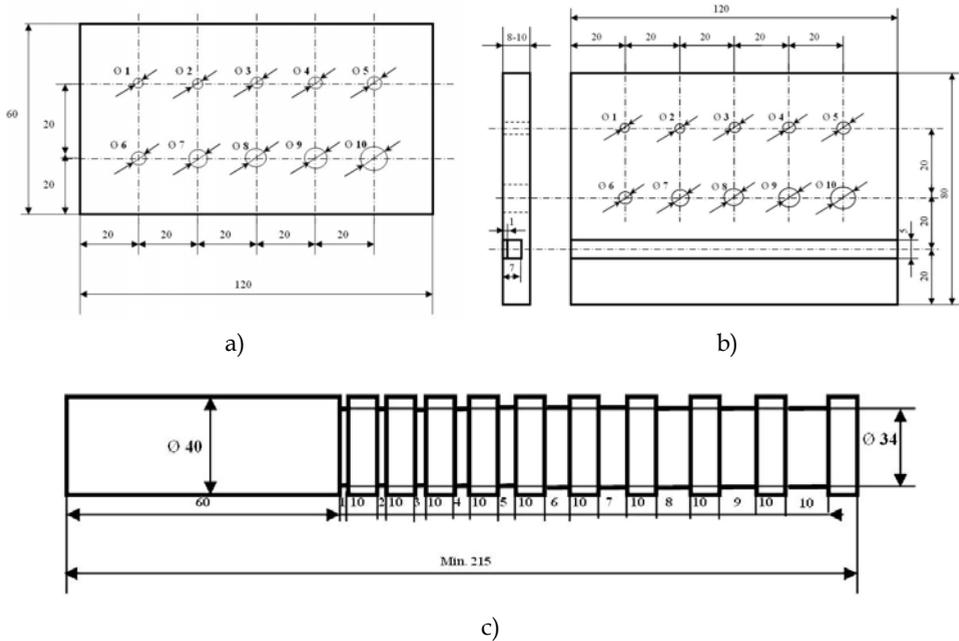
- a) Type 1 test piece cu with  $\varnothing 1$  to  $\varnothing 10$  mm hole-type simulated defects  
 b) Type 2 test piece with  $\varnothing 1$  to  $\varnothing 10$  mm hole-type simulated defects and a notch (channel) with variable depth between 1 and 7 mm.  
 c) Type 3 test piece with 1 to 10 mm wide, simulated notches

Fig. 10. Test piece for thermographic test of the layers deposited by thermal spraying

The test pieces with artificial imperfection were realized according to the sketches presented in figures 10. The holes and notches were filled with a Poxiline-type polymeric material, the surfaces being afterwards polished, sand blasted and cleansed with technical alcohol. Using the electric-arc thermal spraying procedure, a metallic layer was deposited on the surfaces with artificial flaws, using the following materials: Metco/ZnAW zinc wire,  $\varnothing 1.62$  mm and Metco/Tin Bronze wire,  $\varnothing 1.62$  mm.

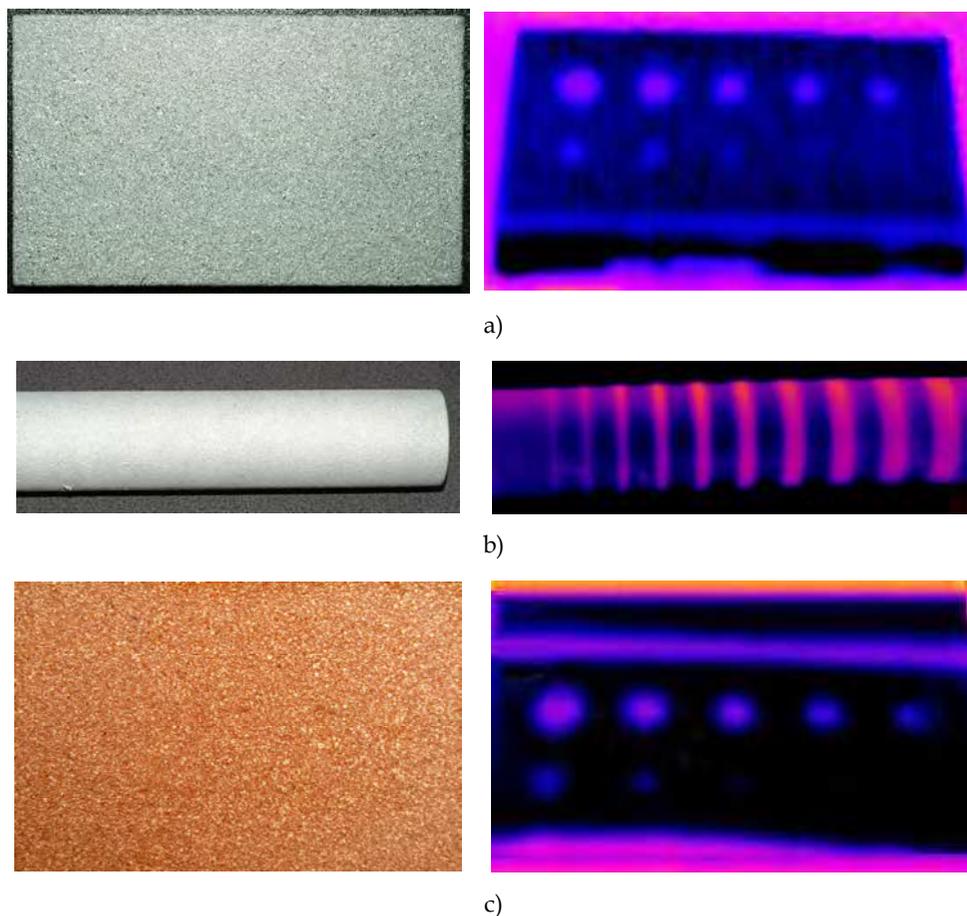
- a) Test specimen - zinc coating,
- b) Test specimen - zinc coating,
- c) Test specimen - bronze coating

Fig. 11. Active thermography testing of metallic coatings;

Figure 11 presents, comparatively, the images of the test pieces with simulated flaws and their thermal images.

One could observe that the examination's sensitivity is influenced by the temperature of the examined part and by the coating material type. A lower temperature of the tested part leads to a more accentuated thermal contrast and a better flaw's detection. It was also established that a maximal thermal contrast is obtained after a certain period after the thermal activation (triggering the flashbulbs), and both the maximal temperature registered in the flaw area and the time after which the contrast is maximal depend on the flaw dimension.

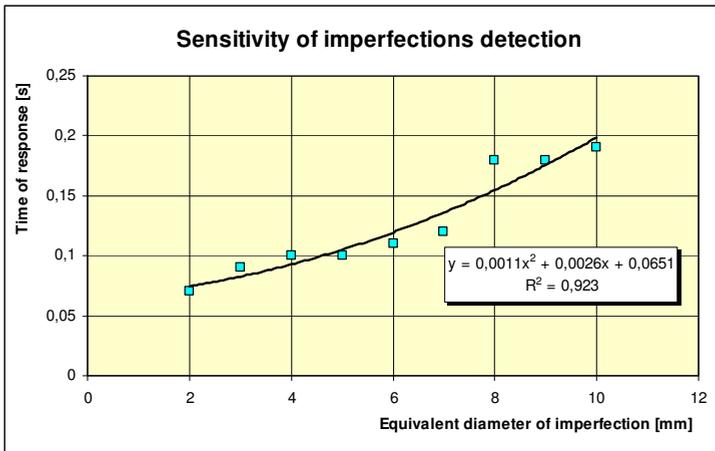
Fig. 12. Sensitivity of imperfections detection curve

Figure 12 presents the sensitivity curve for imperfections detection related to a thermal spraying coated surface obtained using electric-arc thermal spraying procedure, S235J2 steel for substrate and bronze wire (Metco/Tin Bronze cu Ø 1.62mm). Figure 13 presents the correlation between maximal surface temperatures recorded during the thermographic examinations versus the imperfections sizes, for the same type of coated surface.

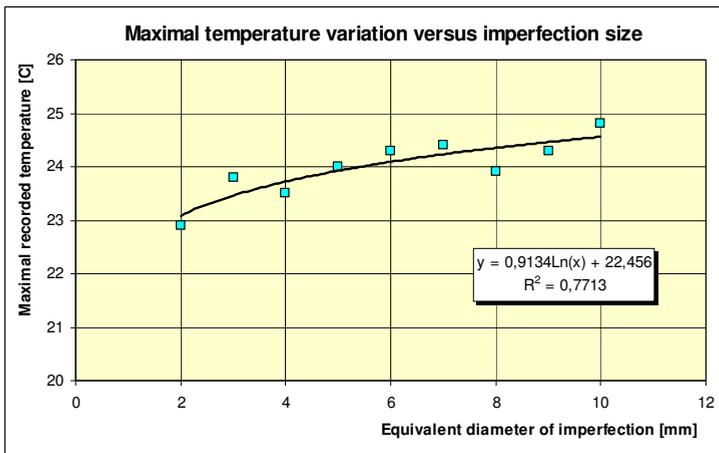
Fig. 13. Maximal temperature variation versus imperfection size

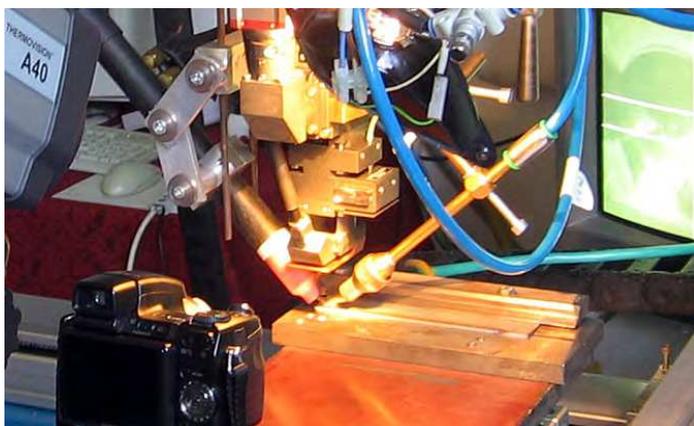
Fig. 14. Experimental system with 3 video acquisition systems: CCD camera, 25fps video camera, IR thermographical camera

The first steps in the development of the new laser-arc hybrid process required to investigate the hybrid process dynamics by doing bead-on-plate experimental work and using two video acquisition systems (one co-axial with the laser beam and one perpendicularly on the welding direction) in combination with thermal imaging of the processed area (figure 14) which proved that thermal imaging can be a tool fit for necessary investigations.

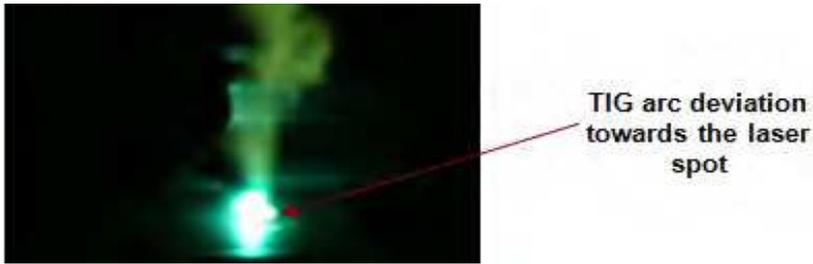
Fig. 15. LB (Laser Beam) generated plasma and TIG arc deviation toward the laser spot

While the video acquisition system allowed to reveal the way the two processes interact (figure 15), the IR thermography revealed important information regarding the intensity of the process interaction, the stability of the process by means of relative temperature variation of the processed area and why specific phenomena takes place (figures 16 and 17).

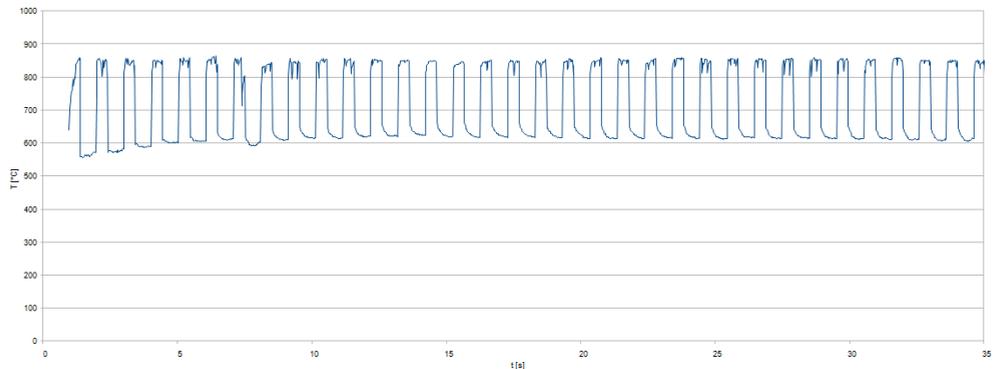
Fig. 16. Temperature variation of the monitored area (process variant: pulsed TIG-laser,  $I_{av}=28A$ ,  $F_{recvW}=1Hz$ ):  $T_{max}=865.2^{\circ}C$ ;  $T_{min}=591.807$ ;  $Amplitude=273.4^{\circ}C$

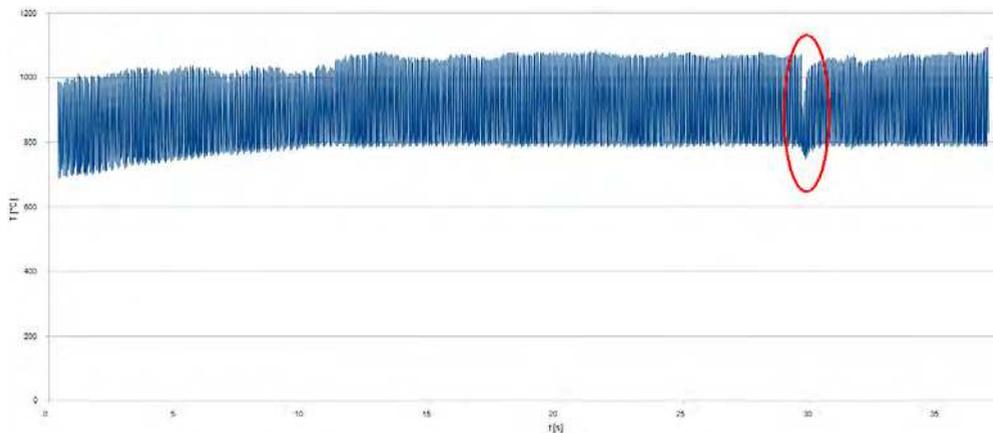
Fig. 17. Temperature variation of the monitored area for pulsed laser-TIG variant without laser protection gas at average TIG frequency (15Hz) – red circle indicates an instability

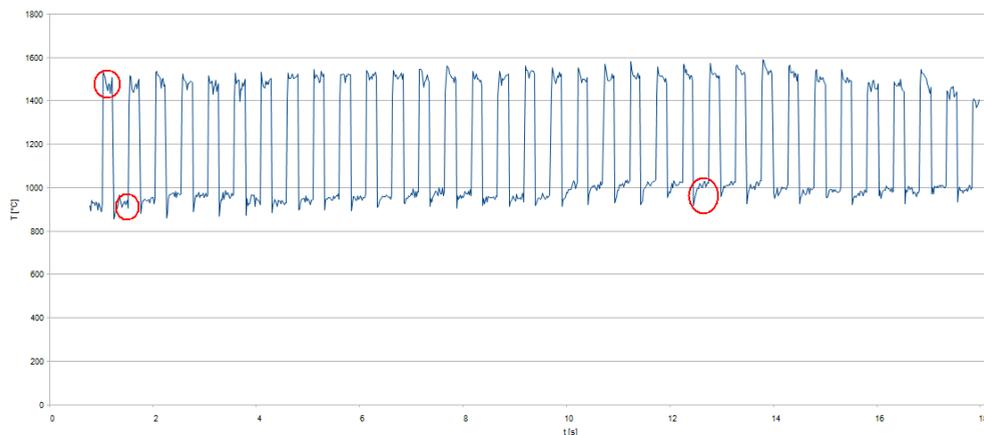
Fig. 18. Spikes in temperature variation (red circles) of the monitored area indicating the laser – arc interaction (process variant: pulsed TIG-LASER, TIG freq. 1Hz, ratTIG 40%)

The three specific coupling situations (Birdeanu et al., 2009) for the pulsed laser-TIG hybrid welding process – during the peak current, during the base current and during the base-peak-base current transition – could be also be identified, beside using the normal video acquisition system, using the thermal imaging with peaks of increases in the temperature of the monitored area, especially for the low TIG current frequencies (figure 18).

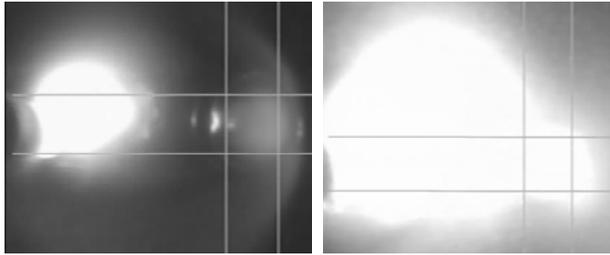
Fig. 19. Stronger influence on the pulsed TIG arc with pulsed laser beam as leading process both for base current and peak current regions ( $I_{av}=20A$ , TIG rat=40%, FTIG=1Hz) (Birdeanu et. al, 2009)

Other important information regarding the process stability and the laser beam – electrical arc interaction was determined by evaluating the maximum temperature variation of the monitored area during the process and correlating that data with the video recordings of the two video acquisition systems. By processing the acquired data and evaluating the maximum temperature variation of the process, it was determined that the LASER-TIG variant (laser beam as leading process) was more stable and this could be observed both by using the visual video recording by observing the TIG arc stability due to its deviation towards the laser beam spot (Figure 19), by visual inspection of the weld (Figure 20), which could be correlated to a slight increase of the variation of the maximum temperature difference but at an increased absolute value of the temperature (Figure 21).

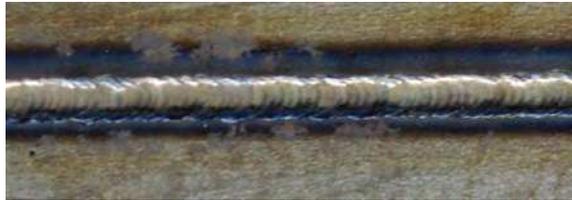
Fig. 20. Welded bead visual aspect for LASER-TIG variant

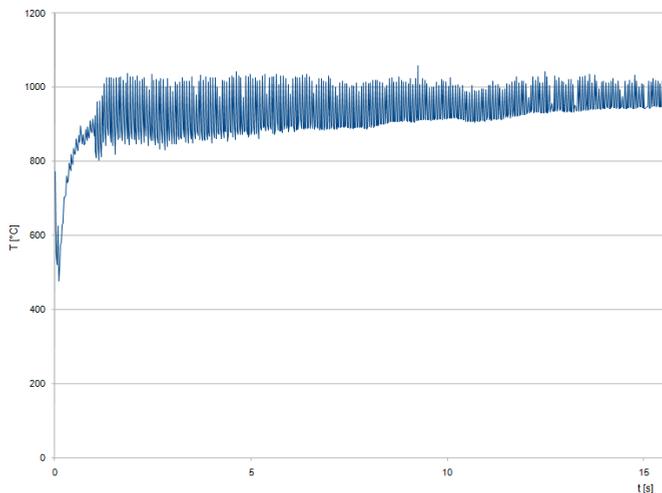
Fig. 21. Excerpt of temperature variation for LASER-TIG variant ( $T_{max}$ : 1058.251°C,  $T_{min}$ : 861.738°C, amplitude of temperature variation: 196.513°C)

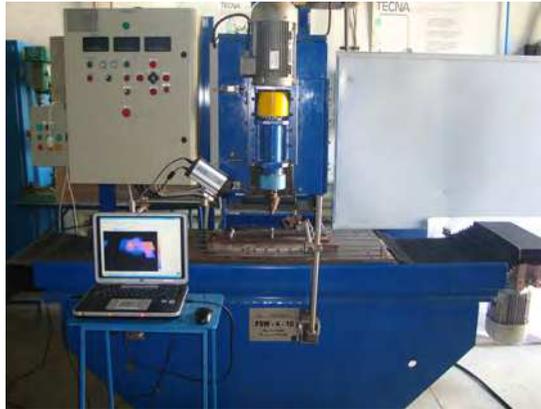
Fig. 22. FSW machine from ISIM Timișoara, Romania

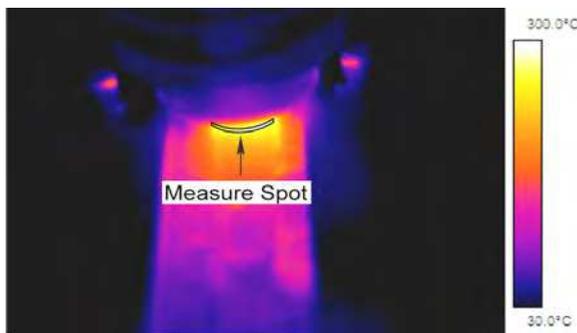
Fig. 23. Measure spot seen on the infrared image

The temperature recording was realized on-line, using a Thermo - Vision A 40 M camera, at an acquisition rate of 25 images/s. The camera was placed on the welding equipment, (figure 22) in order to trace the intersection zone between the tool shoulder and the weld surface, on the back semi-circle zone ( $\pi/2$ ), figure 23. The temperature recordings and processing were done by using the Thermo Cam Researcher Pro specialised software.

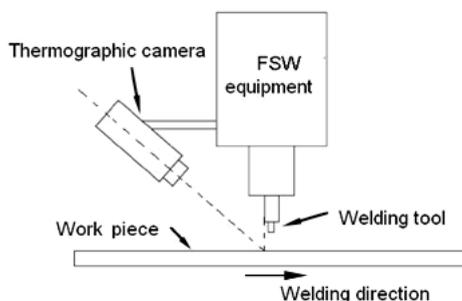
Fig. 24. Scheme of positioning for thermographic camera regarding to FSW machine

could be obtained. The measurements were made on the joint line at a distance of 1 mm behind the welding tool shoulder (figure 24).

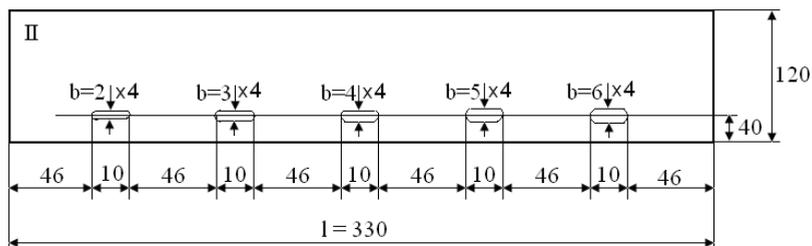
Fig. 25. Sketch of samples with simulated defects

The experiments (Dehelean et al., 2008a) demonstrated the viability of infrared thermography in detection of the defects during the welding process. The experiments were based on using different forms and dimensions for the artificial defects made in the welded sheets. The sketch with the positions and the dimensions, for the case of artificially simulated defects having elliptical slits with variable width 2-6mm and constant depth  $h=4\text{mm}$ , are presented in figure 25.

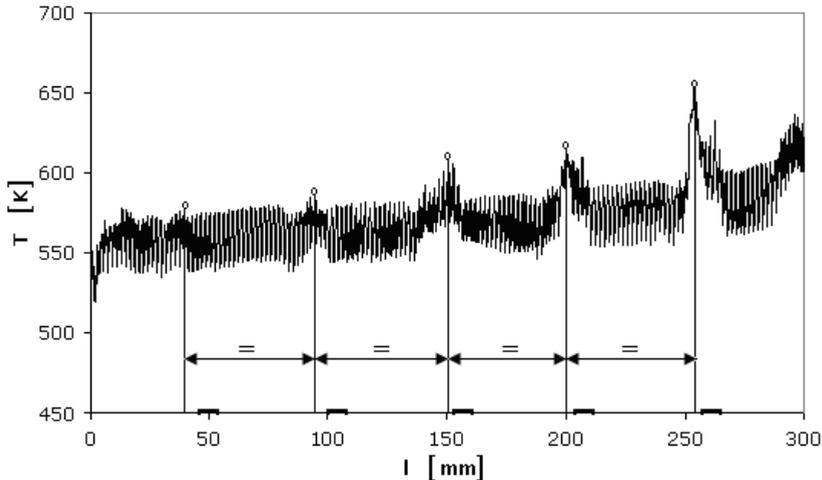
Fig. 26. MIT recording of the process

In respect to the temperature evolution, recorded by the thermographic camera, for the welds done over the open slots, the recording  $T = f(l)$ , presented in the oscillogram from figure 26 was obtained. Significant for the experiments are the “jumps” that appear on the temperature graphic, in front of the slits, due to local overheating.

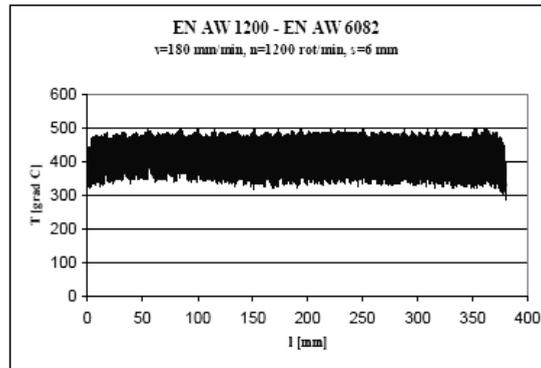
Fig. 27. Temperature evolution during FSW process

Based on the results obtained through the developed method by using simulated defects, one can mention good results in respect to the monitoring of the FSW process used for some concrete applications. By analyzing the temperature evolution diagram (figure 27), e.g. in case of welding of dissimilar alloys EN AW1200-EN AW 6082, uniformity is observed along the full length of the welded joint, after the welding process has been stabilized (after approximate 50-70 mm from the beginning of the welding process), (Cojocaru et al., 2011b) and, through X-ray analyse it was verified that the welded joint was free of defects. For such a welding application, after the stabilization process, the average temperature recorded in the joint line area was approximately 450°C.

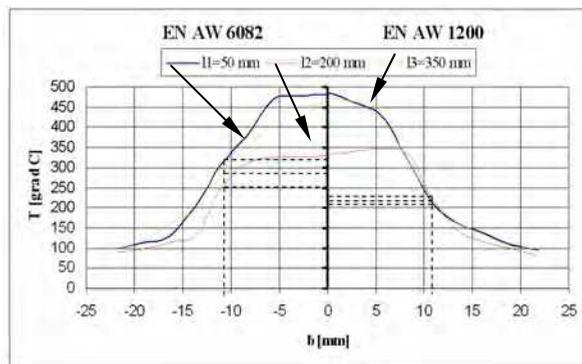
Fig. 28. Comparative evolution of temperatures

- before 50 mm of welding, the process is not yet stabilized and the optimum plasticizing temperature of materials (75-80% of melting temperature) was not reached.
- after the welding process stabilisation, the highest temperatures were recorded in the joint line area  $\approx 465^{\circ}\text{C}$ .
- in interference zone of the welding tool shoulder and welding materials, to  $\pm 11\text{mm}$  from joint line, the following temperatures were recorded:  $250\text{-}300^{\circ}\text{C}$  (EN AW 6082), respectively  $\sim 205\text{-}230^{\circ}\text{C}$  (EN AW 1200), (Cojocar et al., 2011b).

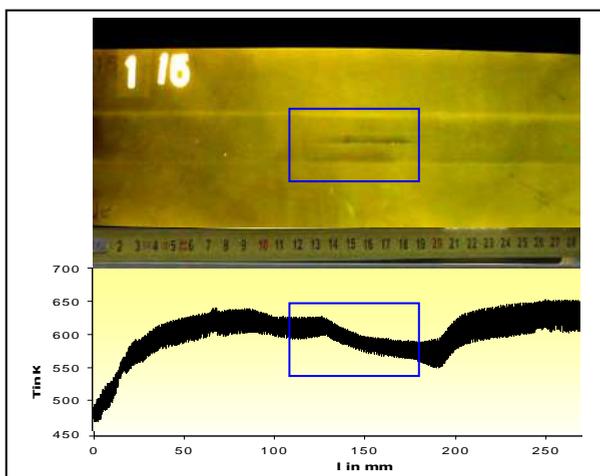
Fig. 29. Defect detection with radiographic control and correlation with temperature diagram

Another example is presented in figure 29 which shows the formation of a weld defect which occurred at friction stir welding of AZ31B magnesium alloy. The existence of the defect (revealed by X ray control) does determine a perturbation on the temperature diagram.

It was also observed an 80°C decrease of the temperature along the zone in which the defect occurred (lack of penetration), followed by an increase towards the stable values of the temperature after the defect position was overcome (Dehelean et al., 2008b). The cause of the defect was also identified being a malfunction/fault of FSW machine, which was characterized by ~ 40% reduction of rotational speed of welding tool. While the welding speed was kept at the prescribed values. The temperature developed during the process is directly proportional with the rotational speed, it decreased with about 80°C, reaching values below the optimum temperature for plasticizing of the welded materials. As a result of the machine malfunction, there was an insufficient mixing of the materials, a consolidated nugget was not achieved and a tunnel type defect did appear (figure 29).

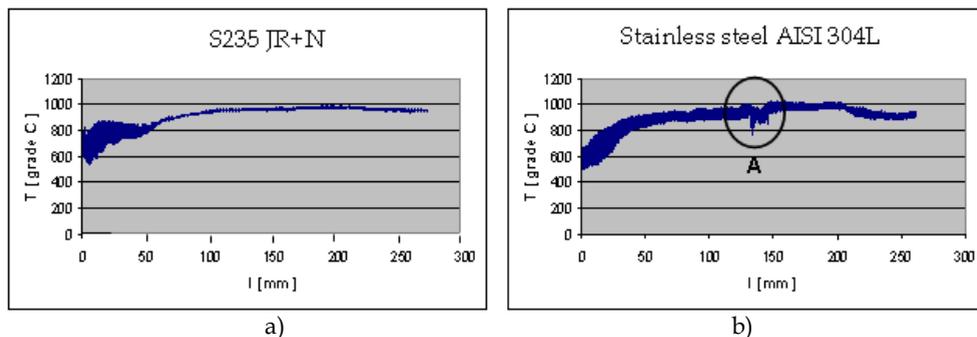
Fig. 30. Evolution of temperature monitoring by thermographic camera

Another particular case where IR thermography allowed the identification of a faulty condition occurred during welding experiments of AISI 304L stainless steel. Analyzing the evolution of temperature diagram from figure 30 b one can notice that approximately 150mm from welding start there was a disturbance (area A). The subsequent verifications of welded sample revealed that in that area a 20% pin damage occurred (a volume of approx.

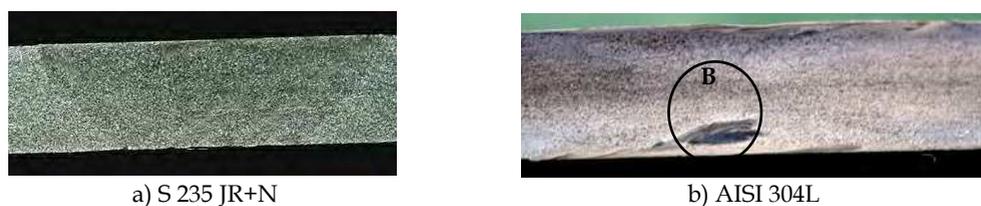
Fig. 31. Macroscopic aspect of welded joints

20% of pin broke, which remained „implanted” in the welded material, figure 31b, the area marked B), (Cojocar et al. 2011a).
