H₂S Pollution and Its Effect on Corrosion of Electronic Components

4.1. Corrosion behavior of silver and silver plated copper leadframes in H₂S polluted outdoor and indoor environments

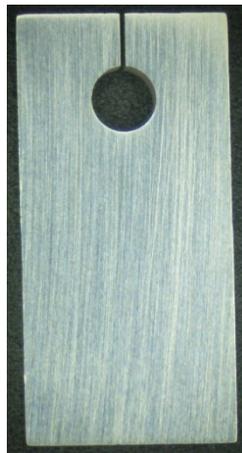
Figure 1. Metallic silver coupon

The exposure assembly was developed in Mexicali, Baja California, which is an urban semi-arid zone near to the Cerro Prieto geothermal power plant, the largest and oldest geothermal field in México. Prior to their exposure, the rectangular metallic silver coupons (99.95% pure and 10 x 5 x 1mm in size) were polished with silicon carbide (SiC) abrasive papers to 1200 grit, then were fine polished on a nylon cloth using a 3µm diamond suspension and finally were rinsed with deionized water and dried with nitrogen gas flow (Figure 1).

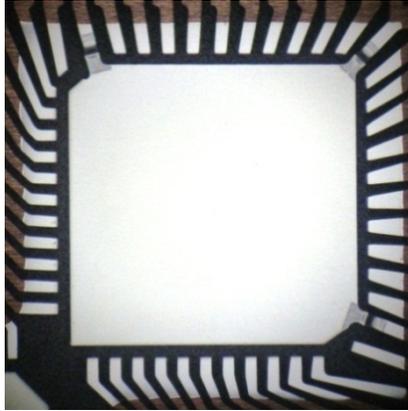
Figure 2. Silver plated on copper frame

The leadframes materials, used for a wide range of microelectronics devices, consist in a copper frame with a silver electroplated die paddle and leads to provide mechanical support to the die during the assembly process and for external electrical connection. Dimension of silver plated area is 6x6 mm with a thickness of 6.5µm (Figure 2).

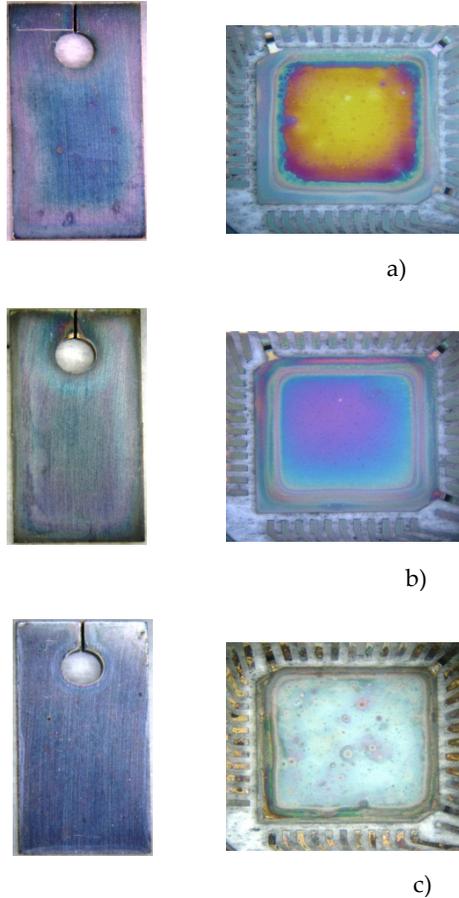
Figure 3. Tarnishing appearance of silver coupons and silver plated copper frames, after 60 days of exposure: a) inside the clean room, b) outside the clean room and c) in test chamber.

Exposure Site	Silver Coupons	Silver plated over leadframe
Inside clean room	Royal blue coloration in the center and slightly surrounded by purple in the edges.	Light gold coloration surrounded by purple and blue in the edges.
Outside clean room	Gray coloration in the center and slightly surrounded by purple in the edges.	Purple and blue coloration in the center surrounded by squared shaped lines of purple and royal blue. Small stains were observed in the purple centered area.
In test chamber	Uniform gray coloration.	Gray coloration surrounded by royal blue in the edge. Several purple and dark stains were observed along the silver plated surface.

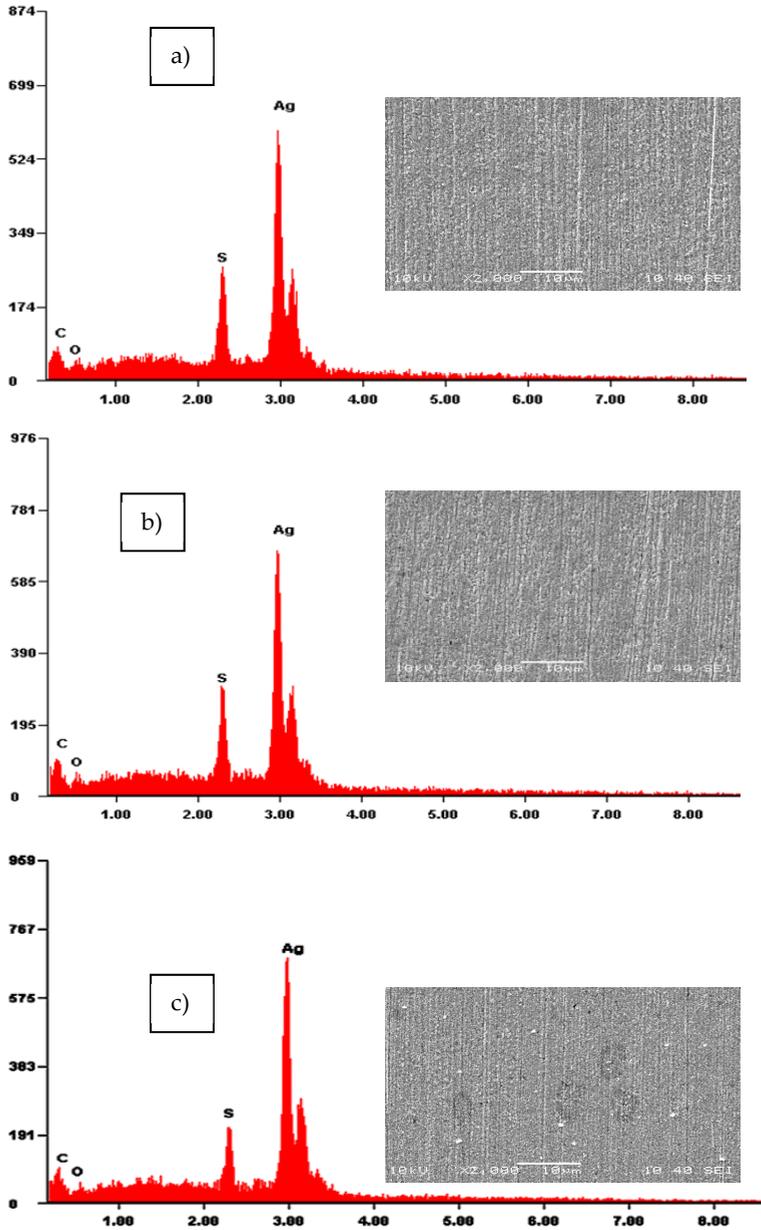
Figure 4. Results of SEM and EDS analysis of metallic silver coupons after 60 days of exposure: a) Inside clean room b) Outside clean room and c) Test chamber.

After each exposure time, the samples were analyzed by SEM and EDS in order to observe the corrosion products morphology and chemical composition. In the case of metallic silver coupons, it was observed an uniform morphology with absence of dendrites or whiskers, and the presence of silver sulfide (Figure 4). For the case of silver plated on copper frames, they presented dendrites along the corrosion film (Figure 5). Punctual microanalysis was performed over representative areas with and without dendrites and was noted that, the

areas with dendrites presented just a little higher silver sulfide composition but in general composition in both areas was similar in the case of samples coming from inside and outside the clean room.

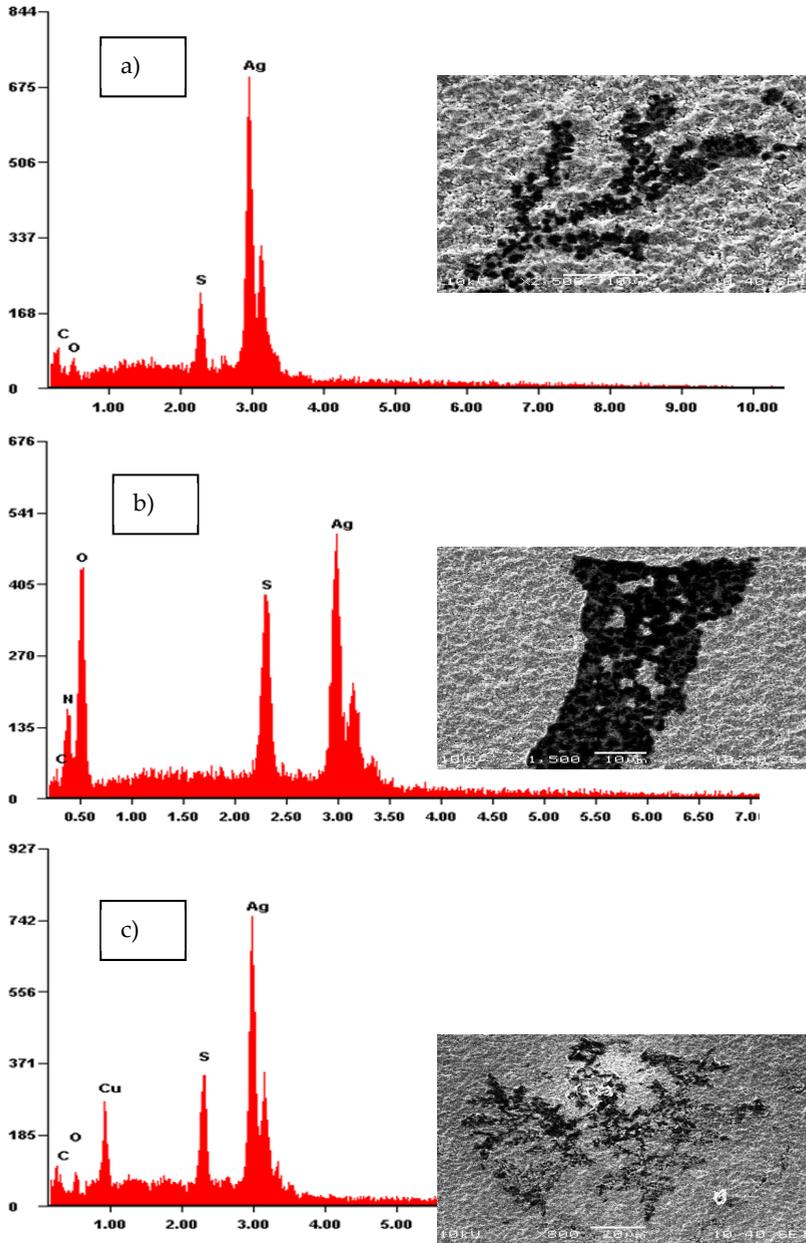
Figure 5. Results of SEM and EDS analysis of silver plated on copper frames after 60 days of exposure: a) Inside clean room b) Outside clean room and c) Test chamber.

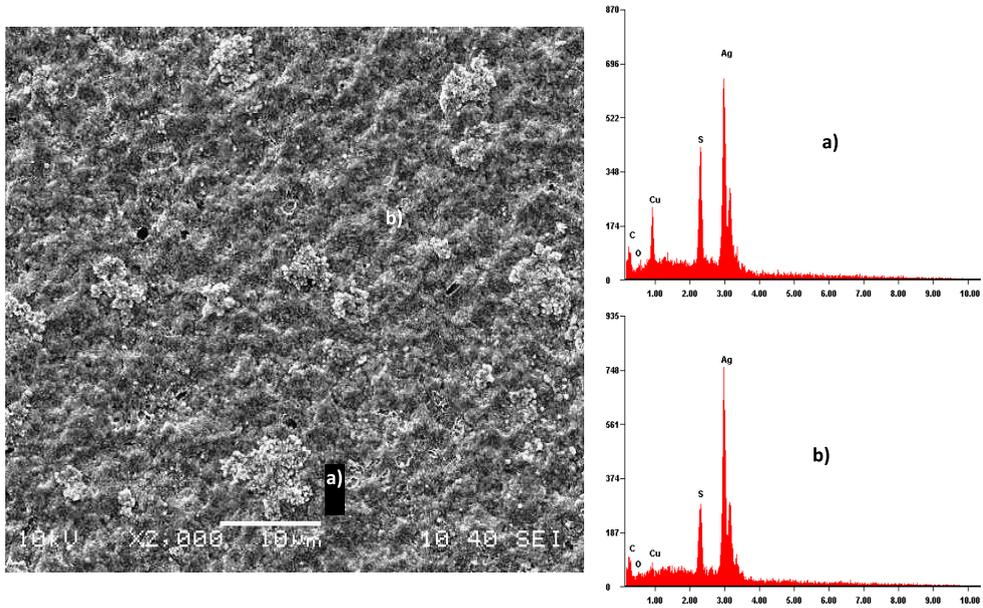
Figure 6. Corrosion products of copper in two different points (a and b) that comes from underneath the silver through the porosity of the plated layer.

In the test chamber samples microanalysis it was detected in the corrosion film, the presence of copper sulfide in addition to silver sulfide. Figure 6 shows corrosion products of copper that comes from underneath the silver through the porosity of the plated layer. EDS microanalysis confirmed the composition of rich zones with corrosion products of copper. This could be

happen in this site due to the higher conditions of RH and temperature. The thickness of the silver plated over copper is a very important factor in the reliability of microelectronics, when they are exposed in corrosive environments. A thick silver coating without porosity is highly recommended to avoid influences of the copper substrate on the corrosion mechanism for these materials. Regarding the exposure of metallic silver coupons to study silver corrosion over a long period of time, the presence of dendrites was observed after 12 months and after 24 months, thin branched whiskers were formed on the surface of silver (Figure 7 and 8).

On the samples exposed in the sheltered test chamber corrosion products of copper were noted due to the porosity of the silver plated copper frame.

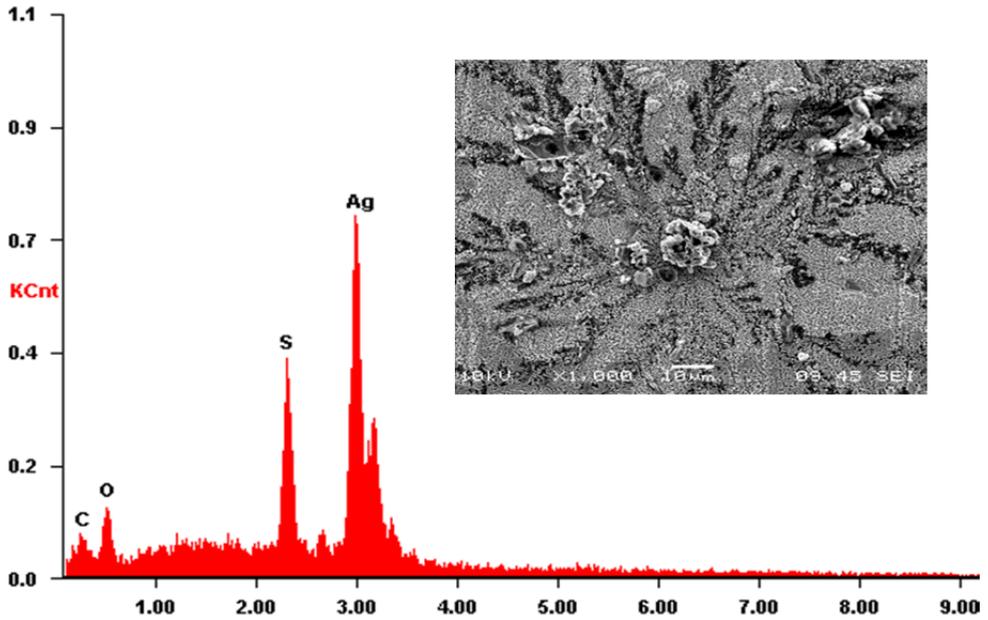
Figure 7. SEM and EDS analysis results for silver after 12 months of exposure in the test chamber.

Regarding the silver coupons exposed in the test chamber used to study the corrosion behavior in a long period of time, growth of dendrites after 12 months and growth of whiskers after 24 months was observed.

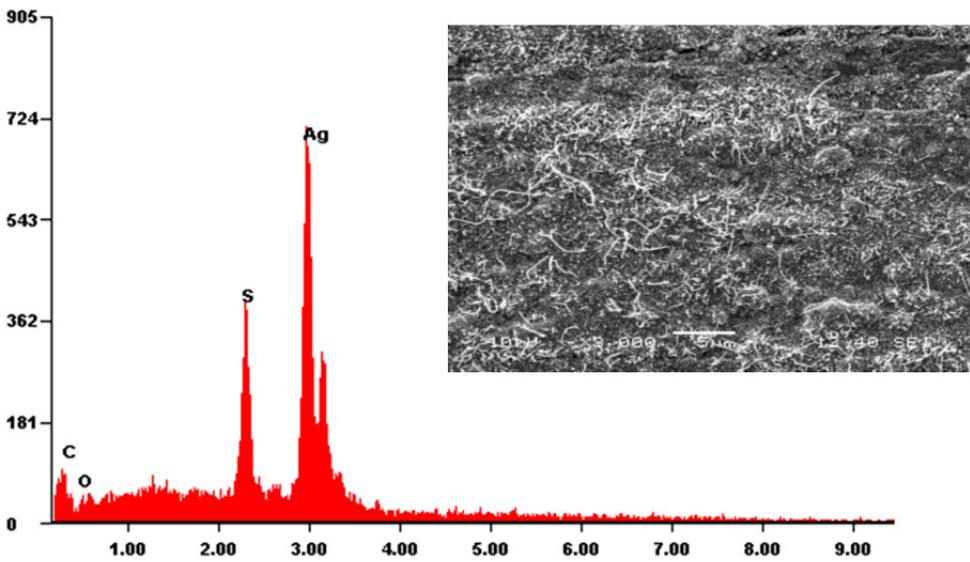
Figure 8. SEM and EDS analysis of metallic silver coupon after 24 months of exposure in the test chamber.

Since whiskers are elongated single crystals of pure metal, they are highly conductive and can cause short circuits and arcing in the electronic and microelectronic devices. There are different shapes of whiskers, they can be straight, kinked, hooked, or forked, and some are reported to be hollow. High temperature and certain thickness of silver sulfide (Ag_2S) are factors that favor the rapid growth of whiskers. (B. Chudnovsky, 2002)

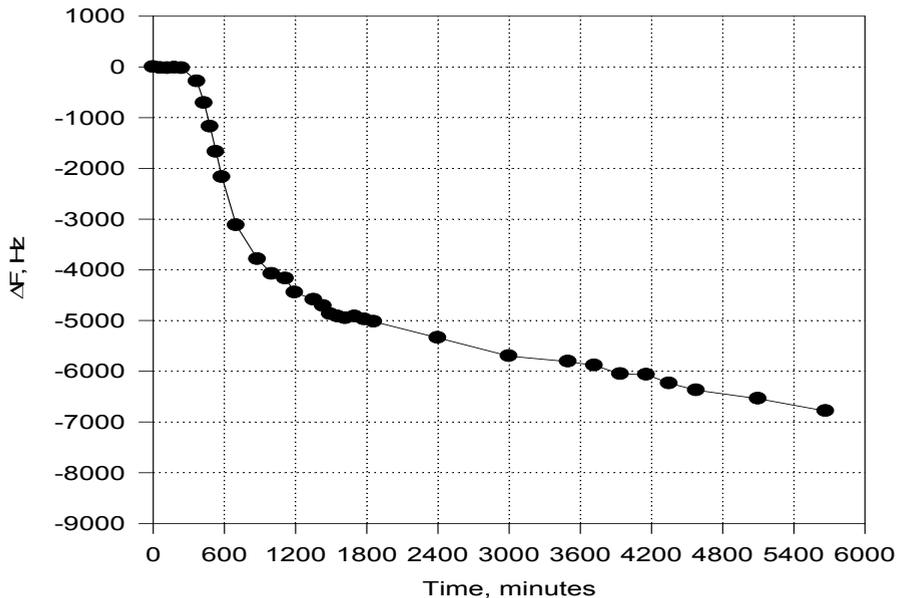
Figure 9. QCM Frequency – Time curve of active Ag surface at 25 °C, 38.7% RH and 0.5 ppm H₂S

This QCM technique was applied for real time determination of the mass gain and hence the corrosion rate and the Ag_2S layer average thickness. The specimens were Maxtek, 5 MHz, one inch in diameter polished quartz crystals covered by Ag on the active surface having a diameter of $\frac{1}{2}$ inch. The temperature was held constant (25°C) and the RH were monitored applying a Hygro-Thermometer Data logger during the experiment. The average registered RH value was 38.7 % with fluctuations during the experiment of ± 5.6 %.

The controlled H₂S concentrations were achieved by additions of known volumes of H₂S gas to the transparent plastic chamber containing, the covered by Ag one inch in diameter QCM quartz crystal serving as a specimen. A set of Frequency – Time curves were registered for H₂S concentrations in the range 0.05 to 1 ppm which values represent the minimal and the maximal concentrations of this pollutant, while the average annual value for Mexicali was found to be 0.1 ppm (B.G. Lopez et al, 2007). The frequency – time curve for 0.5 ppm H₂S concentrations is shown on Figure 9. The change of the curve slope about the 1000th minute can be explained with the thickness increasing of the formed Ag₂S layer, thus making difficult the further H₂S gas diffusion through it in order to reach the fresh Ag surface. Using the curve shown on Figure 9 it was calculated that the rate of the Ag₂S formation for the first 700 s represent 6.14 ng/cm.s while for the next part of the curve it falls almost twice to 3.27 ng/cm.s. The calculated rate of Ag₂S thickness increasing is 6 nm/s, for the first part of the curve and 3.19 nm/s for the second part. These values showed that the Ag₂S layer formation is very fast even at ambient temperature defining the need of measures to be taken for Ag surface protection.

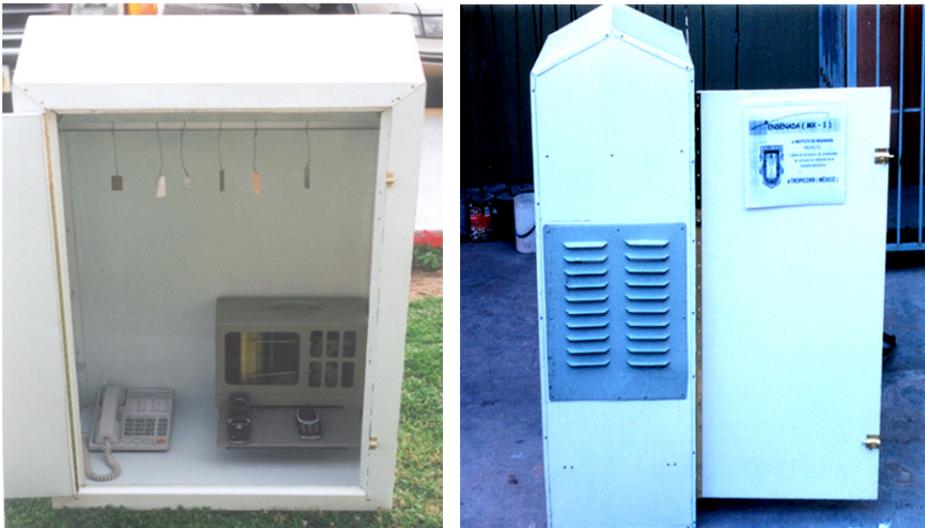
Figure 10. Simulation chamber for corrosion: left. Front view with installed specimens, Right. Side view with the ventilation device.

The specimens for corrosion tests were carbon steel, copper, tin, nickel and silver, with exposure periods of 1, 3, 6, 12 and 24 months in an upright position (ASTM G 1, G 4). An aluminum metal cabin, which allows free circulation of air, was built to simulate the conditions of indoor environments (J. Flores et al, 2006) (Figure 10), and installed 10 meters above the ground on the roof of a building. Subsequently the specimens were weighed on an analytical balance.

The corrosion products morphology was observed in a optical microscope before being cleaned and reweighed to obtain the mass loss on an analytical balance to the nearest 0.0001 g. The simulation chamber was fabricated with pre-coated aluminum and had a volume of 0.1m³ with two air inlets blinds coupled to metallic filters in order to permit the penetration of gases with the flow of air and to prevent the penetration of dust to avoid mistakes in the weightings. The Scanning Electron Microscope (SEM) was used and the chemical composition was determined by Electron Dispersive X-ray (EDS).

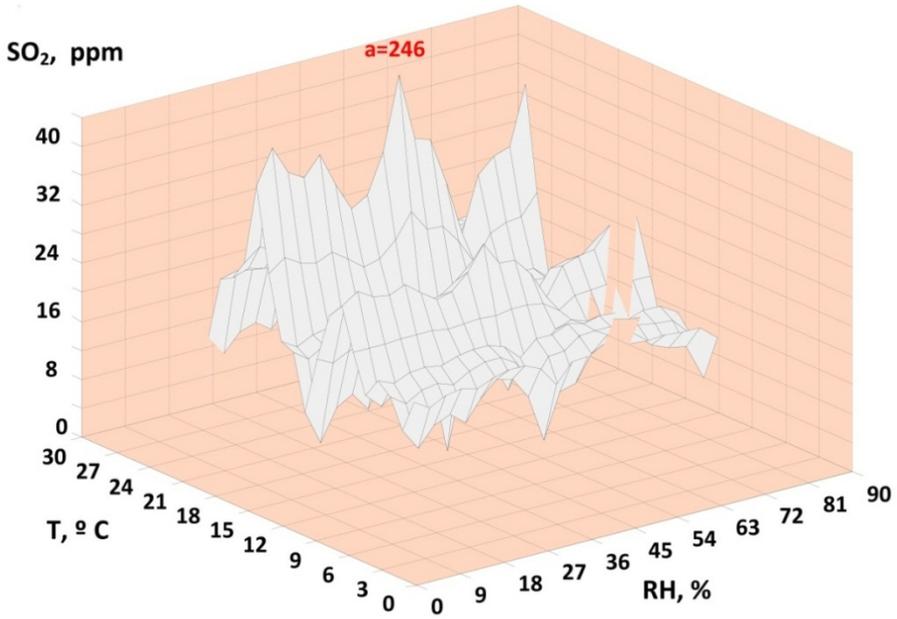
Figure 11. Correlation of temperature, RH and SO₂, a) represents maximum corrosion rate (mg/m².year) of copper

The Figure 11 shows the evaluation of corrosion of copper at 2 ° C to 13 ° C and RH of 34% to 70% indicating that the corrosion rate diminishes. At temperatures of 23 ° C to 30 ° C, with RH levels of 30% and 75%, the corrosion rates increases. This methodology was applied for the corrosion behavior of the other metals tested and the results showed a very good fit in all the cases. Nevertheless, it is necessary to analyze data from several environmental monitoring stations in order to establish a map of the main pollutants behavior by season, zone, climate, economic activities, temperature and RH for at least 5 years. This map must be the most possible closer to the real conditions.

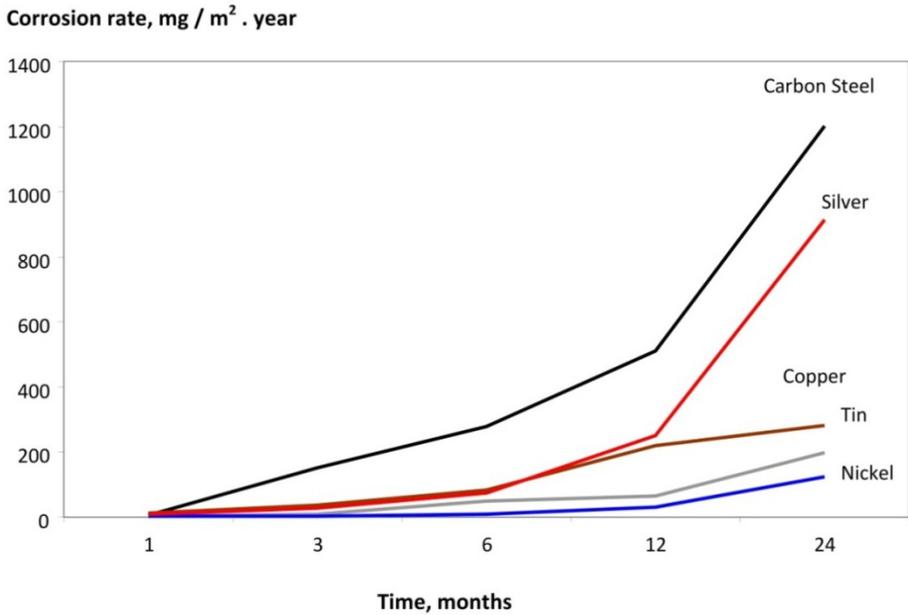
Figure 12. Corrosion rate of metals in the simulation chamber (2003 to 2005)

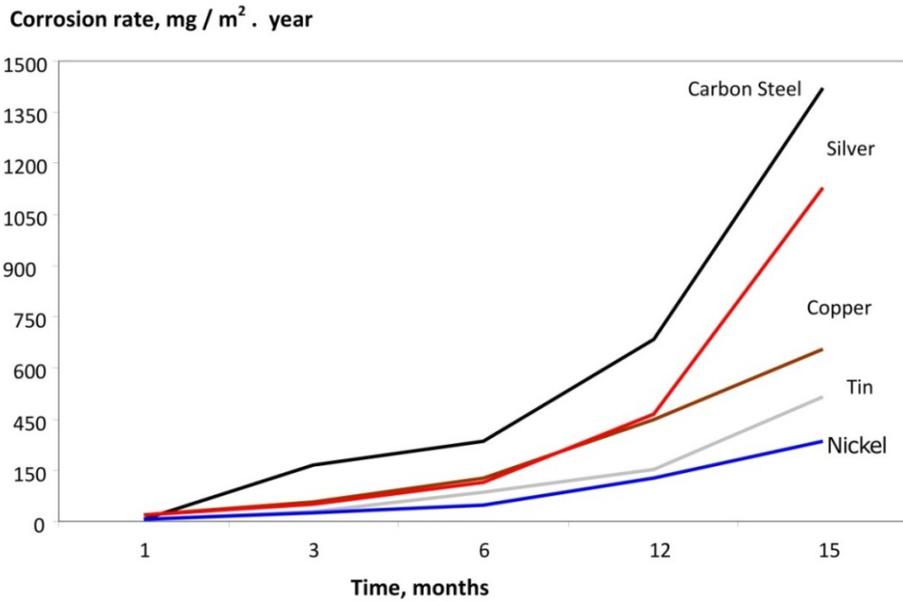
Figure 13. Corrosion rate of metals in industrial plants (2003 to 2005).

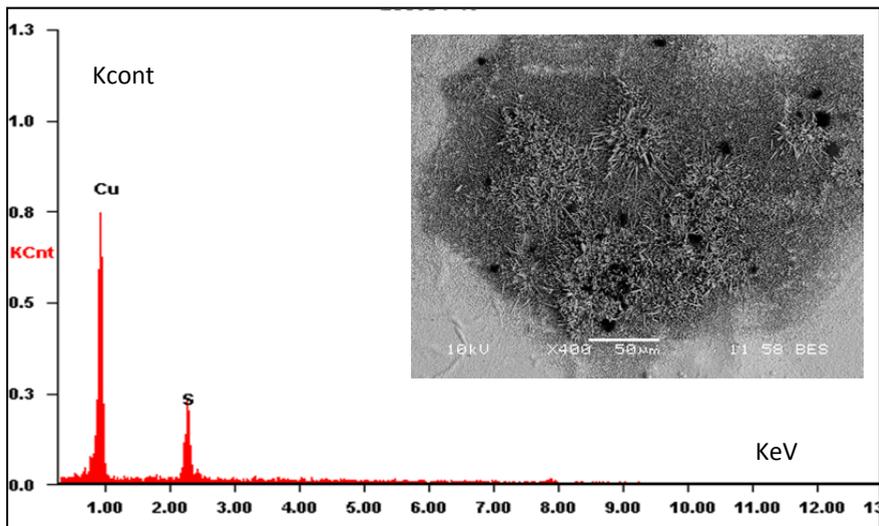
Figure 14. SEM microphotograph of copper after 6 months of exposure at indoors and EDX analysis.
