# Resonance in Electrical Power Systems of Petrochemical Plants

Job García and Gabriel García  
*Instituto de Investigaciones Eléctricas*  
Mexico

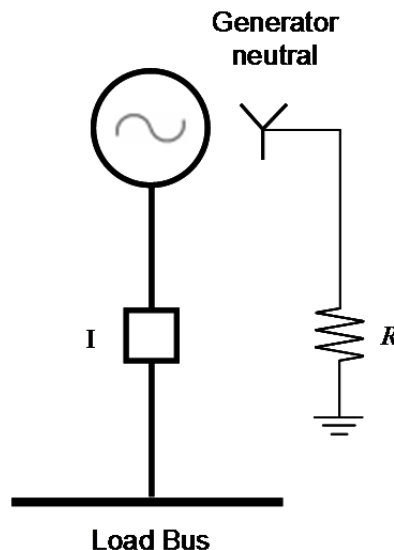
Fig. 2.1.1. Resistance with grounding.

In large systems where we have a high capital investment in equipment or losses which have a significant economic impact, we use the low impedance grounding [Manning, 1964; Shipp & Angelini, 1991]. In this scheme, a resistor is connected, normally a value that allows only a ground fault current of 200 to 800 A, through the neutral grounding system, see Fig. 2.1.1. As the grounding impedance is a resistance, any transient overvoltage is quickly damped and the overvoltage does not stay for a long time [Shipp & Angelini, 1991].

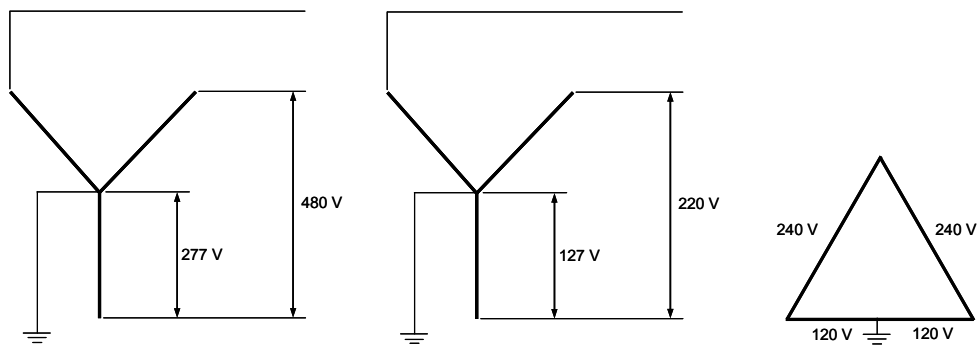
Fig. 2.2.1. Neutral solidly grounding.

Solidly grounding systems are the most commonly used. These schemes can be used in systems operating with a single phase loads, tending to a safe operation, see Fig. 2.2.1. If the system is not solidly grounded, the neutral system remains floating to ground, and remains as function of the load line to neutral and exposed to unbalanced voltages and instability [Shipp & Angelini, 1991].

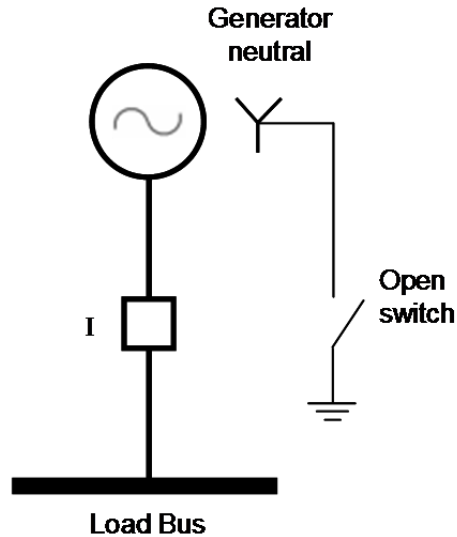
Fig. 2.3.1. Ungrounded neutral.

A floating system is used in those systems where service continuity is the main concern, see Fig. 2.3.1. The perception is that the floating systems provide greater continuity on the service. This is based on an argument that the ground fault current is smaller and therefore, the heating produced by the presence of such failure is negligible [Shipp & Angelini, 1991]. That way, the line to ground faults can remain on the system until it's convenient to remove them. This idea has some validity only if snapshots or "solids" failures are considered. However, in practice, most faults begin as ground faults by arcs of low energy. When starting a ground fault arc, we can have the following problems:

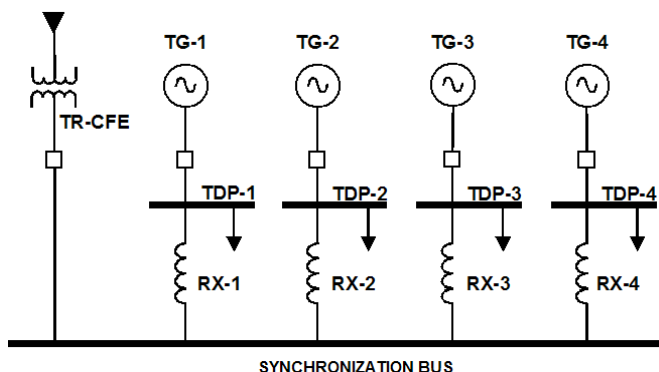
Fig. 3.1.1. Typical generation scheme of a petrochemical plant.

It is extremely necessary to maintain the electrical power supply of petrochemical power plants; therefore most of them have their own electrical energy generation. In some petrochemical plants there is a common practice to associate an electrical generator with a load connected directly to the electrical generator terminals. Most of the plants use 30 MW generators at 13.8 kV with a load on the order of 15 to 20 MW associated to their terminals. The generators are interconnected trough a synchronizing bus with short circuit current limiting reactors as shown in Fig. 3.1.1. The use of these limiting reactors is associated with voltage regulation problems and with the necessity to overexcite the generators, causing problems with generator stator core. However, the use of this scheme maintains the continuity of energy supply to the load sustained through the public network when generators are out of service.

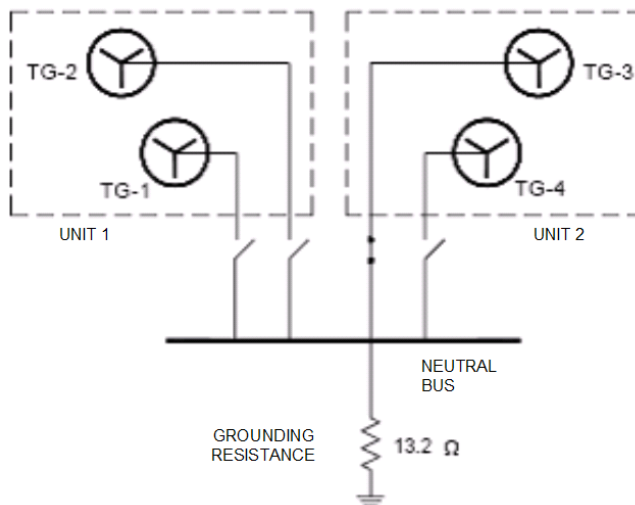
Fig. 3.2.1. Actual generator neutral grounding scheme.

The neutral grounding method used in a petrochemical plant is shown in Fig. 3.2.1. The system has two power units, the first unit consists in two generators of 32 MVA (TG-1 and TG-2) and the second one with 2 generators of 40 MVA (TG-3 and TG-4). The four neutral generators are connected to a neutral bus through an interrupter. The neutral bus has a low resistance bank connected to ground. Therefore, only one generator is connected to ground.

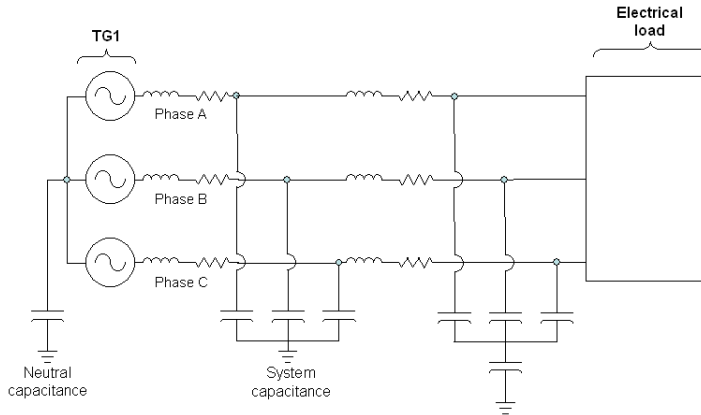
Fig. 3.3.1. Diagram of one generator neutral grounding.

Considering an ungrounded generator, that feeds an electrical load, as shown in Fig. 3.3.1. The generator model is represented by a source and an inductance in series. The cable and the load inductance are illustrated too. Also it represents the cables capacitance, the capacitors banks and the surge arresters.

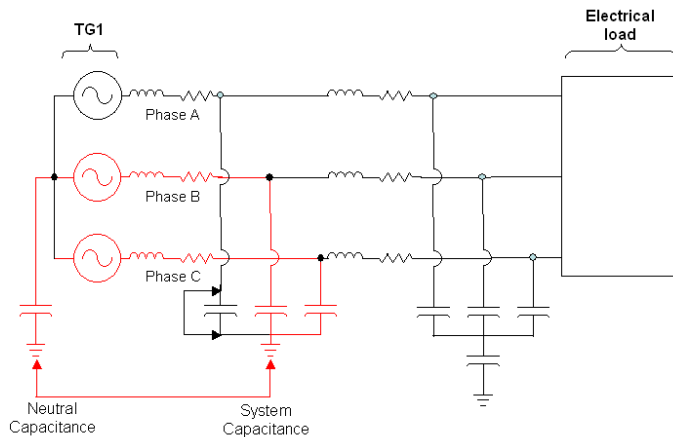
Fig. 3.3.2. Fault in phase A and current return path.

The system has a steady performance. The load is feeding by the generator; the neutral current is almost zero. The generator is grounded by its own capacitance. There is not current through the neutral generator and there is a third harmonic voltage of 1 kV peak to peak approximated. When a ground fault occurs in the system, a return current through the generator capacitance and a voltage appears through the neutral, which affects the voltage applied in the un-faulted phases, as shown in Fig. 3.3.2.

During the ground fault short circuit, the un-faulted phases have a distorted waveform. With this distorted wave, the generator supplies the demanded electrical energy in conjunction with the electrical public network. At this moment, the question is if all network with capacitance and inductance distributed values of all component, are in resonance or it is represented in somewhere of the circuit where it has appropriate tuned values. Founded evidences in some faults, demonstrate that resonance is located specifically and the damage takes place in the nearby equipments to the overvoltage site. The ground fault occurs in a different phase from that had failed previously. In practice, the second fault could occur at a different site where it occurred at the first time, the crucial condition is that the inductance and capacitance are synchronized and forming a series resonant circuit as shown in Fig. 3.3.2.

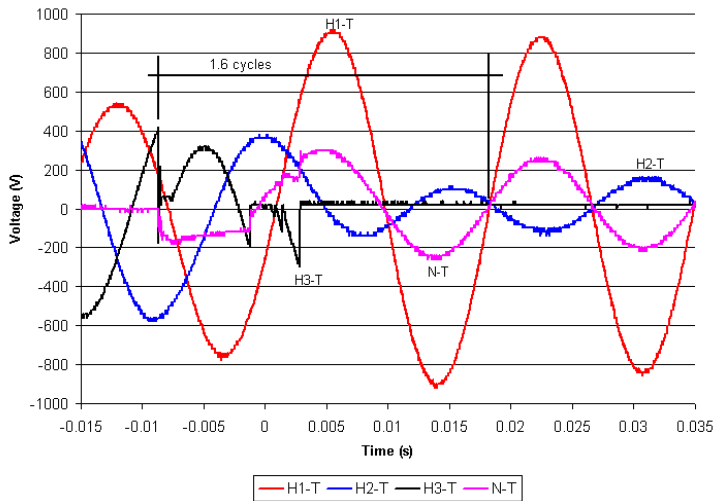
Fig. 3.3.3. Voltage increase in the no fault phase A into an ungrounded circuit.

When a current is injected through the neutral capacitance, the neutral potential increases, in such a way that ground potential of the phases change to voltage between phases due to neutral shift. Although it is negative, this situation is considered in the electrical systems designs. For example, power cables are designed with 173% of insulated level. As shown in Fig. 3.3.3, an increase in the magnitude for the next phase in sequence to the ground fault phase is observed.

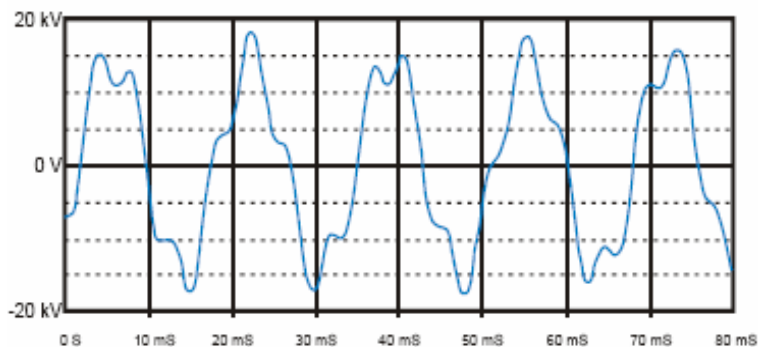
Fig. 3.3.4. Waveform of phase neutral voltage generated during a short circuit.

This voltage increase is not a problem for electrical equipments due to it is considered in design. The problem turns pessimistic due to short circuit current of ground fault phase to neutral, affecting the waveform of un-faulted phases, which stay with a no sinusoidal waveform. As a result of the interaction between fault phase and the others phases, it is obtained a waveform, as shown in Fig. 3.3.4.

During a short circuit the phase-neutral voltage is affected, and it is attributable to harmonics components, whose frequency depends on the generator inductance and capacitance equivalent values, furthermore, the equipments and accessories that are connected with the generator to a distribution switchboard. If a Fourier transform is applied to the voltage waveform illustrated in Fig. 3.3.4, it is possible to find the frequency of harmonic components. Fig. 3.3.5 exposes the Fourier analysis of generator phase-neutral voltage.

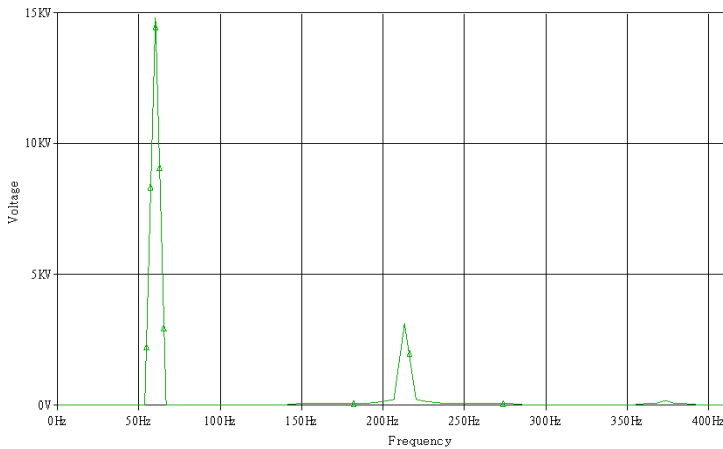
Fig. 3.3.5. Frequency spectrum of the voltage waveform illustrated in Fig 3.3.4.

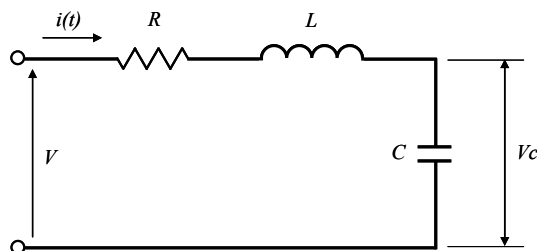
Fig. 3.4.1. Series  $RLC$  circuit.

In a series  $RLC$  circuit as shown in Fig. 3.4.1, the current  $i(t)$  is given by equation (1).

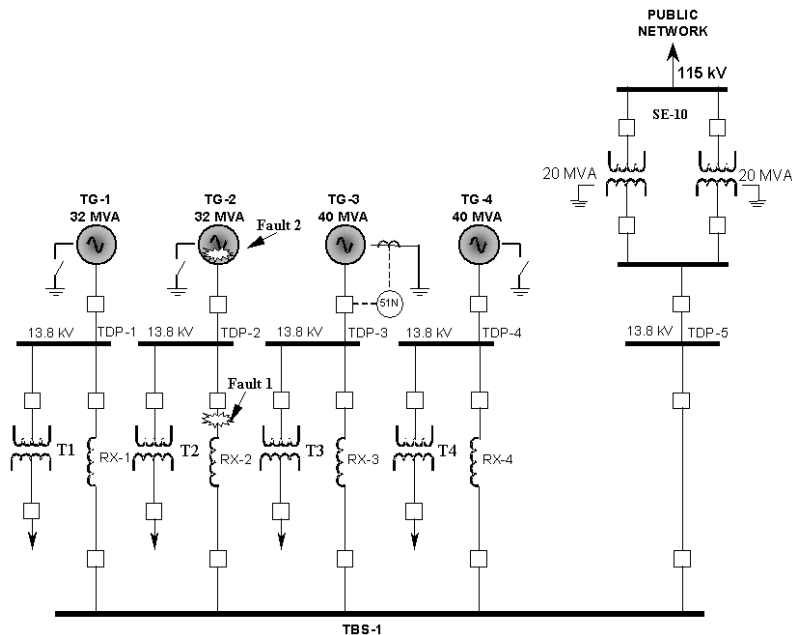
Fig. 3.5.1.1. Localization of faulted cable in the power electrical system.

The fault began with ground fault in the TDP-2 – RX-2 feeder (cable), see Fig. 3.5.1.1, when the ground fault occurred in this feeder, the negative sequence current circulated through the TG-3 neutral and TR-CFE transformer, condition that triggered the generator ground protection. After the trip from TG-3 also triggered transformer protection, therefore the power electrical system was temporarily ungrounded. Subsequently, TG-2 differential protection was operated. This protection operated because there was a ground fault in a coil of R phase into the TG-2 generator. Based on the system conditions at the time of TG-2 fault occurred, and the position of poles damaged, it is considered that this fault was caused, by the series resonance phenomena as a result of ungrounded system.

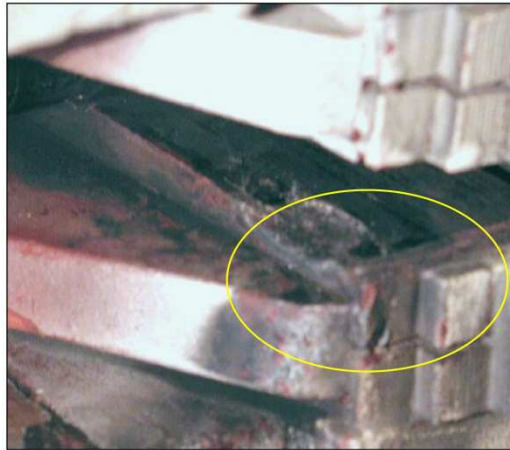
Fig. 3.5.1.2. Damages evidences in the stator core laminations of TG-2.

The generator core damage by electro-erosion, produce by arc flash, is shown in Fig. 3.5.1.2. The arc flash must begin by a magnitude voltage that broke the dielectric distance. For that distance, it is estimated an overvoltage that exceeding 100 kV.

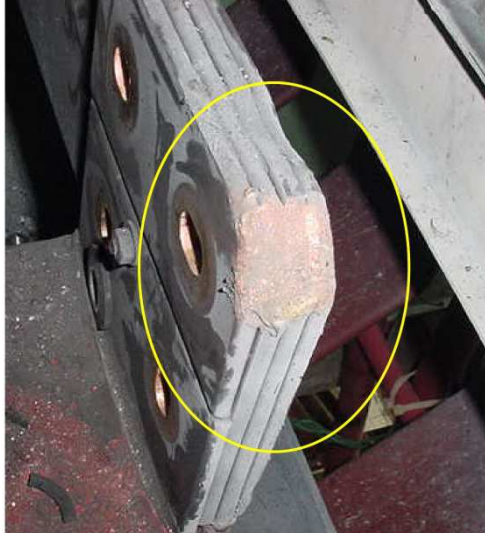
Fig. 3.5.2.1. Electroerosion damages by repetitive or intermittent ground fault arc flash.

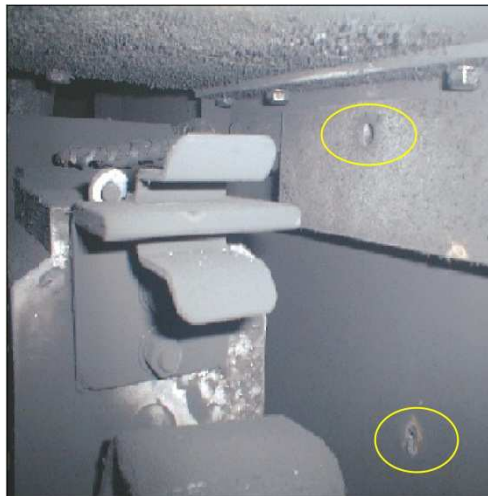
Fig. 3.5.2.2. Arc flash evidences between CT's and metallic walls.

Another switchboard fault was presented in this plant. The evidence showed that there was an arc flash between CT’s connection bars to the switchboard wall. A few minutes before the fault occurred in the 115 kV transmission line in the public network which was feeding the load plant, then it was produced an overvoltage in the 13.8 kV network of the plant. Due to the principal transformer is connected through a reactor to the synchronizing bus; the transient was spread to the feeder circuits connected to the bus. Due to the disturber in the 115 kV line service, the interrupter was operated. Immediately after, the load segregation system was operated.

The voltage regulator of the TG-4 generator tried to absorb the load, however, the generator left of operation by overexcitation protection. The TG-1 and TG-2 generators continued operating and feeding the not segregated load. Fig. 3.5.2.2 shows the evidence of arc flash between CT’s connection bars and the switchboard wall.

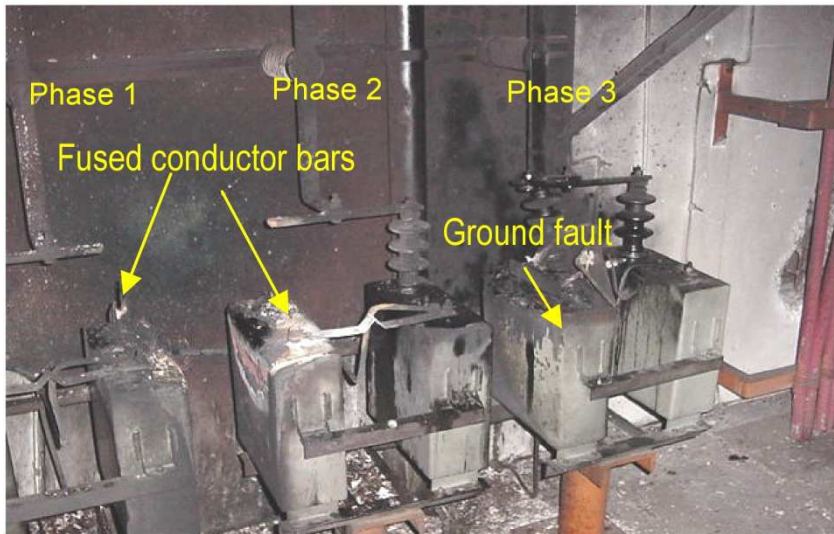
Fig. 3.5.3.1. Capacitor and capacitor bars connections damages.

In the cases above mentioned there was not an evidence of previous fault. In this case, the first fault occurred in a 13.8 kV cable feeder connected to TDP-1 switchboard about 200 meters away from where, 15 seconds after, occurred the second one. The second fault occurs in the called "cell fundamentals" where de protection and measure device's are located. The evidence shows that the generator surge protection capacitors were severely damaged, the connection bars were fused and the two potential open delta connecting

transformers, showed on their surfaces, a evidence of three-phase short circuit (see Fig. 3.5.3.1).

The fault began in a phase 2 feeder as a ground fault, it had produced an overvoltage in phase 3 with sufficient magnitude to cause the capacitor ground fault. The ground reference during the fault was in TG-3 generator; the current must be circulated through the ground resistance in TG-3. The fault performance was apparently like there was not a ground reference; the zero sequence current did not find ground return, it produced overvoltage in the not fault phases. This fact caused the generator operated like an ungrounded system.

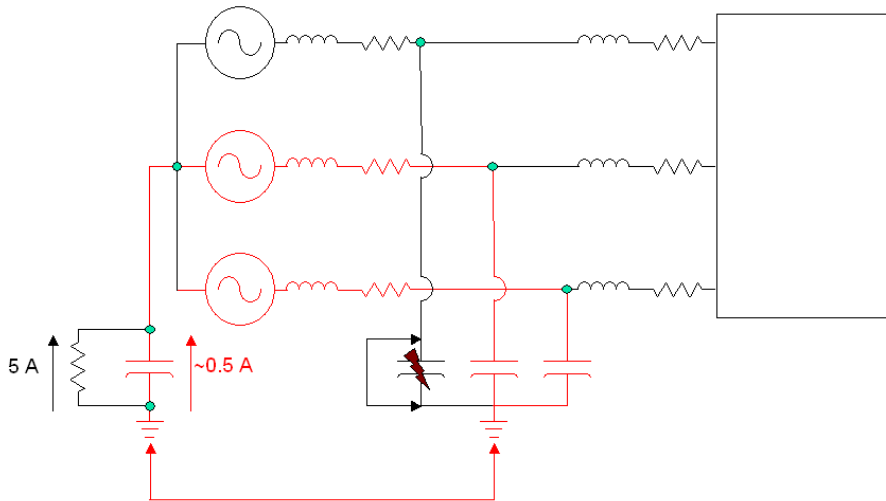
Fig. 3.6.1. High resistance grounded scheme to avoid resonance overvoltages.

It has been observed through the years, that in some instances, when there is a ground fault in the 13.8 kV system, the generator that has a reference to ground sees the failure and the protection system takes it out of service. In this conditions, the electrical power system remains without a ground reference without being able to release the failure. The short circuit currents is limited by the capacitance of the generator, that is in the order of 0.5 A. The injected failure current through the neutral produces a non sinusoidal voltage in the generator output. This voltage excites the failed system and a series resonant circuit can be excited. In this conditions a very dangerous overvoltages are generated. In practice, it has been observed arc flashover between electrodes that are 15 cm apart; and then the overvoltages are estimated in the order of 10 to 12 p.u. So, in order to avoid resonance overvoltages is necessary to have grounded systems to keep and intentional reference to ground. Fig. 3.6.1 shows a high resistance grounded system. When a ground fault occurs the short circuit magnitude is given by the high resistance value, in this diagram is 5 A. Simulations showed there are not maximums overvoltages more than 1.73 p.u. Finally, Fig. 3.6.2 shows a high resistance transformer installed in a petrochemical plant.

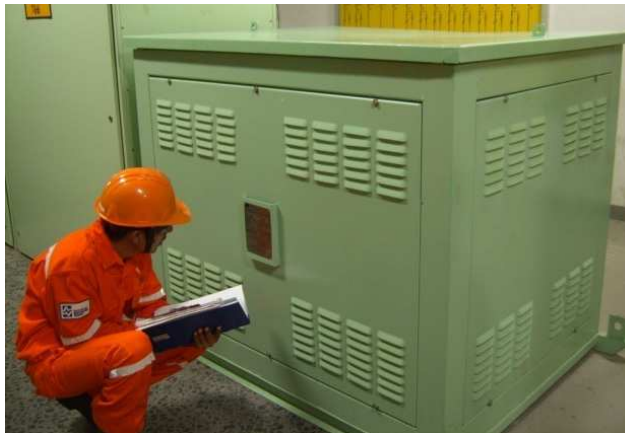
Fig. 3.6.2. High resistance transformer installed in a petrochemical plant.

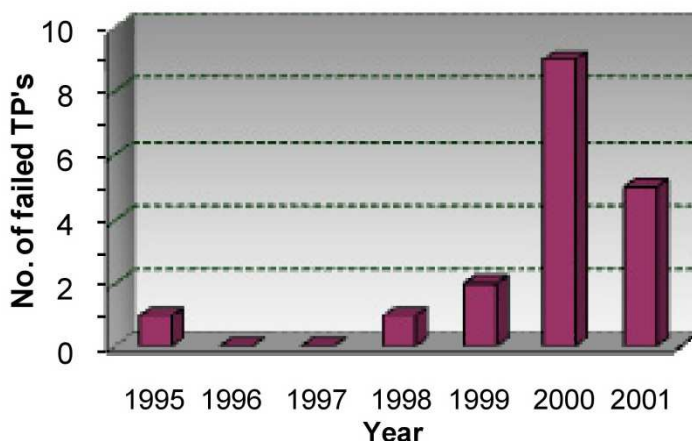
Fig. 4.1.1. Annual rate of PT's failures in petrochemical industrial plants.

The statistics regarding the incidence of failures in PT's, in some industrial plants indicate that as time passes, the number of failures in these devices increases substantially. For example, Fig. 4.1.1 shows the annual failure rate recorded in industrial plants until March 2001.

As shown in Fig. 4.1.1, the failure rate will increase. This is due to growth, sometimes excessive, of the installed capacity carried out without updating studies of the fault current levels and margins of safety switches and feeders. Also it is not considered necessary to make modifications to the grounding system. On the other hand, is a common practice in 13.8 kV to ground only one power equipment, either a generator or a transformer, so that the electrical system is exposed to surges by close-open events on switches, etc., which can be very large.

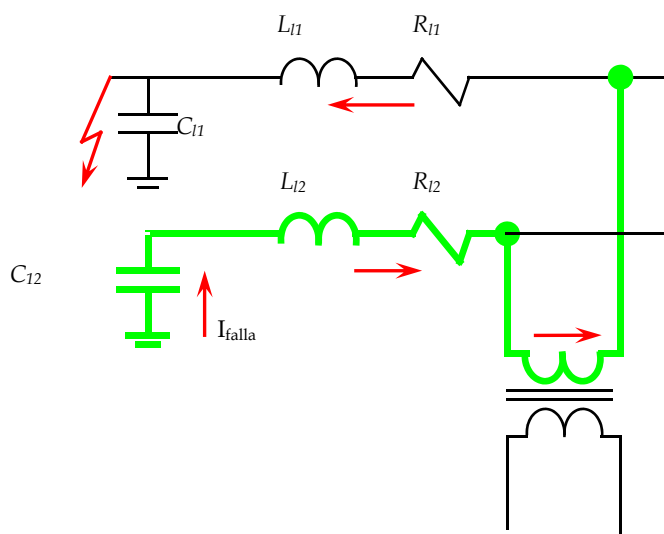
Fig. 4.2.1. Diagram of a PT in open delta connection.

The Fig. 4.2.1 shows that when a ground fault occurs, at the end of one of the feeders there is an RLC circuit formed by the resistor ( $R_{11}$  and  $R_{12}$ ), inductance ( $L_{11}$  and  $L_{12}$ ) and capacitance ( $C_{12}$ ) of the feeders. Under fault conditions the current flows through these elements, this stream may contain a component of a frequency (1 to 10 kHz) that could generate a series resonant circuit.

The typical primary winding inductance of a PT is into the order of 28.5 H at 60 Hz, if the power cable would have a length of 1 m, this would present a capacitance of 1 nF. Therefore, in order to present the series resonance phenomenon requires a 990.8 Hz frequency. On the other hand, in the industrial petrochemical plants surges were detected in 5 to 7 kHz. These surges may be caused by maneuvers or system failure, see Fig. 4.2.2. Therefore, it is concluded that the open delta connection of PT's makes possible the resonance effect.

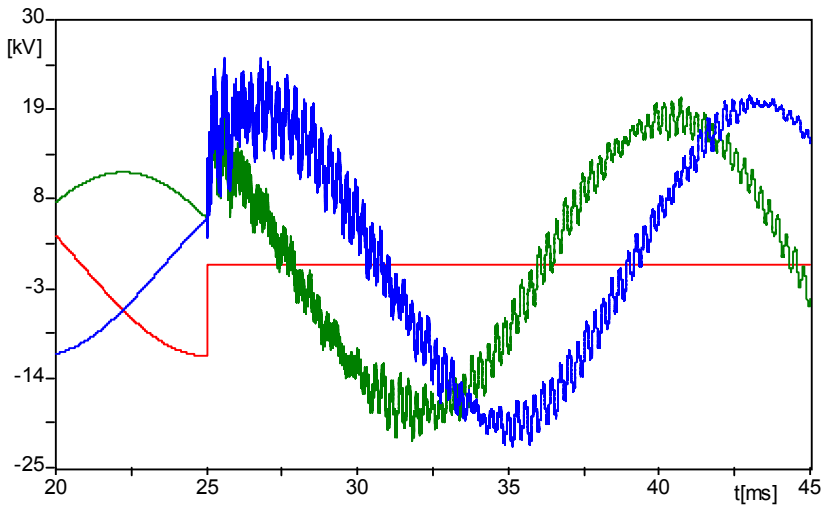
Fig. 4.2.2. Overvoltages registered in an industrial system due to maneuvers in the system itself.

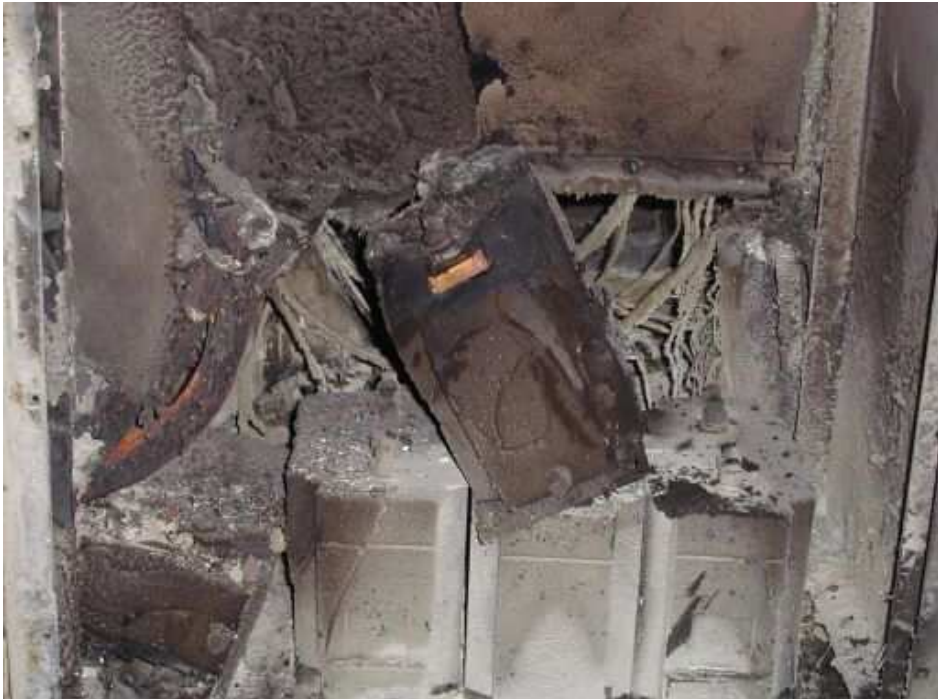
Fig. 4.3.1. Damage to the PT and panel where PT was connected.

Consider the following case, there was a failure of one of the PT's installed on the 13.8 kV level. The PT was located into a medium voltage switchgear connected to the output of a generator in an industrial petrochemical plant in Mexico. PT failure completely destroyed the switchgear that contained the PT, causing in turn the shot of the generators connected to the system and total loss of electrical power plant. As a result, the industrial petrochemical plant was out of operation for several hours, causing significant economic losses. Fig. 4.3.1 shows the damage to the PT, and Fig. 4.3.2, the damage on the switchgear.

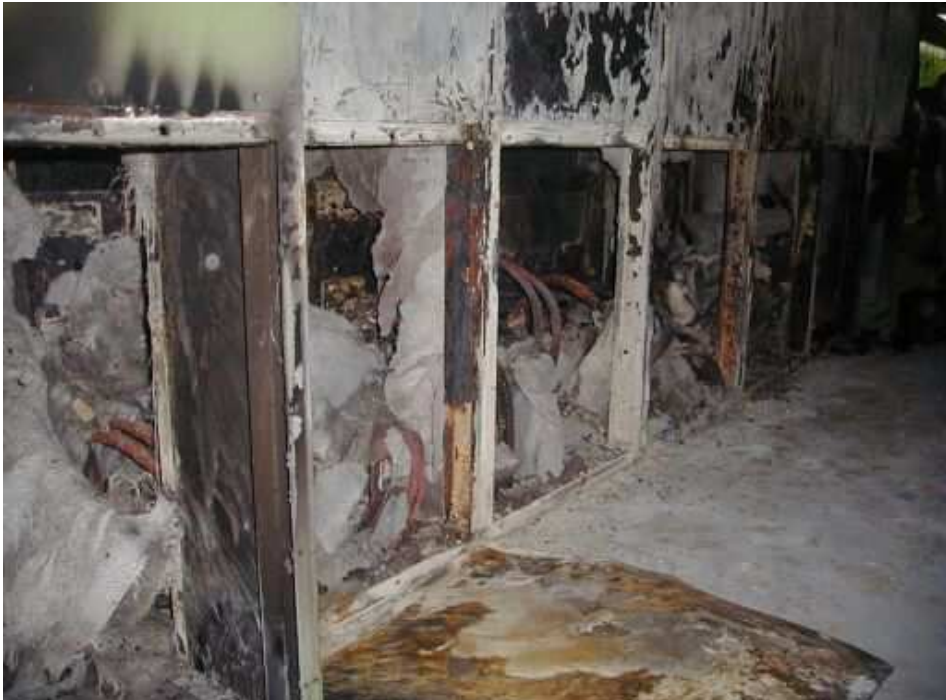
Fig. 4.3.2. Damage to the switchgear where the TP was connected.

The switchgear where PT was connected was of kind of metal-enclosed and was composed of 11 panels of 13.8 kV with a current capacity of 2,000 A. Nine of the panels were vacuum switches with their auxiliary equipment. One of the panels was used exclusively for measurement. The remaining panels, was empty because it could not be restored after the failure of one of the PT's occurred three years ago. One of the feeders of the switchgear was connected to one of the generators of the plant.

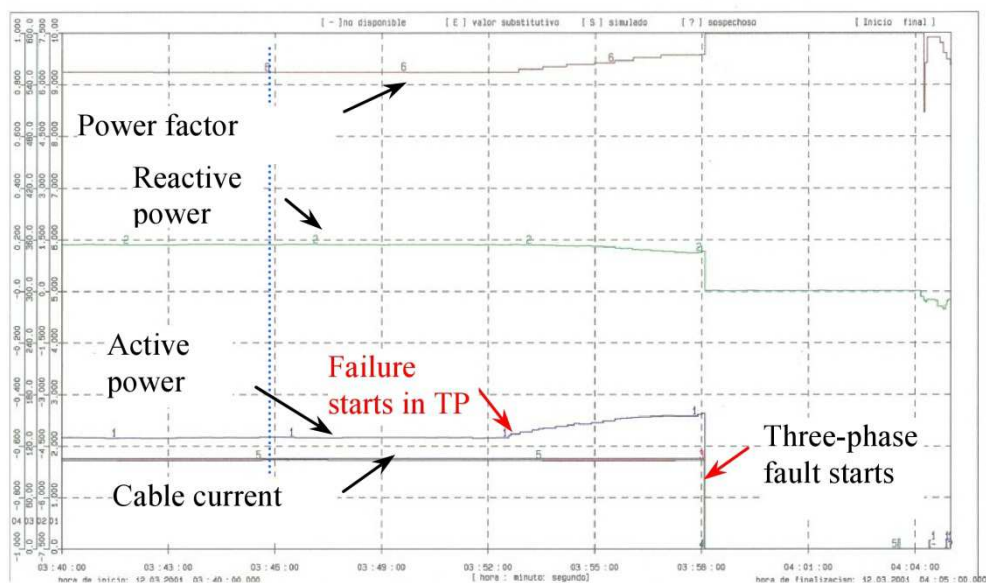
Fig. 4.3.1.1. Signals recorded of the feeder in the switchgear where the PT was installed.

The industrial petrochemical plant where the TP failure occurred has a monitoring and recording system for events and variables. Fig. 4.3.1.1 shows the data of voltage, current and power recorded 20 minutes before the failure occurred.

According to the records of power, there is an increase of active power on the order of 25% between 3:52:30 and 3:58.00. The PT had a two sections winding, each of 55 layers. Before the fault, the voltage was increased from 14.1 kV to 17.6 kV (25%). According to the transformer design, this means that one of the sections is affected at a rate of 12 seconds per layer. The initial conversion ratio was 120 and changed to 150 prior to the occurrence of the fault. That is, the transformer explosion happened after that was damaged 25% of the

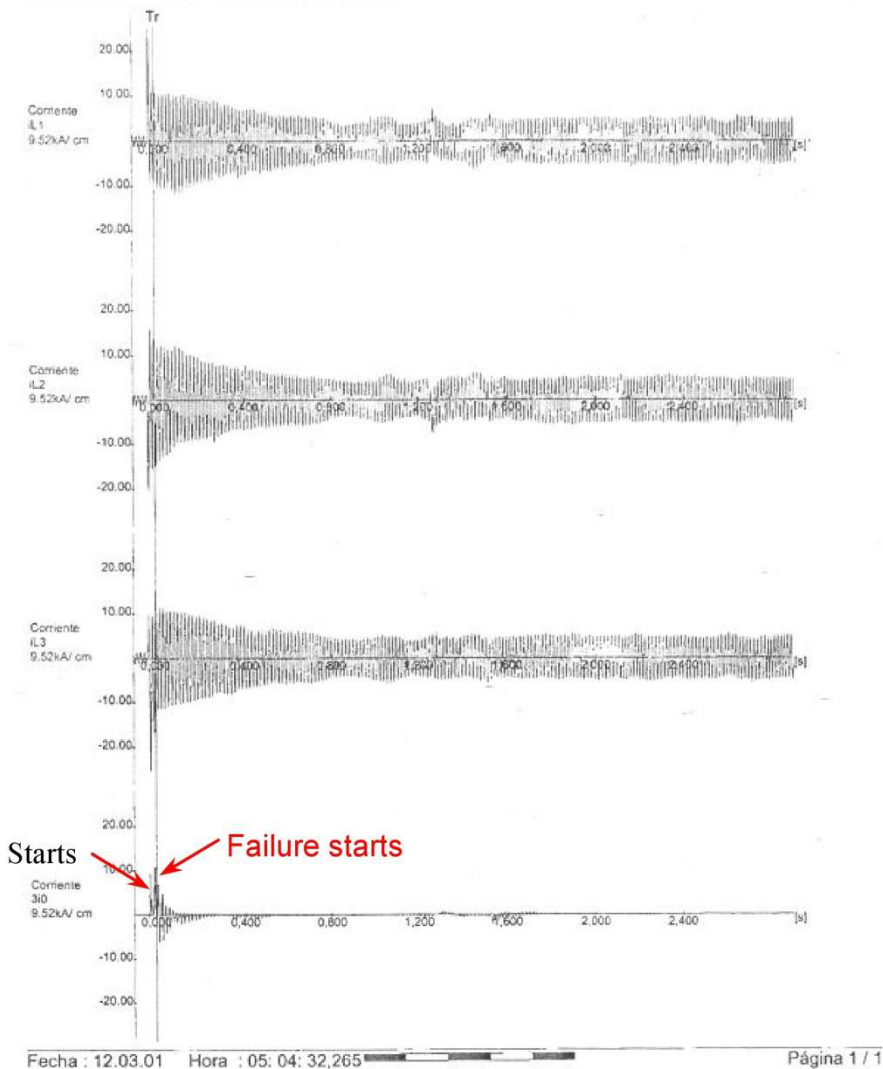
Fig. 4.3.1.2. Current signals recorded in the generator during the fault of the switchgear.

The system logs indicate that the failure of PT began 5'30" before the three-phase fault occurred on the switchgear, see Fig. 4.3.1.2.

Due to the open delta connection of PT's, it follows that the switchgear fire was started by the failure phase (between phases 2 and 3) of PT. According to the records of the fault currents, it is estimated that this event had duration of about 2 cycles (see Fig. 25). As shown in the figure, because the fault is a fault-phase, unbalanced residual current is generated through the common point of the current transformers. From the oscillograms it is concluded that the evolution of biphasic failure to three-phase fault was about 30 to 40 ms.

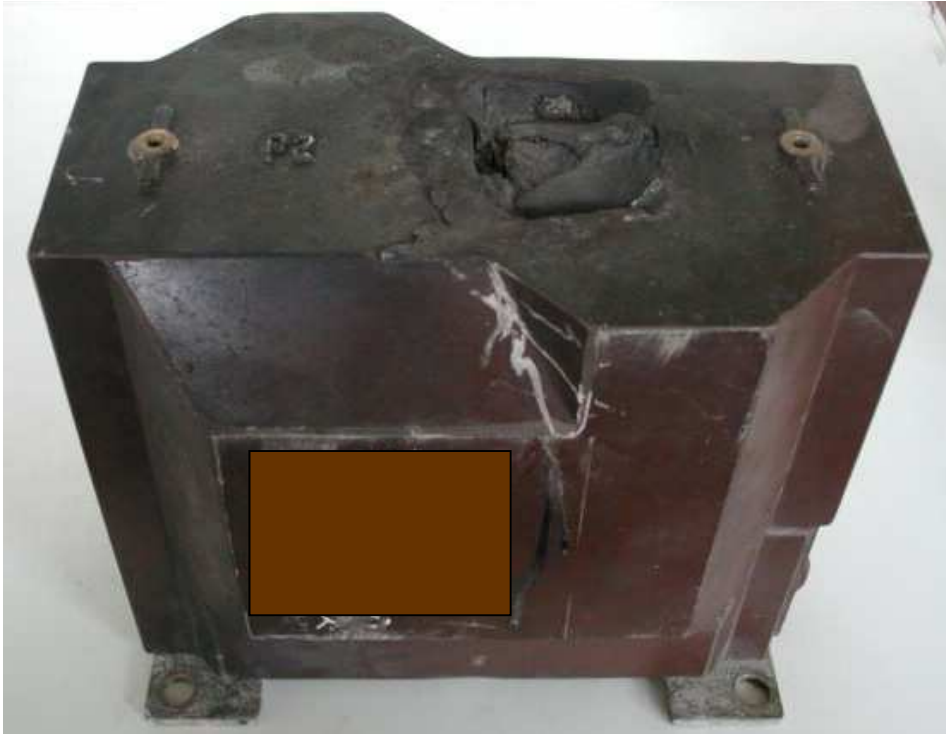
Fig. 4.3.2.1. Potential transformer that caused the failure in switchgear.

The failure of a PT can be started as a short circuit between turns or between rounds in the section of the primary winding of the transformer (see Fig. 4.3.2.1). The fault between turns can be maintained for a period of 5 to 10 minutes, until the pressure built up by the

An inspection at the failed PT indicated some manufacturing defects. Due to the arrangement used for the construction of the windings do not have adequate penetration of the resin between layers. This produces cavities between layers and therefore high levels of partial discharges.

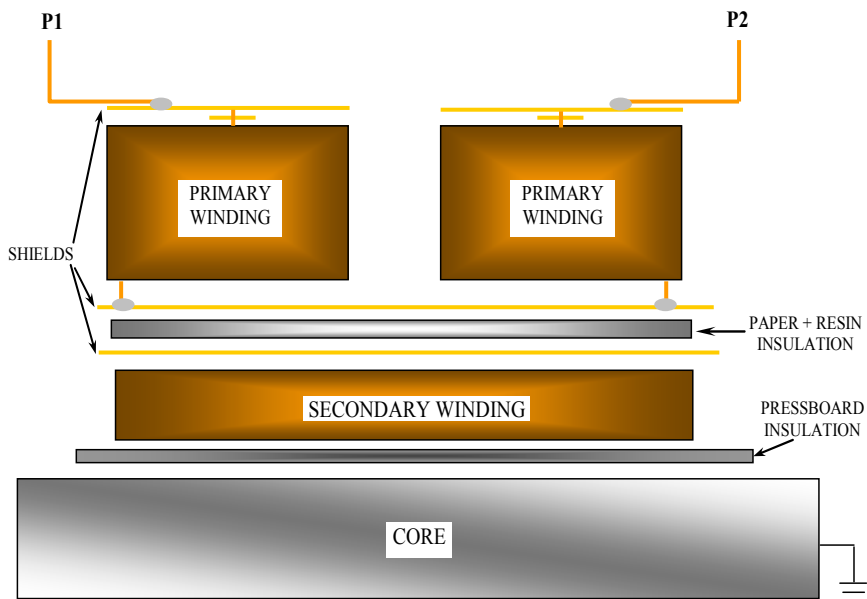
Fig. 4.3.2.2. Schematic design of PT.

The arrangement of the windings of the PT is shown in Fig. 4.3.2.2. Each different sections of the primary winding is made of 31 AWG wire, whose capacity for maximum current is 0.160 A, with a resistance of  $435 \Omega / \text{km}$ . Each section consists of 55 layers and 200 turns per layer so that it has an electrical gradient of about 130 V per layer. Between each layer exists one or two layers of insulating paper impregnated with varnish. It has 3 metal screens (brass) placed in different areas, which are not only used to obtain a uniform distribution of the electric field inside the PT, but also serve as a connection between the different windings.

The core of the PT is covered with cardboard. It is estimated that this arrangement is used to absorb the mechanical stresses (expansion and contraction of materials) produced during the curing of the resin. This will reduce the possibility of fracture of the encapsulation of PT.

It was detected a manufacturing defect in the high voltage windings of PT. In the section that connects the terminal P2, shows a surplus of winding and insulating material in a way peak. That is, the coil is not parallel to the core, which causes the protruding part of the coil winding.

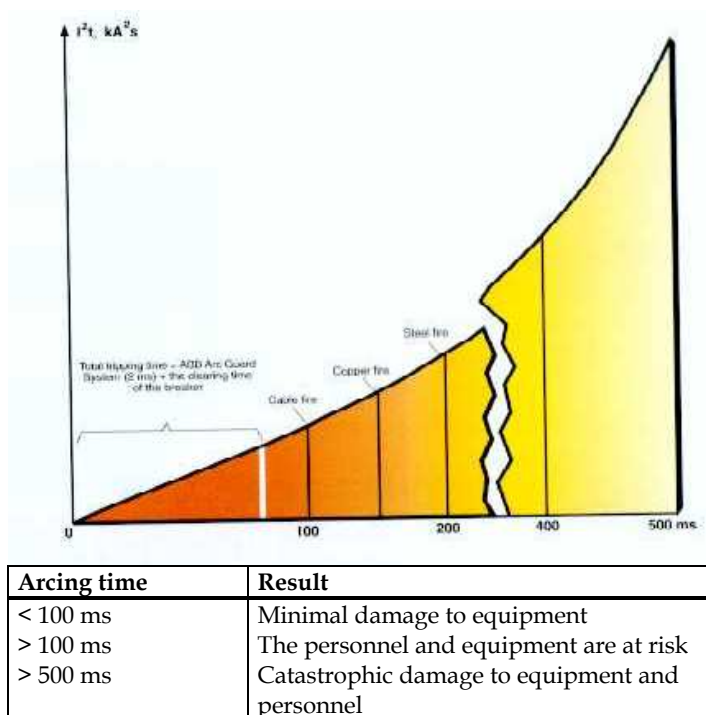
Fig. 4.3.3.1. Graph damage caused by an arc of power versus time.

Fig. 4.3.3.1 shows the relationship between arc duration and damage in different materials of the switchgear. This figure shows that from the 500 ms the damage caused by the arc can be considered catastrophic.

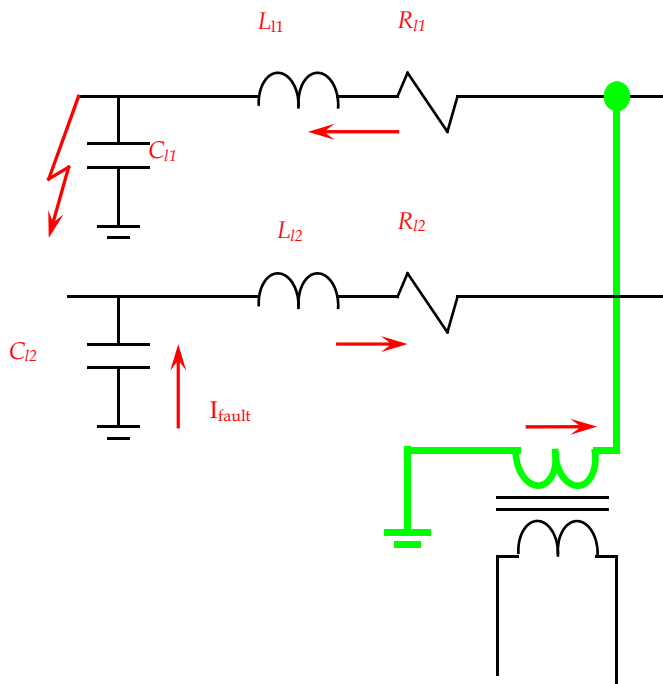
Fig. 4.4.1.1. Circuit connecting a grounded wye PT.

When a failure occurs in the grounded wye connection of PT's, the fuse will act protecting the PT. It is necessary to prevent failures that may arise between phases to prevent arcing that could ignite the switchgear. It is necessary to install non-flammable separators between the panels of the switchgears to prevent fires from spreading to other panels.

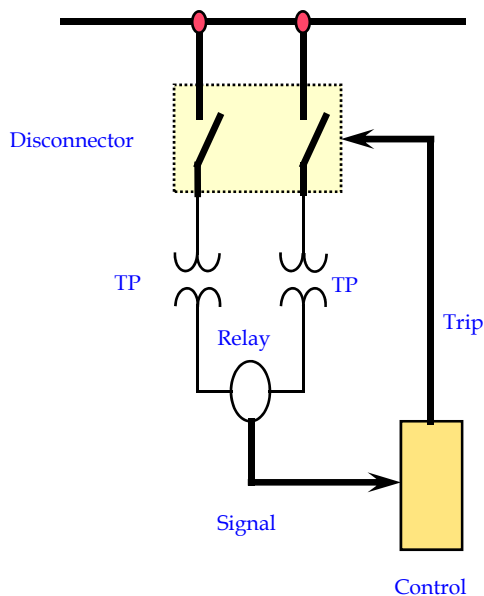
Fig. 4.4.2.1. Connection of disconnector link under load conditions in open delta PT's winding ircuit connecting a grounded wye PT.

Another way to avoid damage in switchgears due to faulty PT's is installing disconnects under load conditions in each of the phases of the open delta, see Fig. 4.4.2.1. Since the failure process is slow it can be detected through a relay to operate as a differential voltage and sent a signal to open a disconnect. This change is easy to implement in new switchgears and requires a specific analysis for each switchgear due to the fault currents that may arise in each.
